CLARK &
ENERSEN

CHURCH OF THE HOLY SPIRIT
FACILITY CRITICAL NEEDS ASSESSMENT

JANUARY 2024

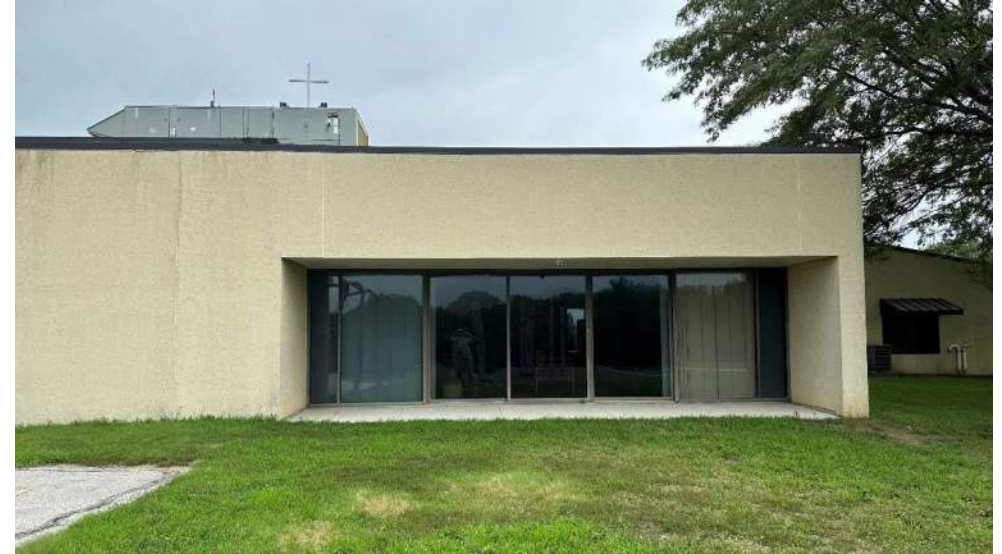
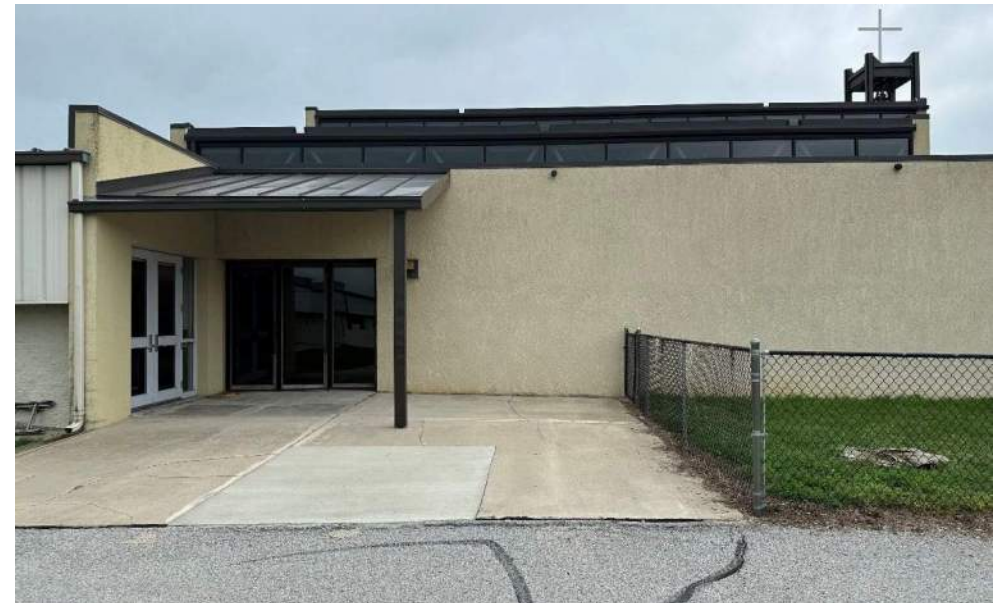
- Pipe downspouts below grade to limit water adjacent to the building.
- The grade is fairly level around the building.
 - Future projects (noted later in the document) should take into account the flatness around the building to increase slopes and promote drainage away from the building and paved spaces.

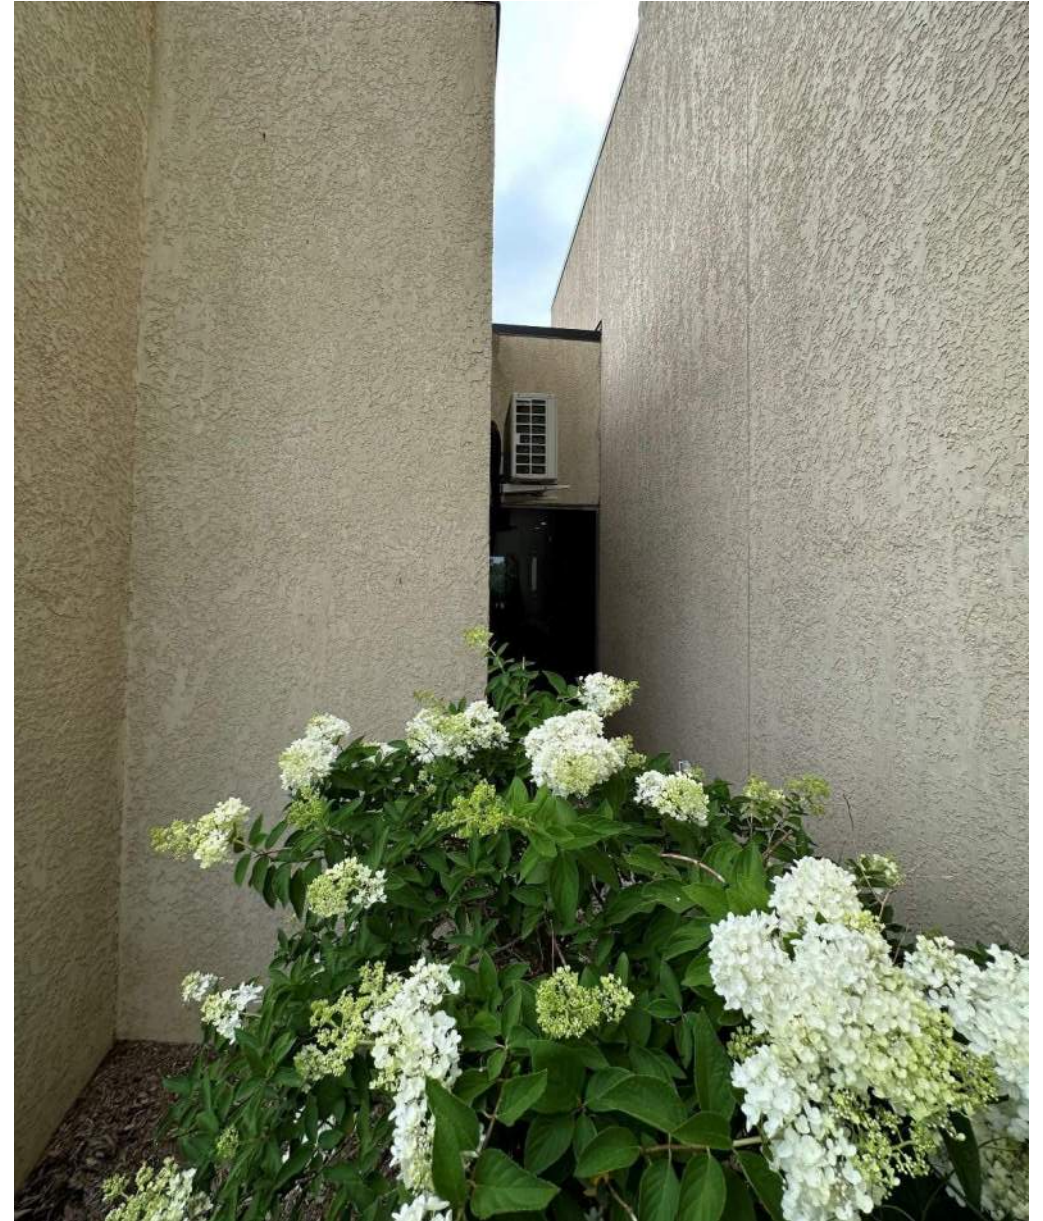
- There are a number of narrow courtyards and areas with limited visibility consider cameras and modifying plant material when applicable.

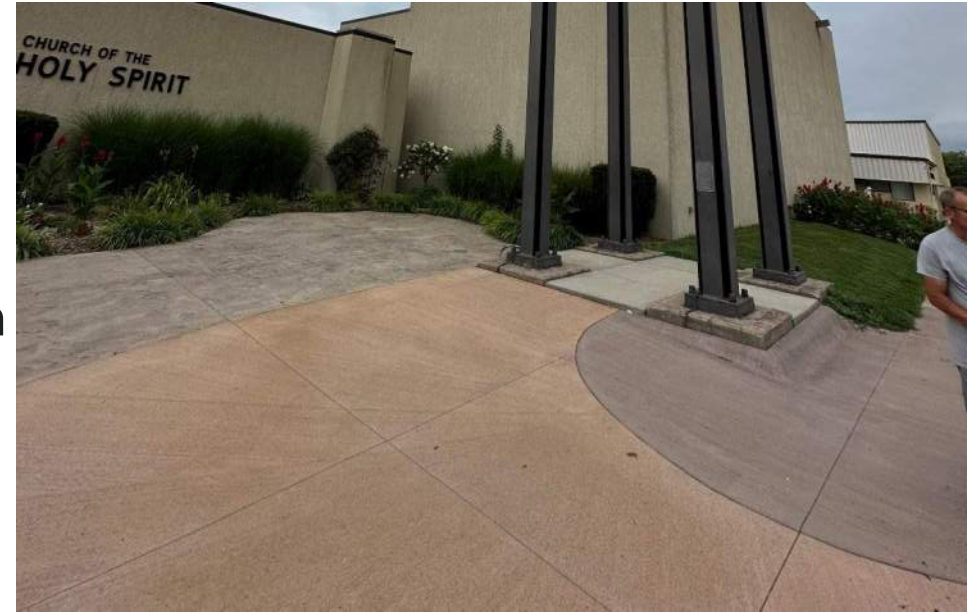
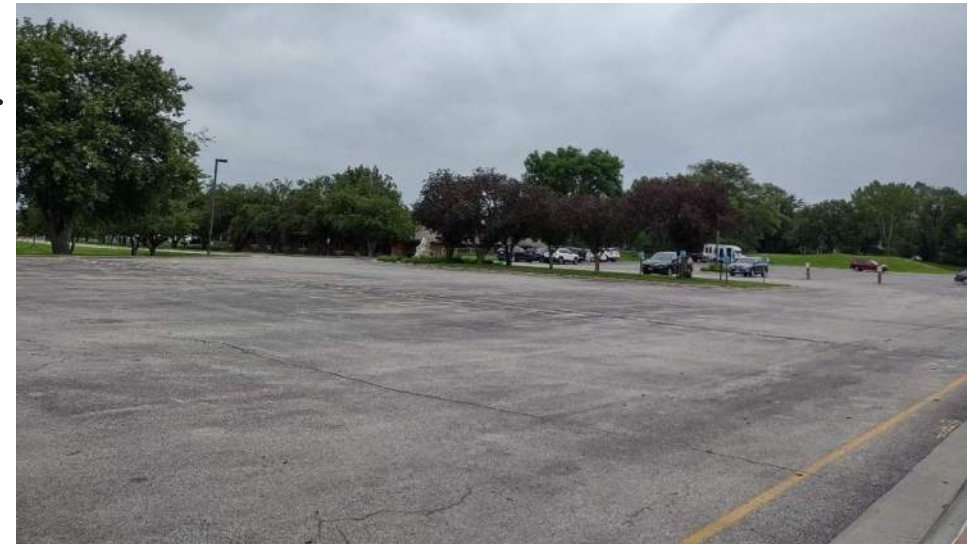
- Overall the pavement has been well maintained, including the colored concrete.
- New curb and gutter as been installed as part of ongoing maintenance.
- The asphalt parking is reaching the end of it's life and considerations should be made for it's replacement. Additional curb and gutter work should coincide with this work.

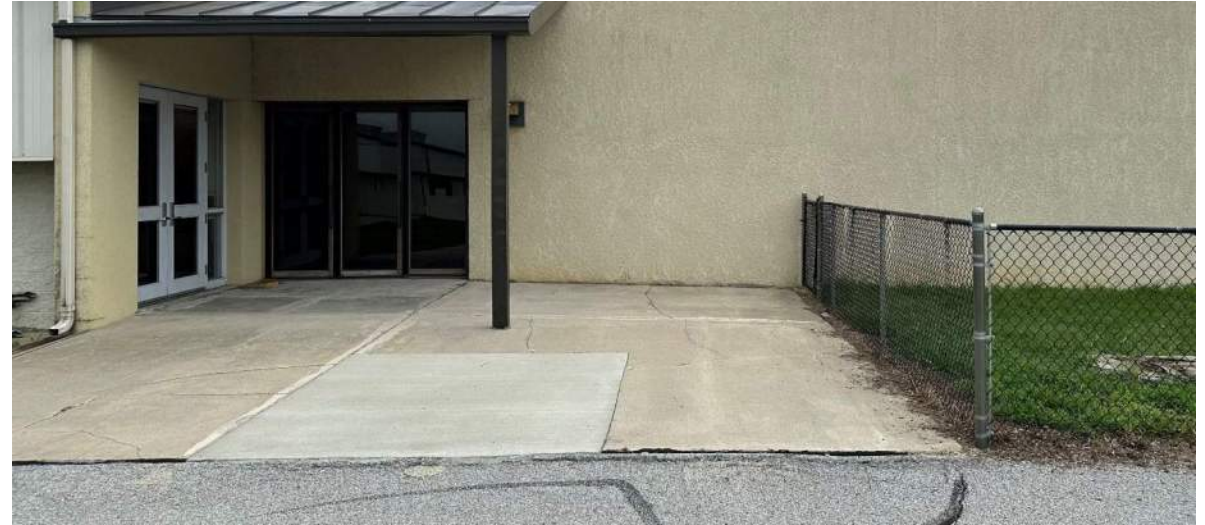
- There are areas of sidewalk that are cracking. Route and seal the concrete to prolong its life.
- Coordinate with the City of Plattsburgh on City sidewalks that are in need of replacement.
- Seal all expansion joints, particularly those adjacent to the building.

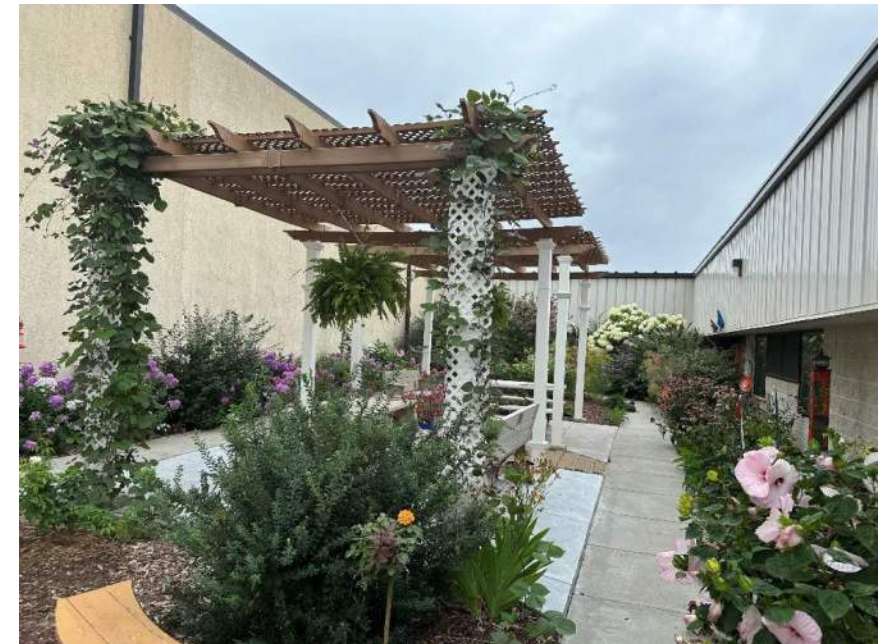
- Beautifully maintained facility
- Monitor health of trees on campus.
 - Emerald ash borer, needle blight and other diseases are impacting trees in the area.
 - Remove trees that are showing decline in the canopies.

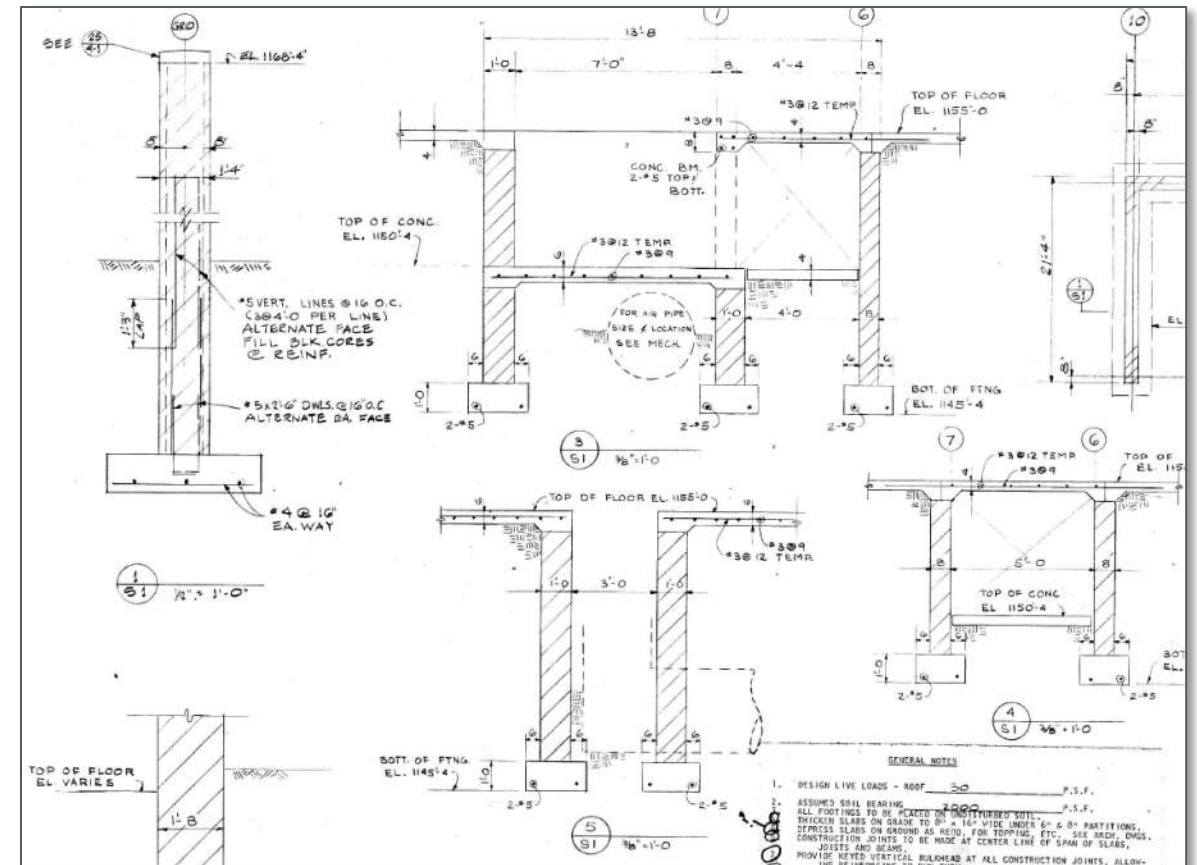
- Foundation system for the CMU bearing walls are drawn as continuous footings with spread footings at the truss bearing locations. No foundation issues were observed.

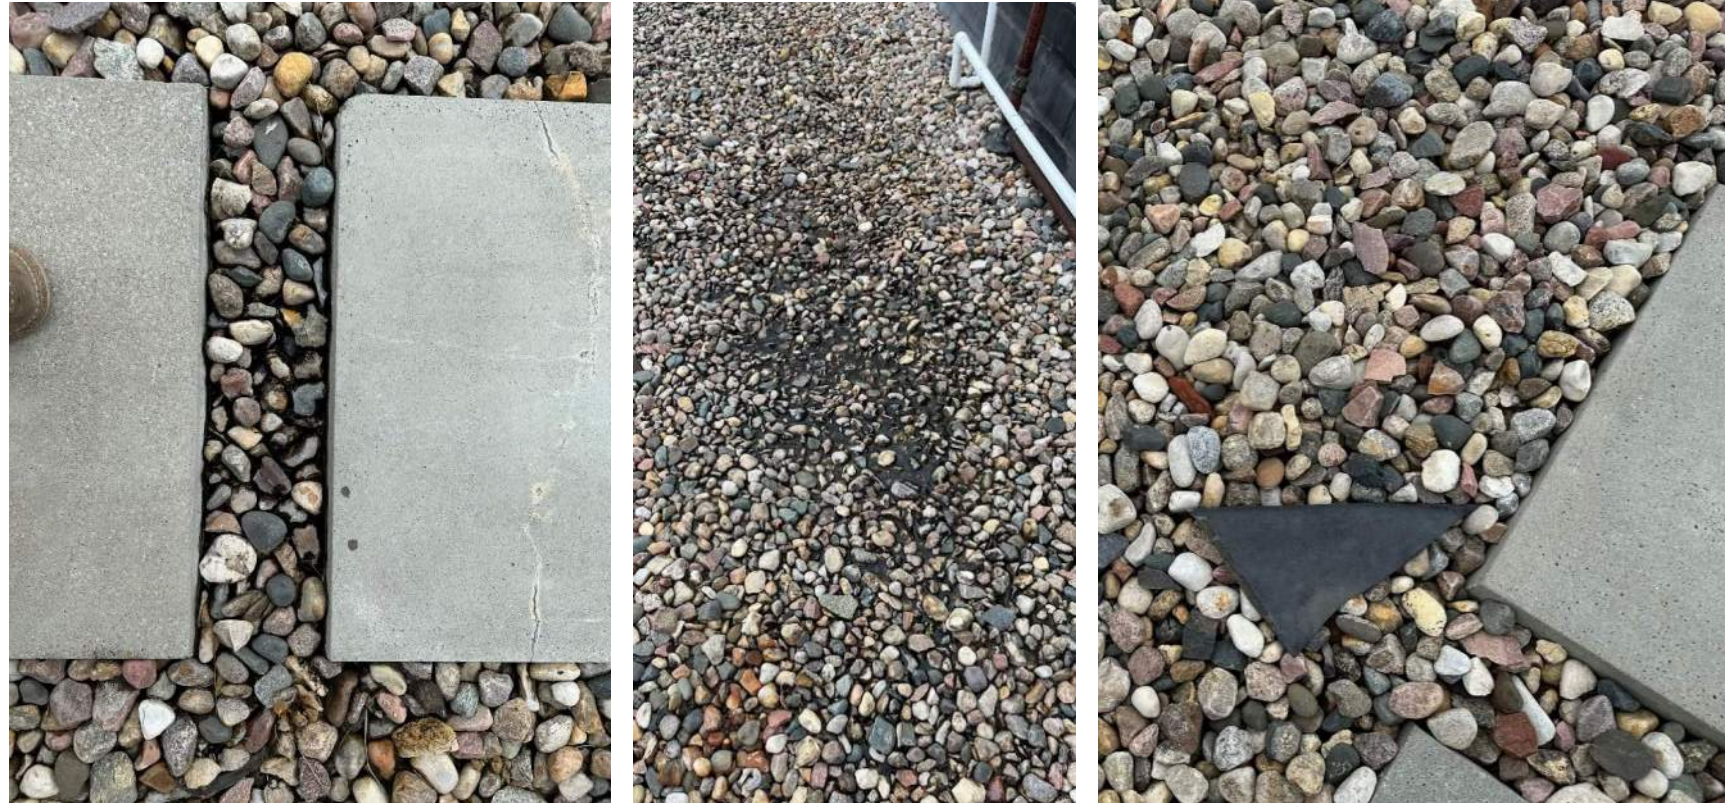
- Ballasted Roof system appears to be in good condition. Small areas of standing water were observed. Roof should be monitored to make sure areas of significant ponding are not occurring.
- Corner of membrane roof was observed to be loose and above ballast. Roofing should be adhered to adjacent membrane.

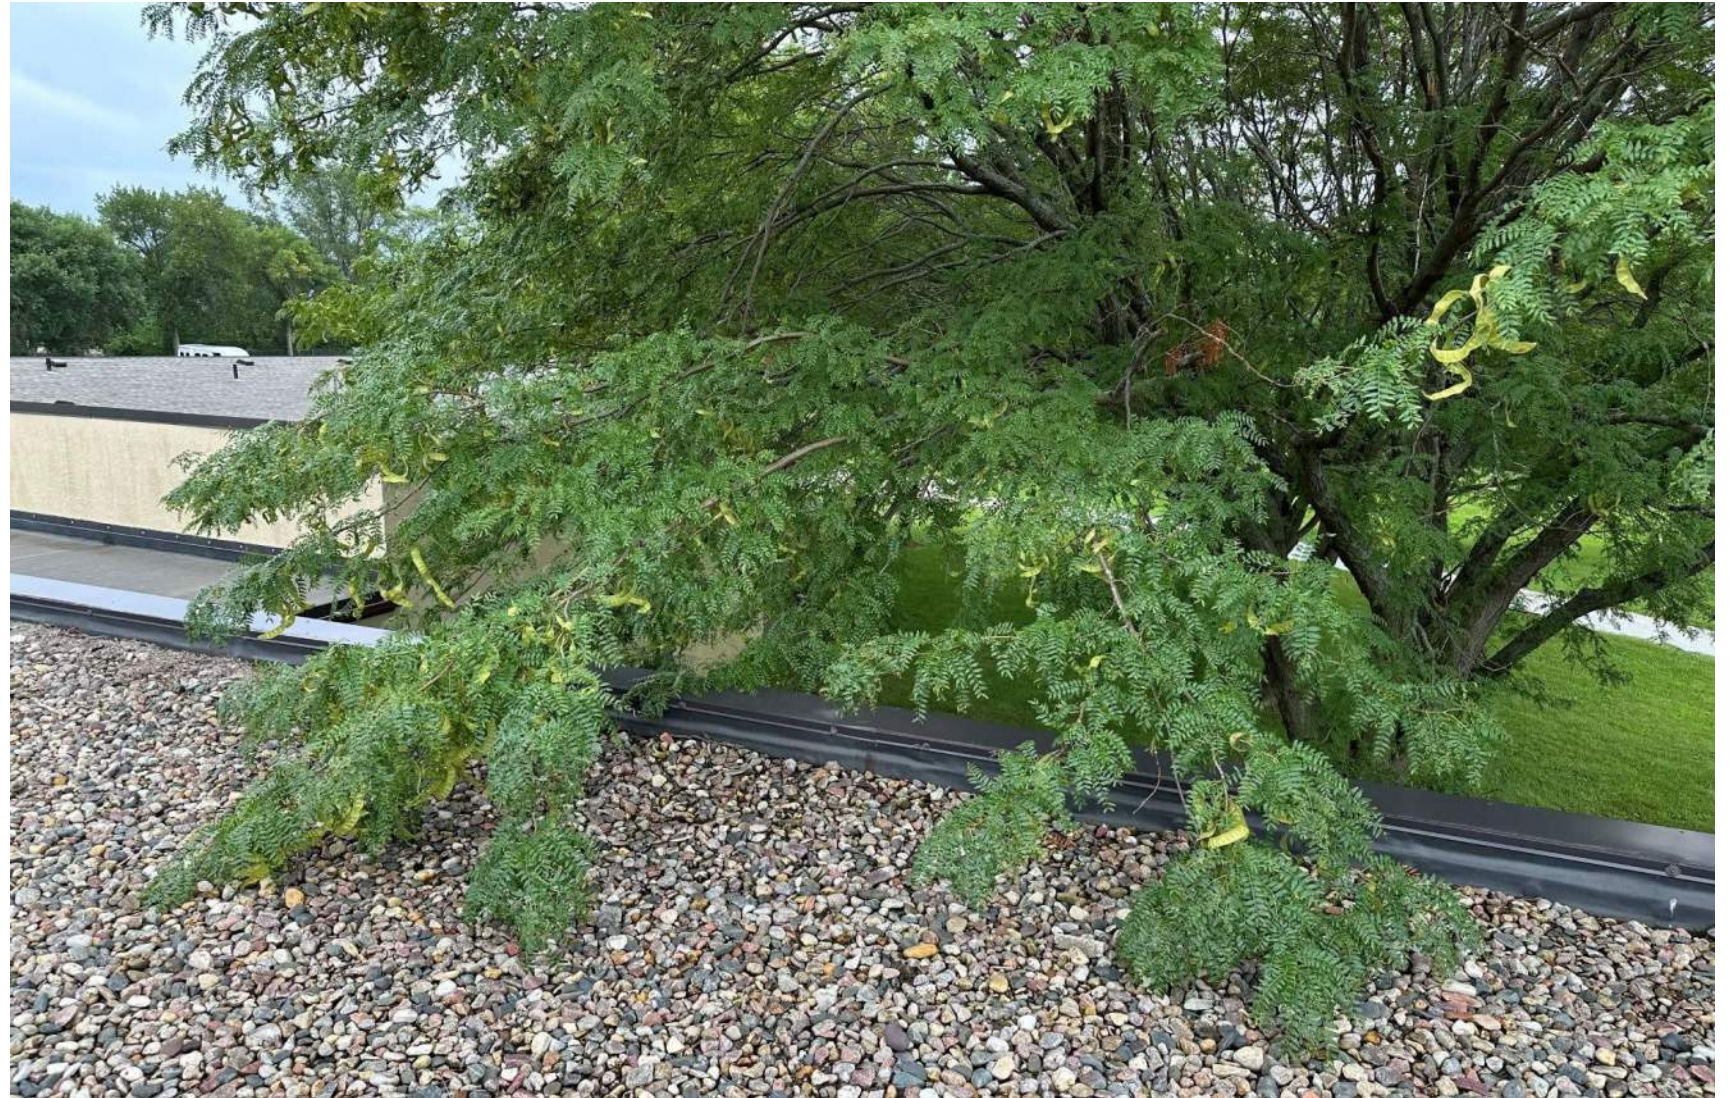
- Tree branches are touching the roof and should be trimmed back.

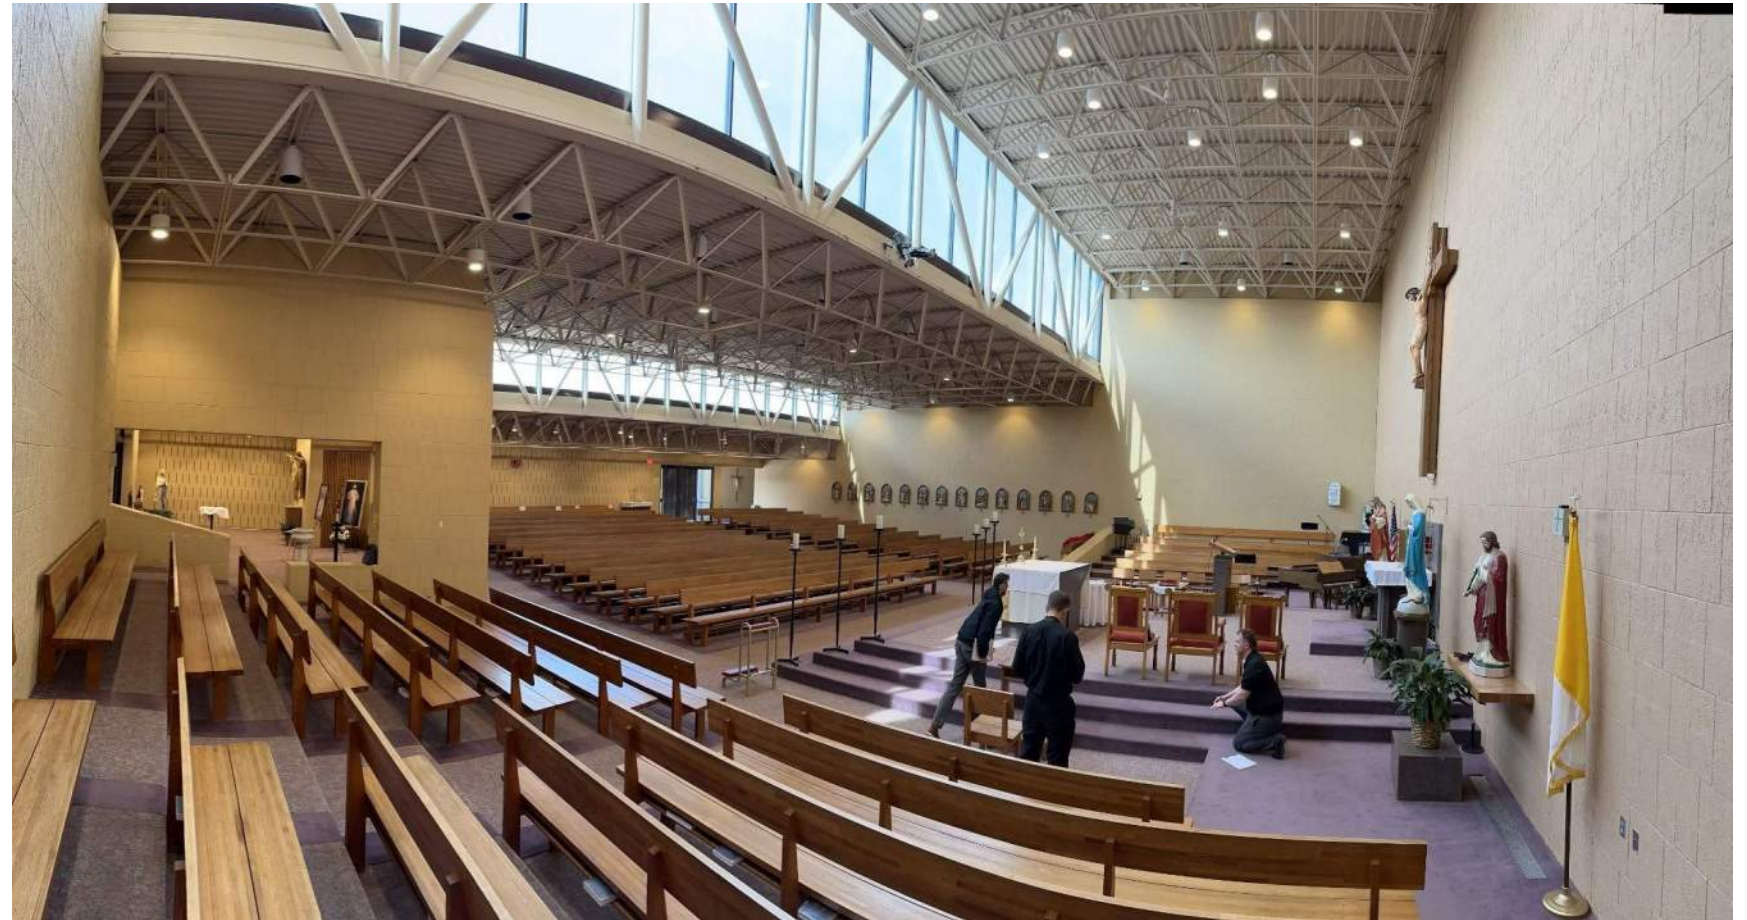
- Roof framing consists of a truss system in addition to two large structural pipe trusses at the elevation changes. Roof framing system appears to be in good condition.

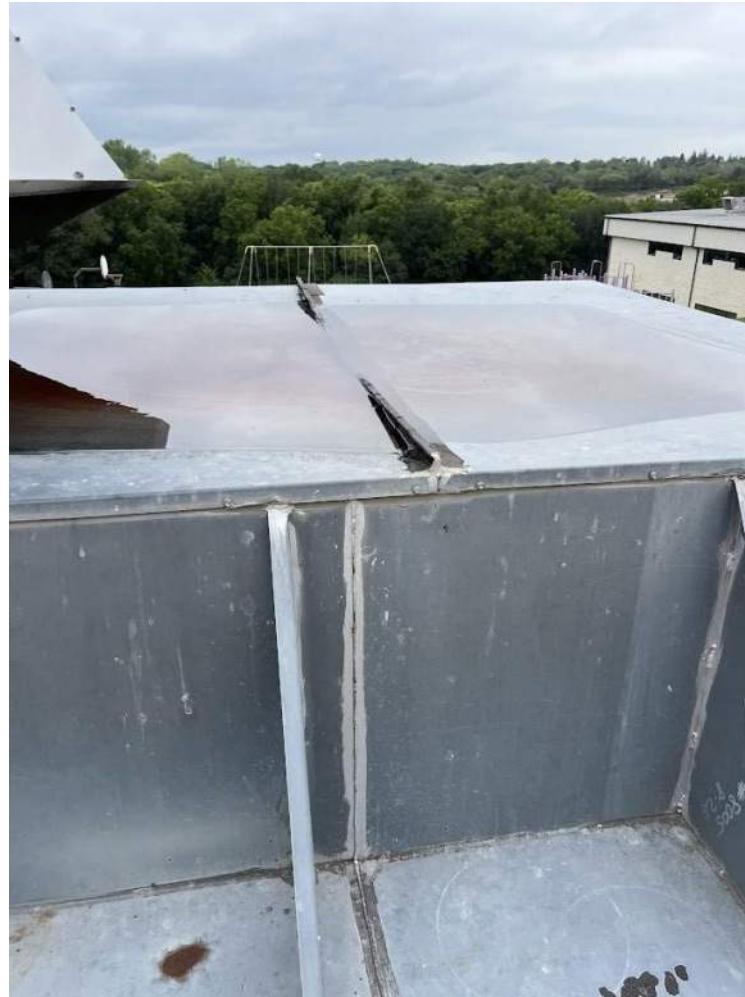
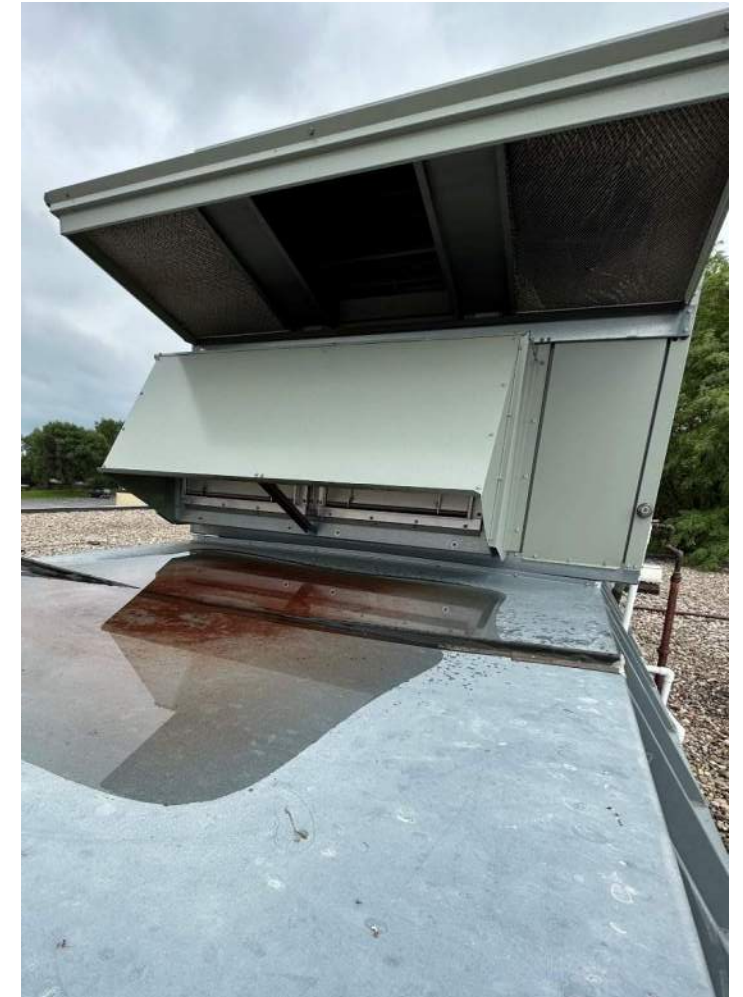
- Ponding on the RTU observed. Panel should be replaced with a stiffer panel that sheds water.

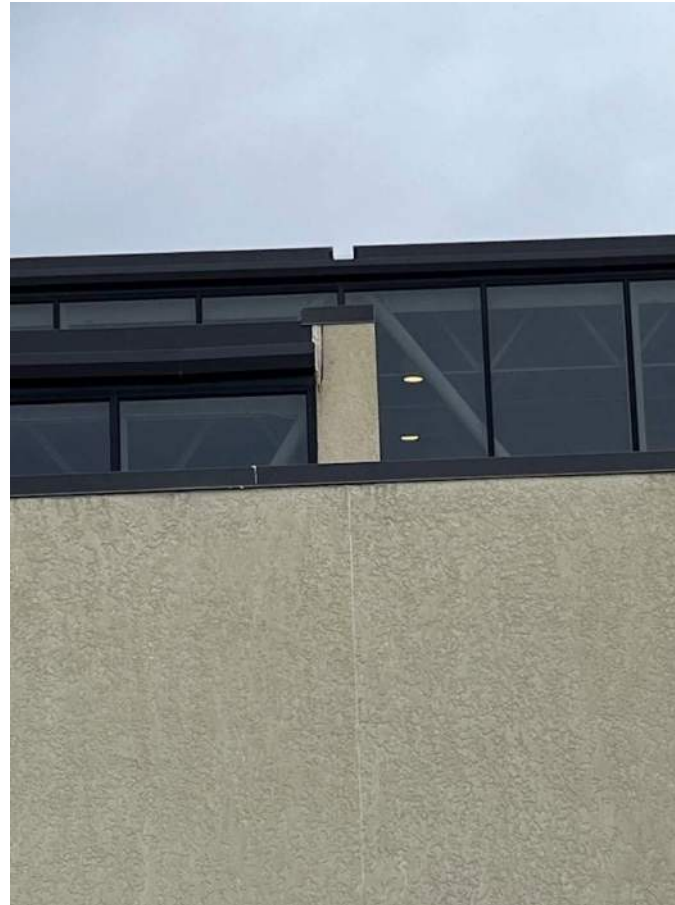
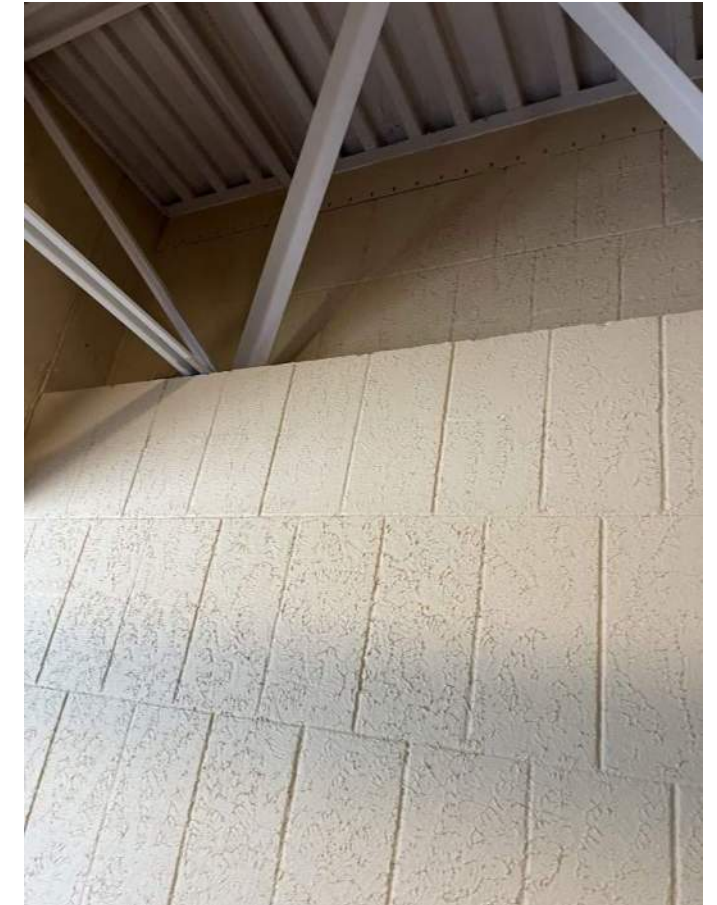
- Walls consist of 8 to 16 inch CMU bearing walls. Walls appear to be in good condition.
- Wall locations supporting the pipe trusses have some minor cracking. Tuck pointing of the CMU should be investigated.

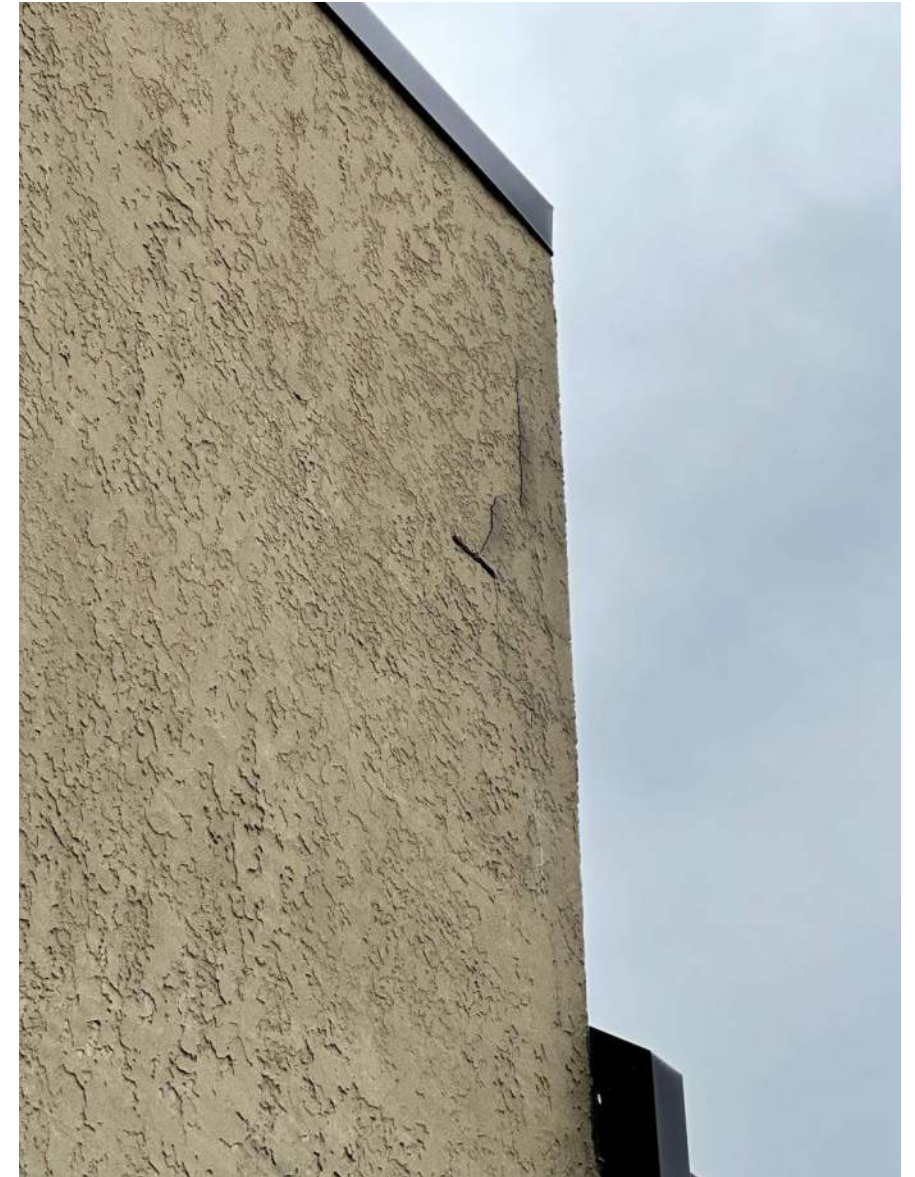
- Although in overall good condition, the exterior finish system of the walls is cracking in several locations. These cracks are primarily near corners where structure meets veneer walls. Finish should be repaired.

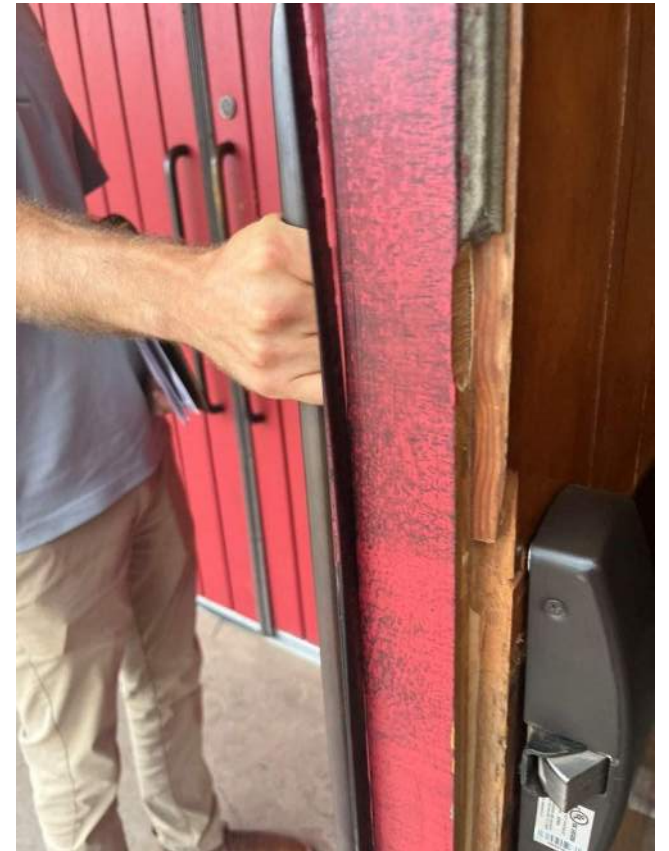
- The majority of doors on the church are original but have been modified
- Main entry doors are equipped with code compliant hardware.
- Both the main entry doors and rear doors have failed seals and should be replaced as part of a larger door and window replacement project.

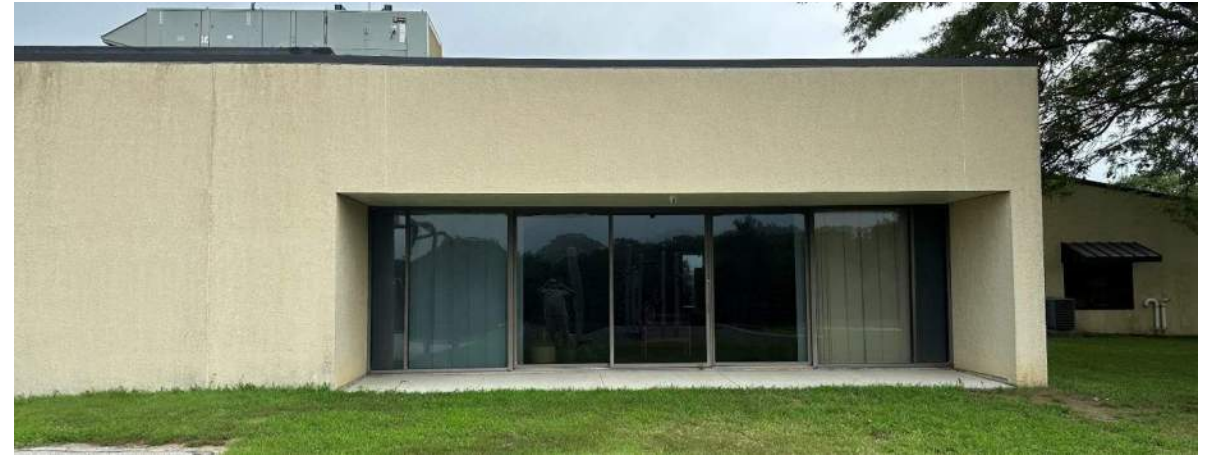
- The church portion has both original and replaced windows.
- All windows should be monitored for clouding and failed seals. Windows with failed seals should be replaced as part of a larger door and window replacement project.

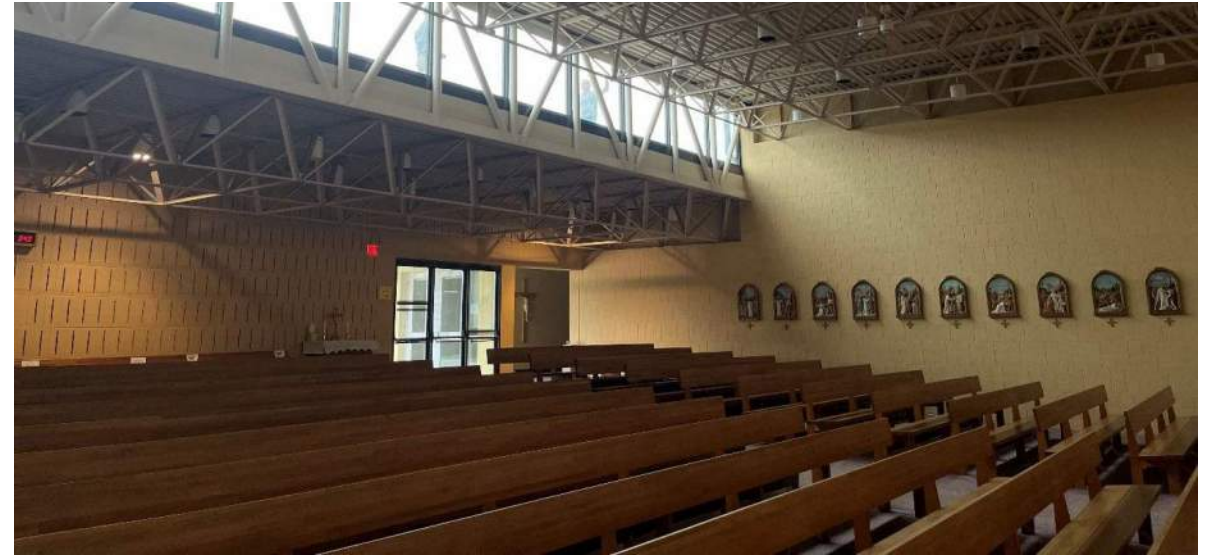
- The majority of walls are exposed CMU in acceptable condition
- Finishes vary from standard, applied plaster, random vertical grouting, and acoustic
- Atypical finish for church spaces

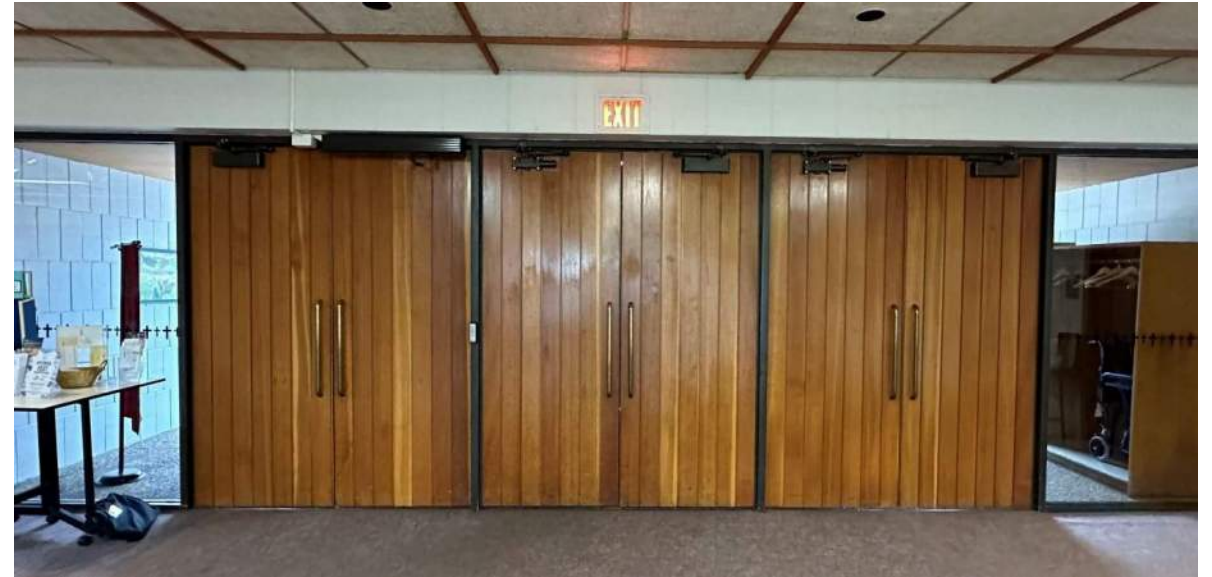
- Doors are overall in good, operable condition
- Except for restroom entries, the majority of doors meet code required clearances

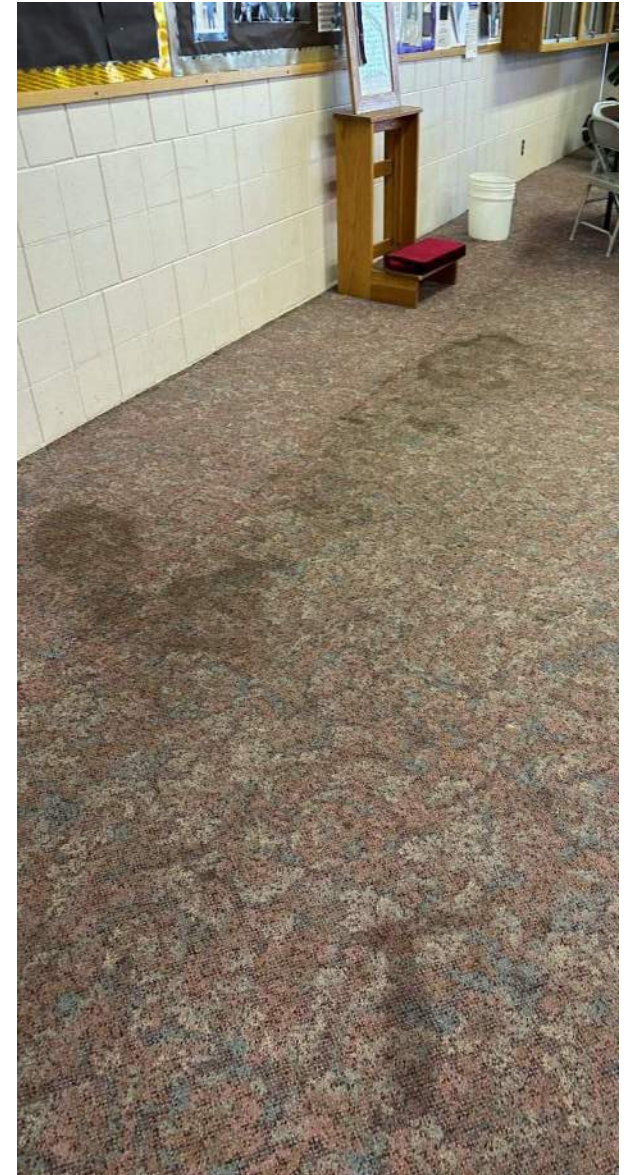
- The church and commons is primarily broadloom carpet in poor condition with very limited life expectancy remaining
- Extensive water damage was observed in the commons, either from poor maintenance or prior water infiltration from the west
- Entire church and commons flooring should be replaced in the near future, consider as part of a larger renovation project

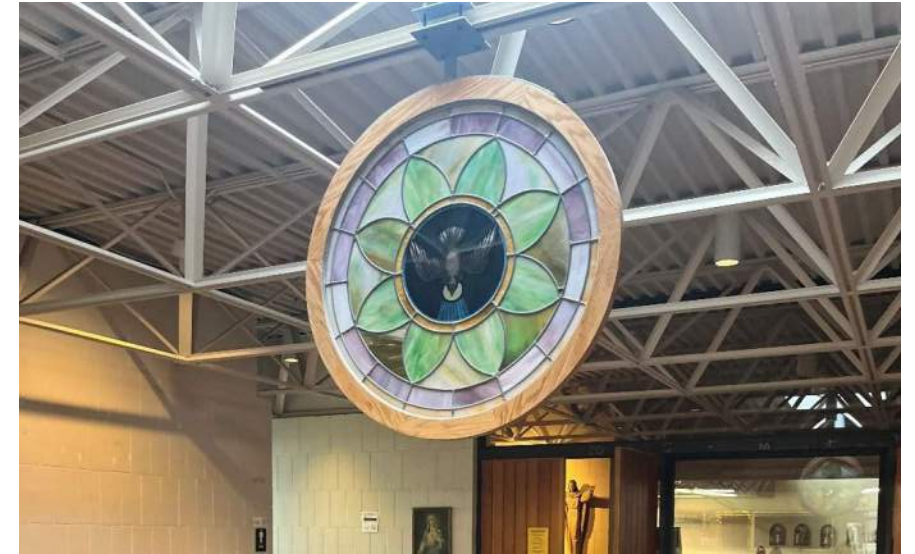
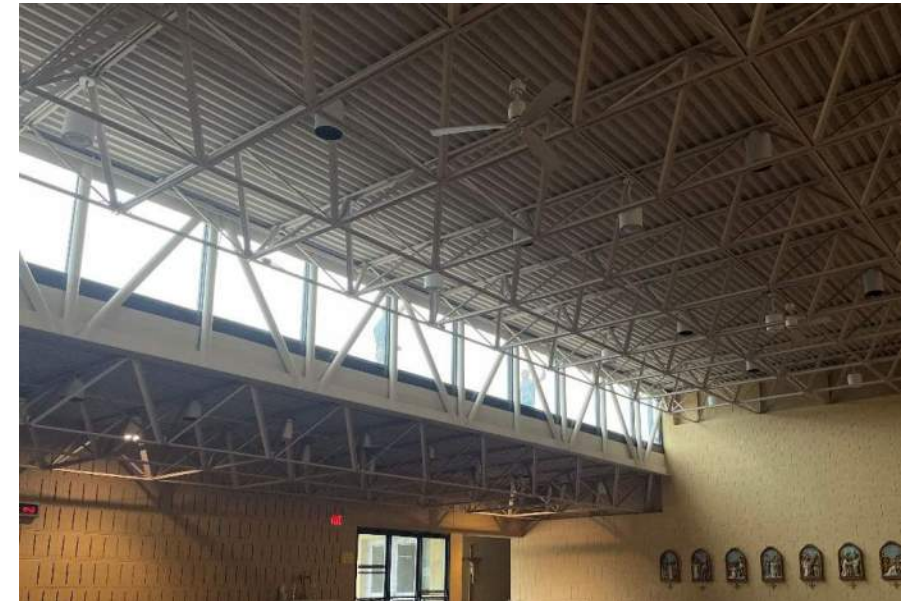
- The ceiling entering the church and in the church are both exposed acoustical deck and structure in acceptable condition
- Atypical ceiling condition for churches

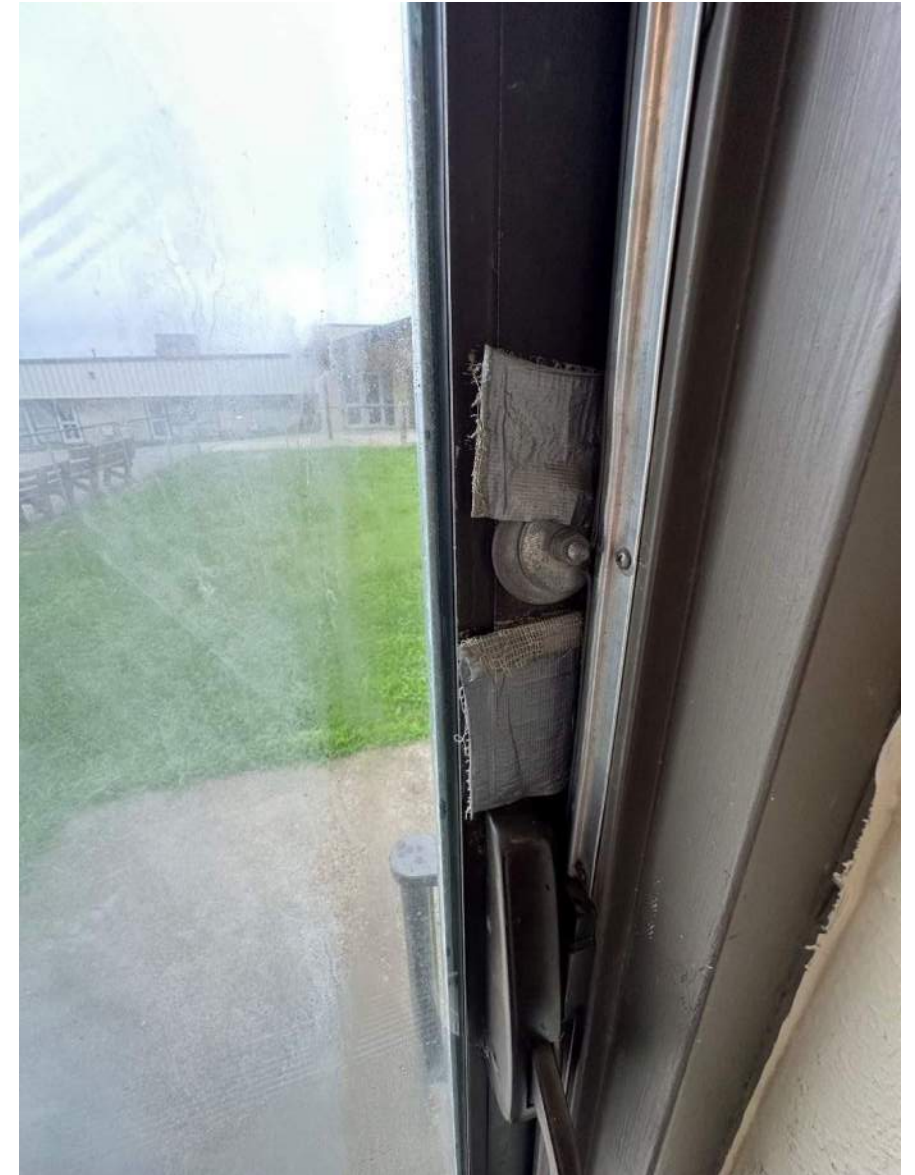
- Majority of door hardware is in good, operable condition that meet code, but some doors were observed with damaged/missing hardware

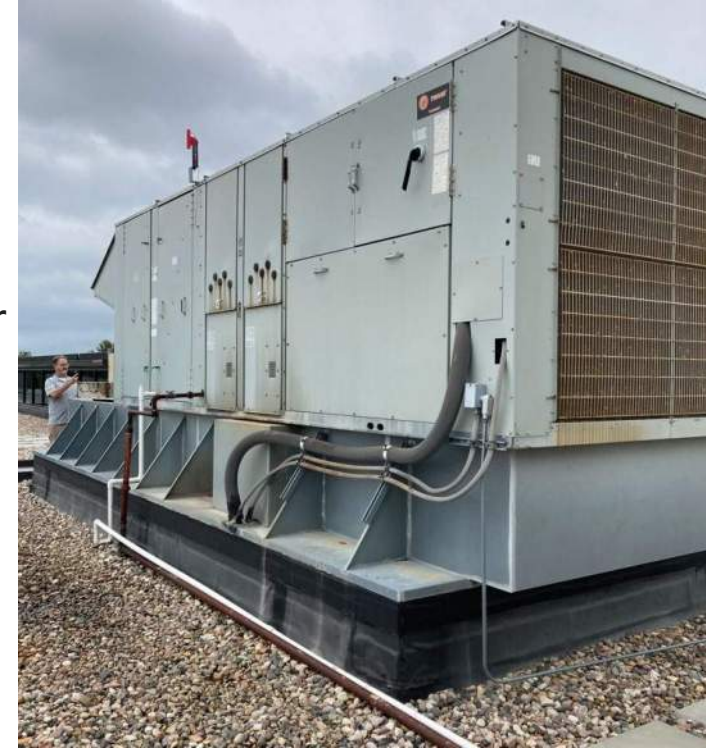
- 1 Multizone Rooftop Unit (DX/gas) –
 - 2004 Manufacture Date
 - Ashrae Median Life Expectancy: 18 Years
 - Maintenance costs will continue to increase due to R-22 refrigerant no longer manufactured.
 - Control issues reported after RTU was struck by lightning and control/circuit boards were replace. Verify with manufacturer operation of unit as designed.
 - According to project documents, underfloor ductwork contains asbestos inside and out.
 - Recommend cleaning underfloor return ductwork/plenum every 10 years for good air quality. Avoid for supply air asbestos ductwork.

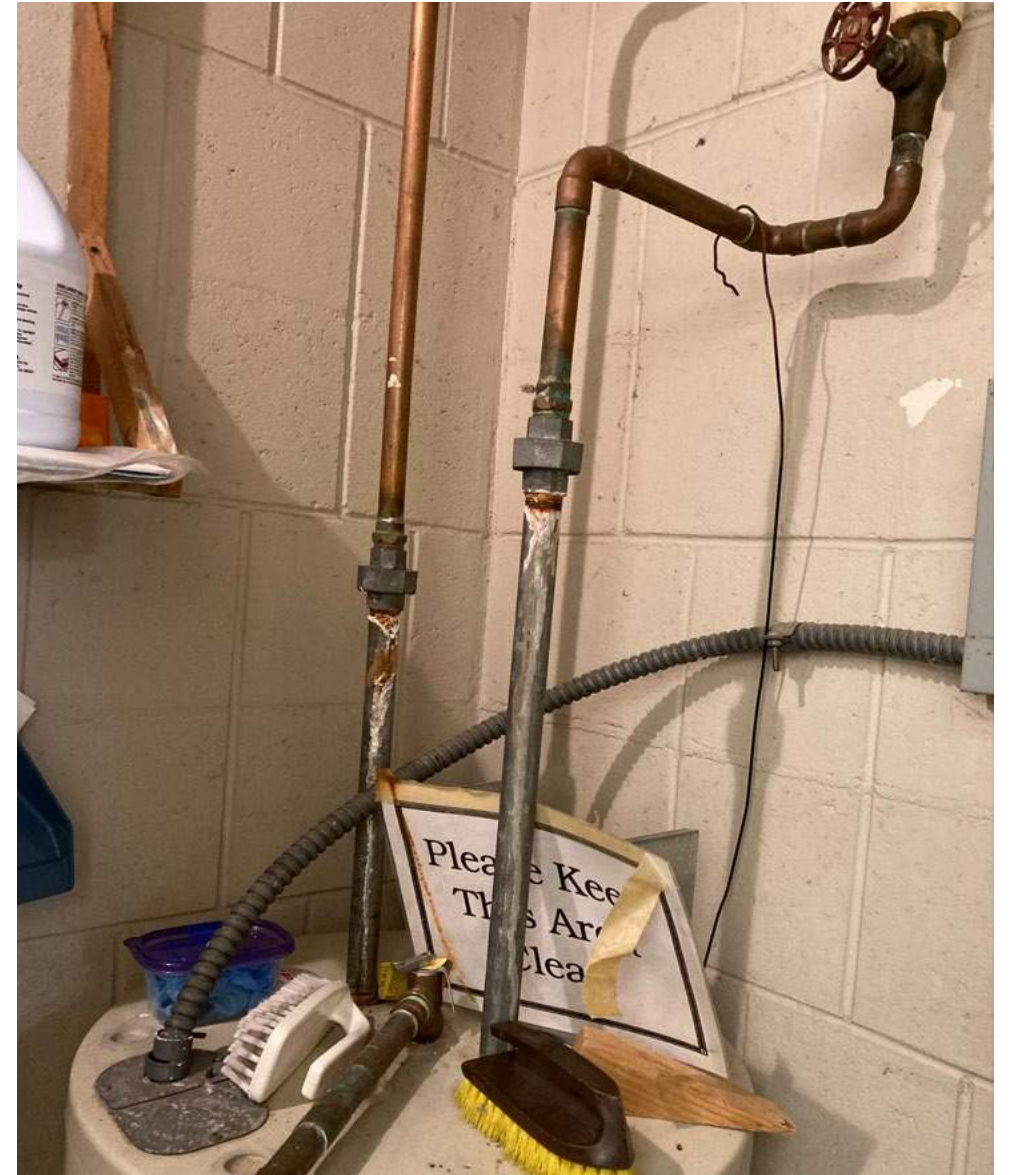
- Equipment
 - Electric Water heater
 - Manufactured in 1997.
 - Corrosion on piping observed. This is likely due to the connection of dissimilar metals. Recommend replacing with copper or pex.
 - Recommend re-insulating piping in janitor's closet.
- Irrigation
 - None observed.
