CLARK &
ENERSEN

CHURCH OF THE HOLY SPIRIT
FACILITY CRITICAL NEEDS ASSESSMENT

JANUARY 2024

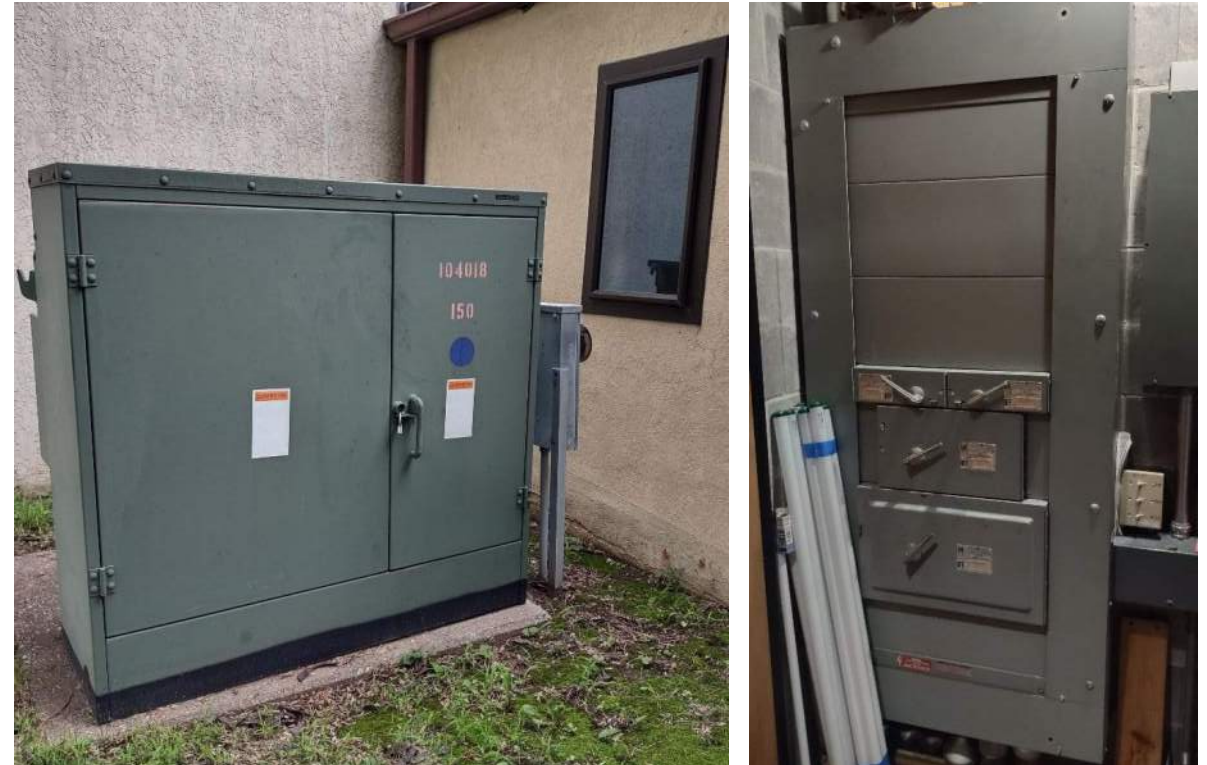
- There is a 150kva utility company transformer located on the southwest corner of the building, which feeds both the Church and the Rectory.
- The main distribution panel is General Electric brand, 600A, 208V, 3-phase, with fused breakers, and is original to the building. Recommend replacing this as a part of any remodel, or building addition project.

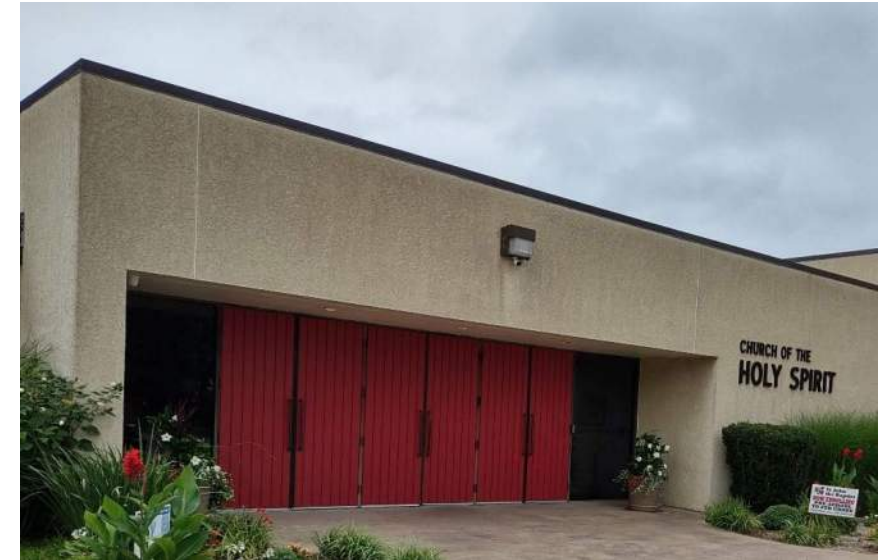
- Exterior building mounted fixtures are located at/near the exterior doors, and we were told that the majority of them have been changed out to LED type. Recommend adding exterior emergency lighting/function at every exit door.
- Only two poles for parking lot lighting, so it may not be properly lit. Recommend new pole type fixtures at new locations to adequately light the parking lot and drive.
- All exterior lighting is controlled by a time clock.

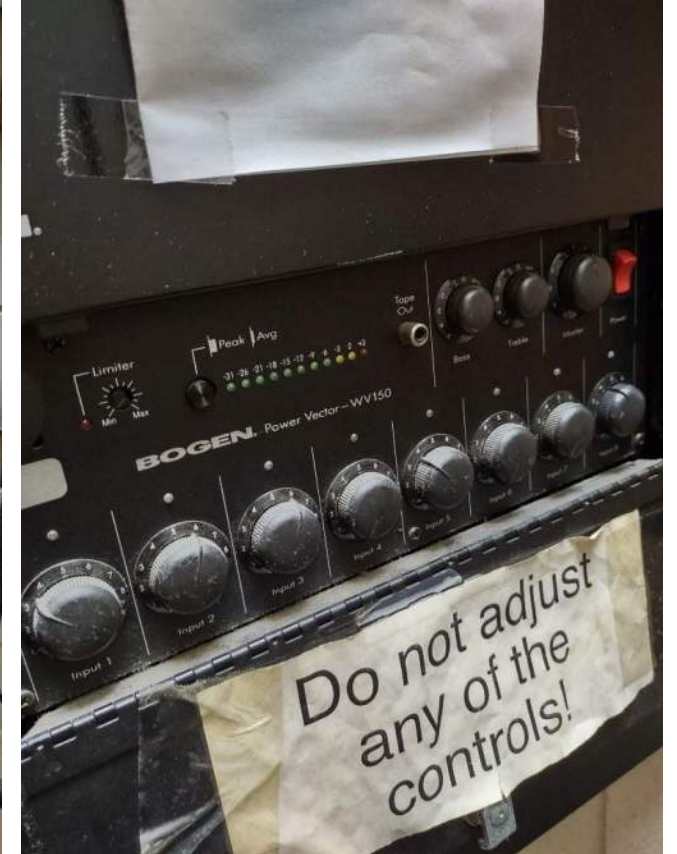
- Worship space has a sound system, and appears to have live streaming capabilities. Did not find information on the age of this system, or how well it works. Recommend having further conversations in order to determine whether or not this system should be upgraded to a newer system.

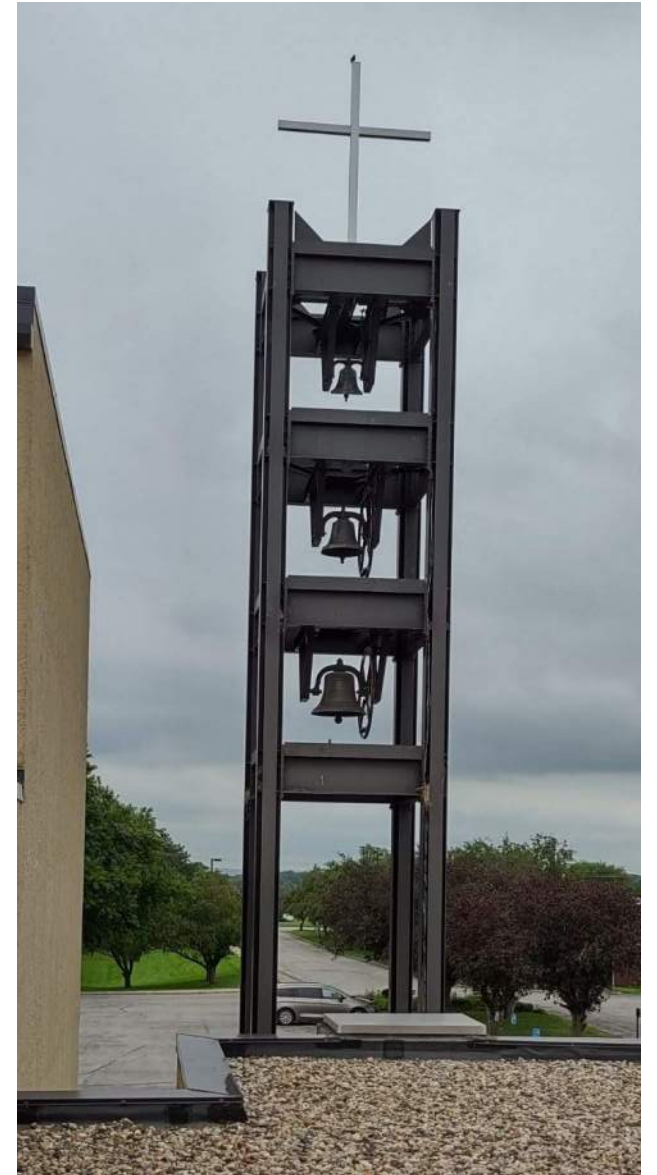
- Were informed that the bottom two bells in the exterior tower are not working. Recommend having those fixed so that this system is fully functional.

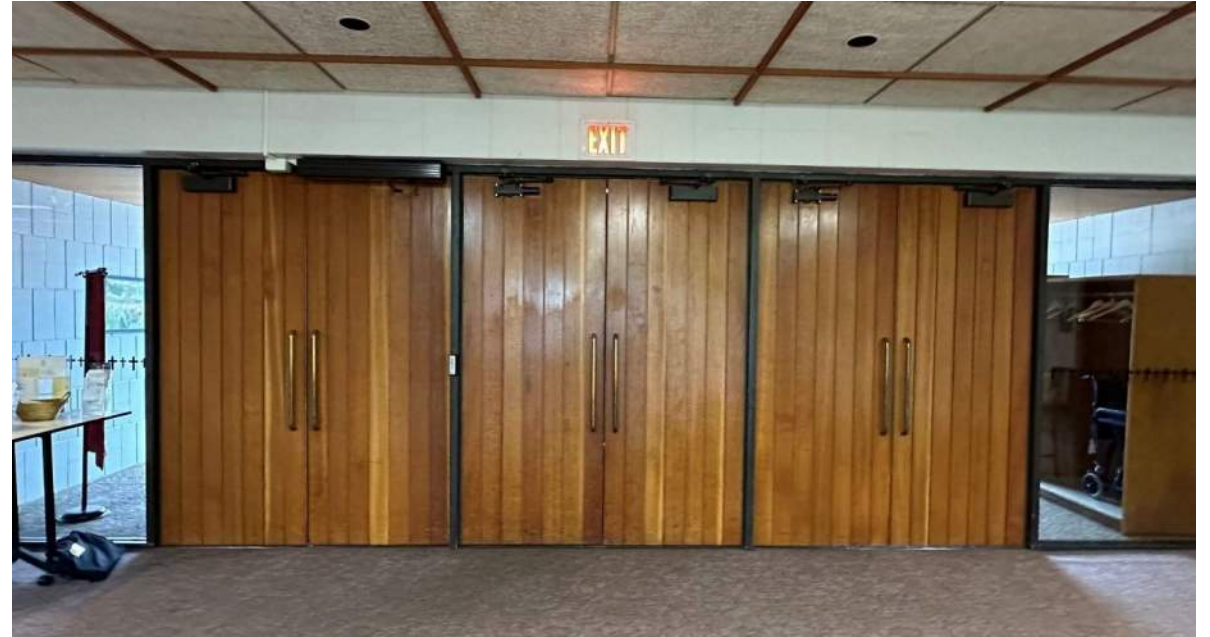
- There are a couple of exit signs, and emergency fixtures, in the church portion of the facility. Recommendation is to add/update exit signs and emergency lighting throughout the church.

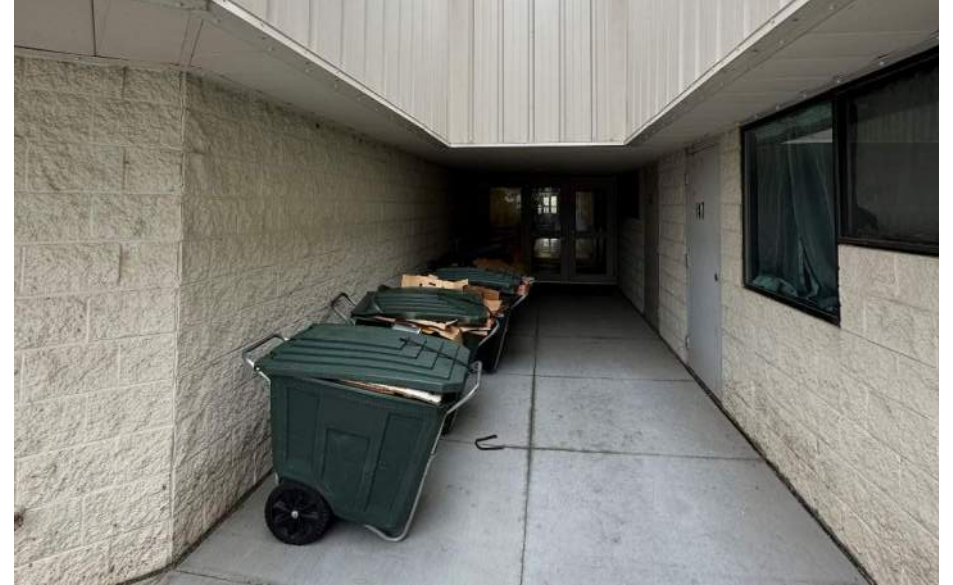
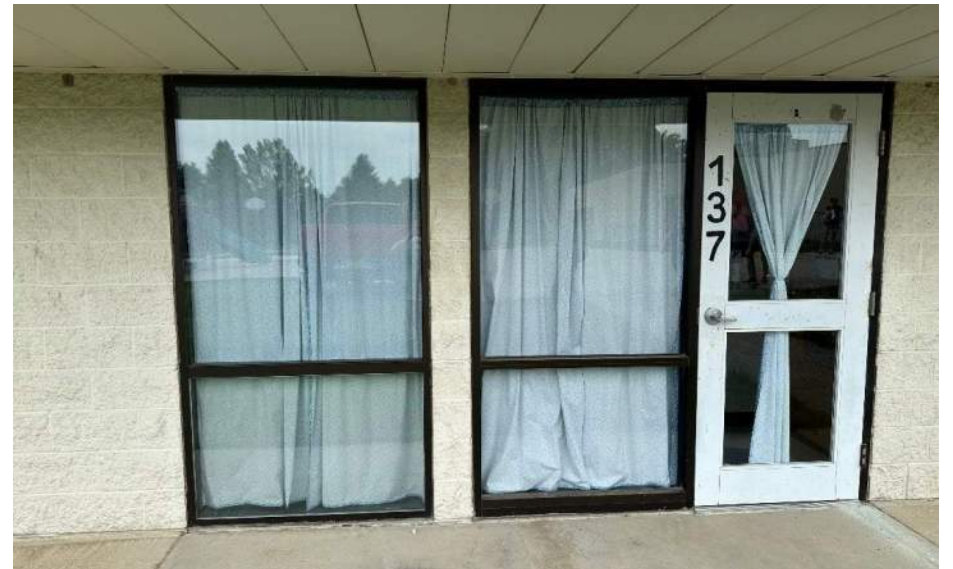
- There are a number of exterior doorways. Consider a security plan to limit access into the school.
- There are a number of narrow courtyards and areas with limited visibility consider cameras and modifying plant material when applicable.

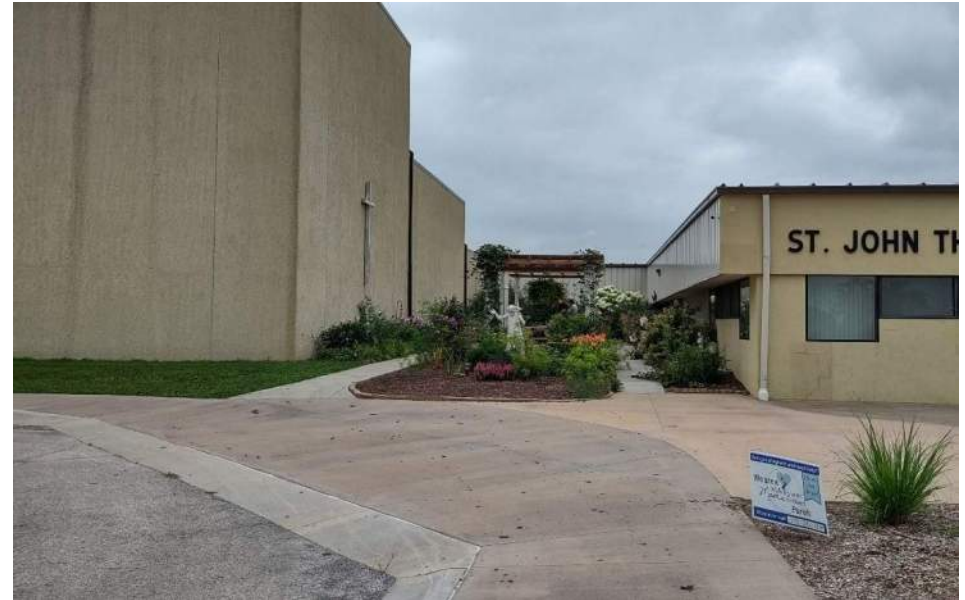
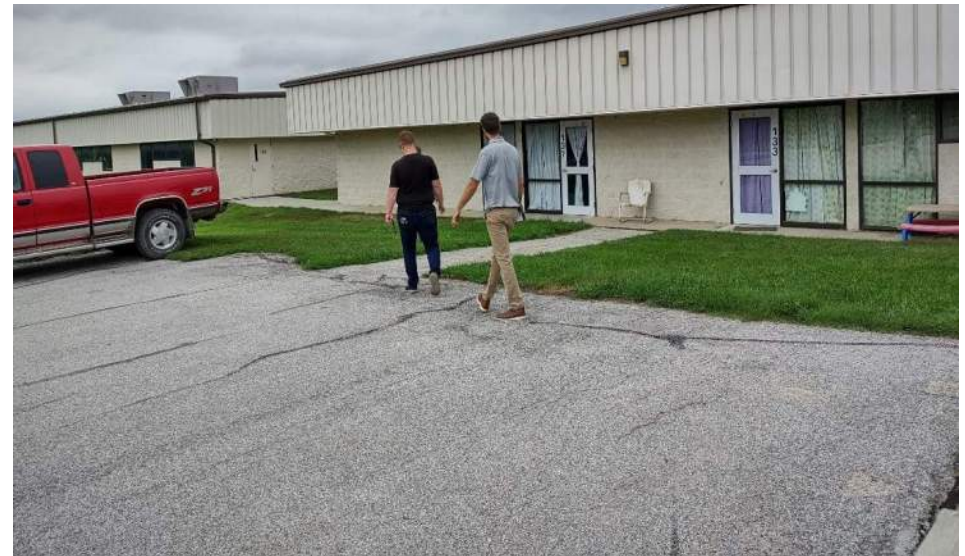
- Overall the pavement has been well maintained, including the colored concrete.
- New sidewalk and service area pavement has been installed as part of ongoing maintenance.
 - Refer to the prior slides regarding drainage for replaced areas
- The basketball / playground slab is nearing the end of its life and should be replaced soon.

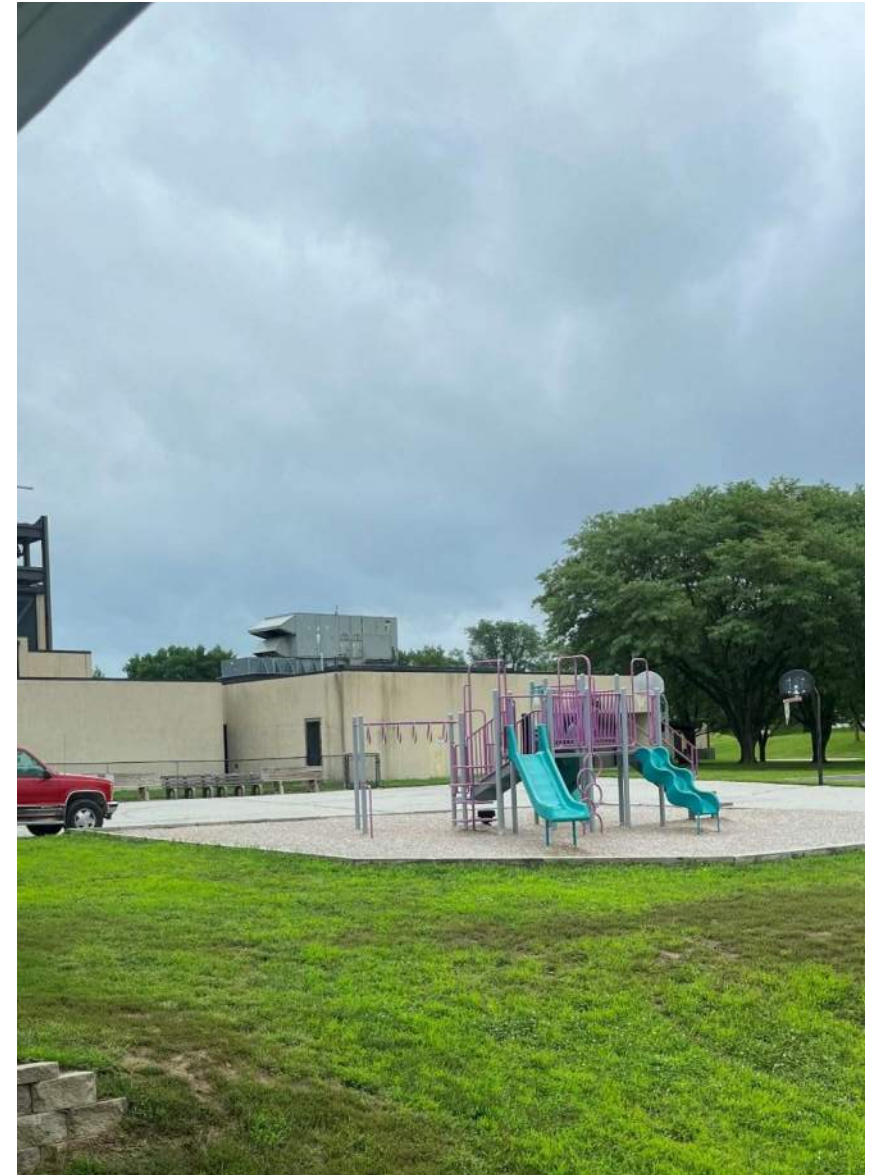
- Replace wooden curbing around play equipment
- Replace playground surfacing for fall protection

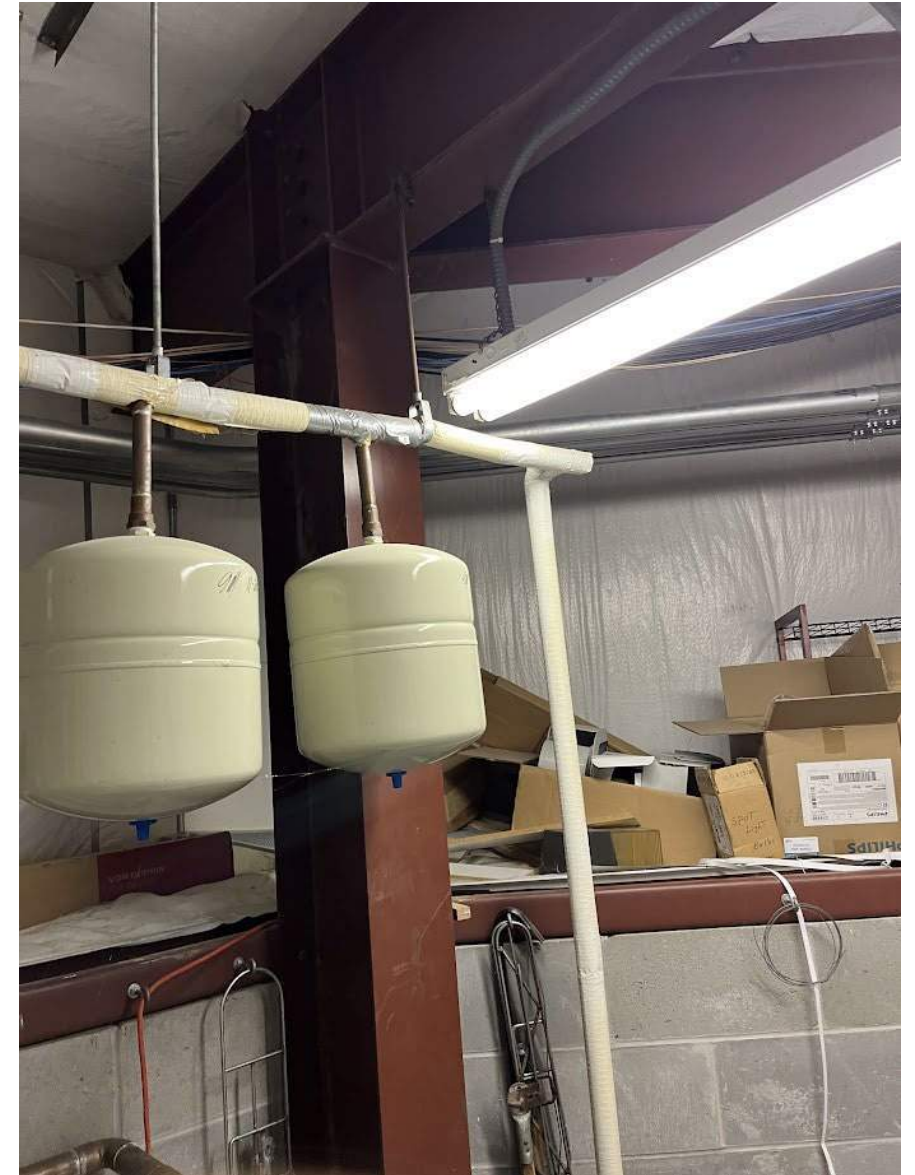
- Cantilevered soffit framing was not designed for storage and should not be utilized for storage unless additional structure is provided.

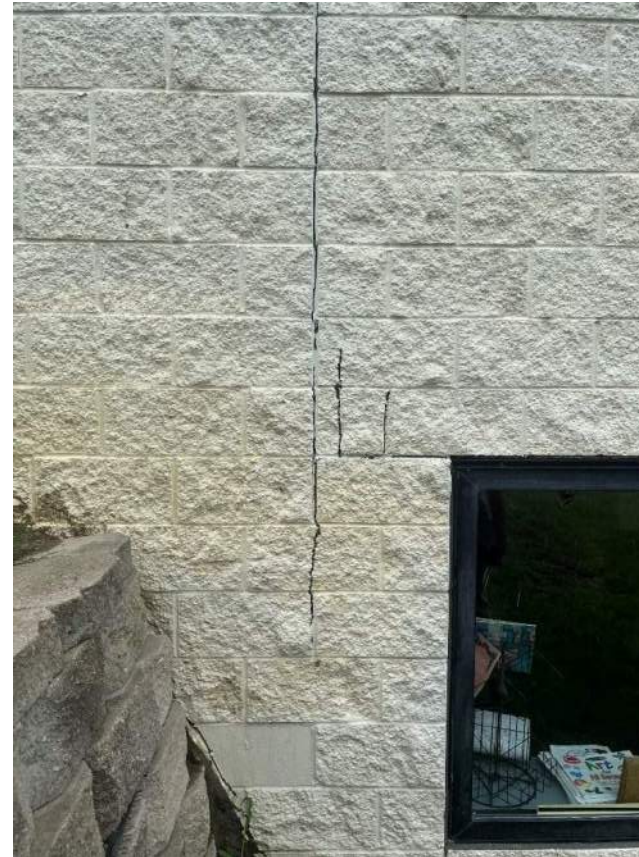
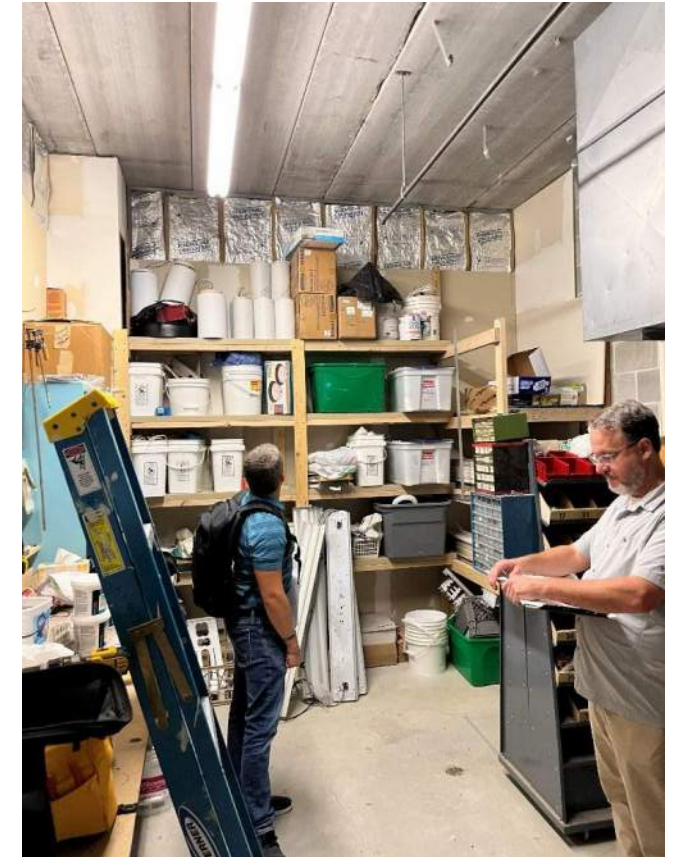
- Structural system is pre-engineered metal building with 8" non-bearing CMU exterior walls. 12" CMU walls are bearing at the lower level of the school addition. Upper level is framed using 8" flexi-core. Structural components of the building appear to be in good condition.

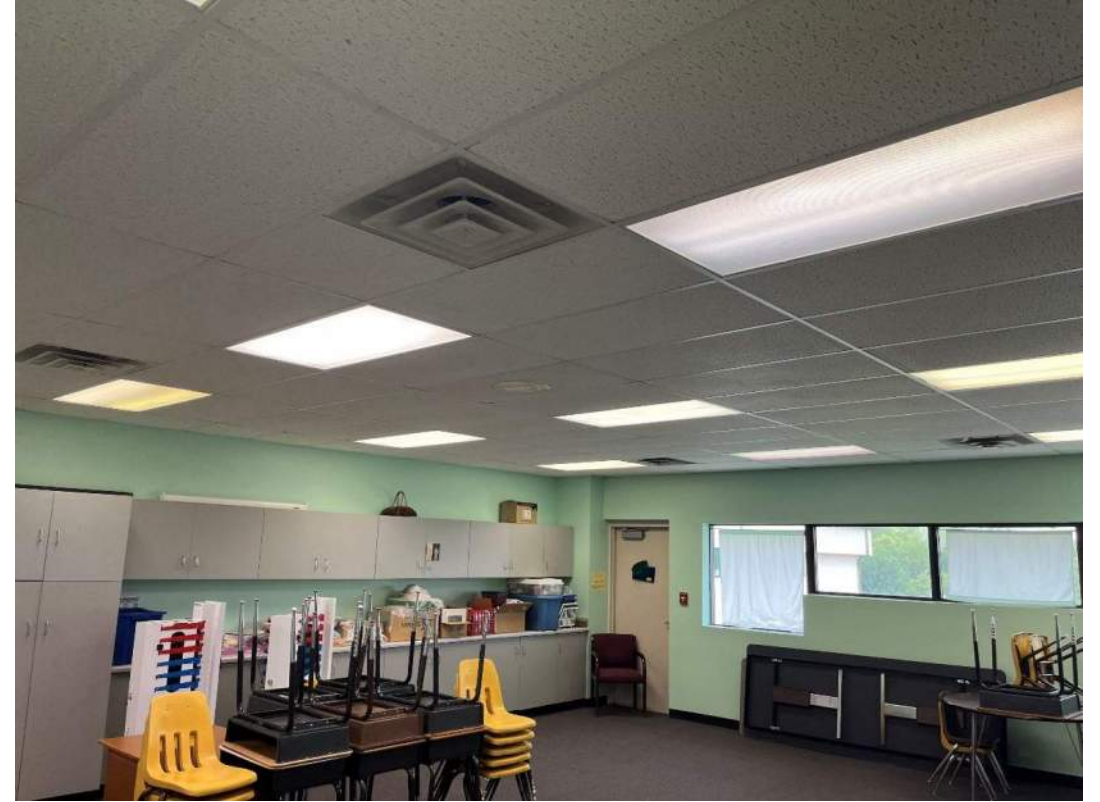
- Interior framed walls are gyp framed walls
- Corridor walls have an impact-resistant wall covering in good condition
- Classroom walls are painted finish and teachers are able to choose their paint color

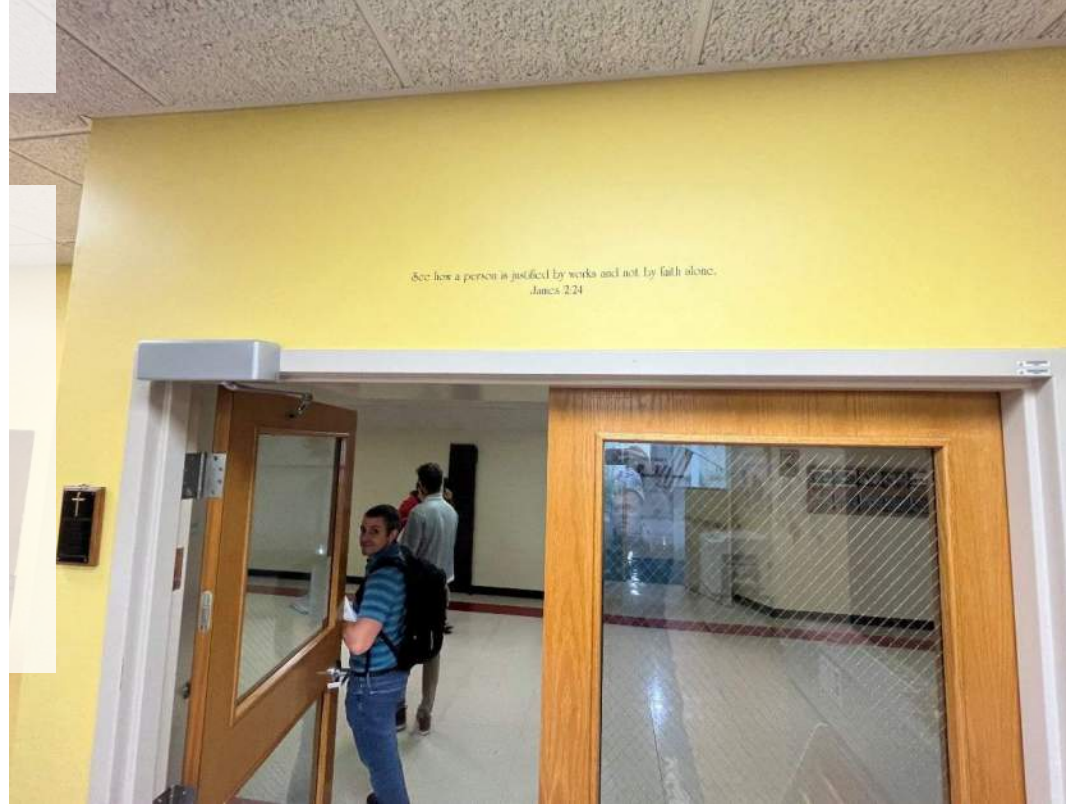
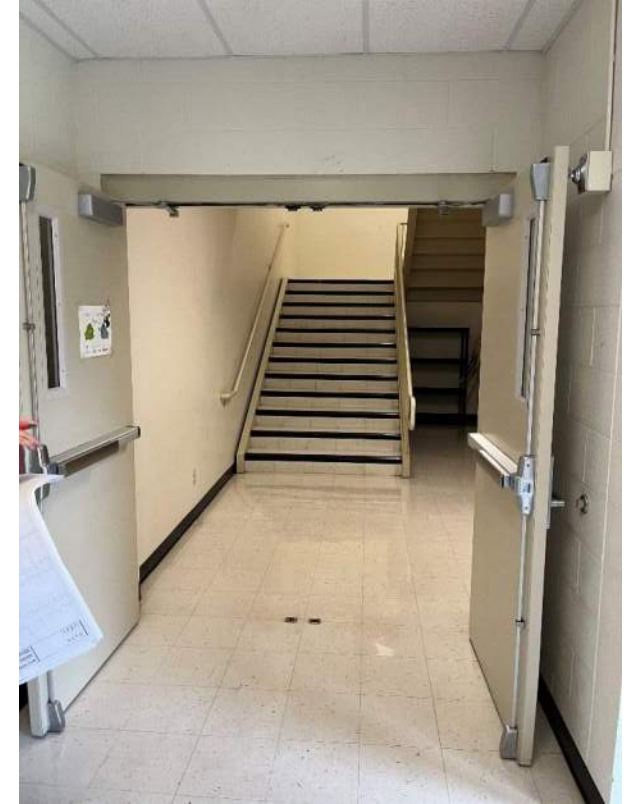
- Most interior doors are wood doors in good condition
- Majority of doors requiring rating are properly labelled

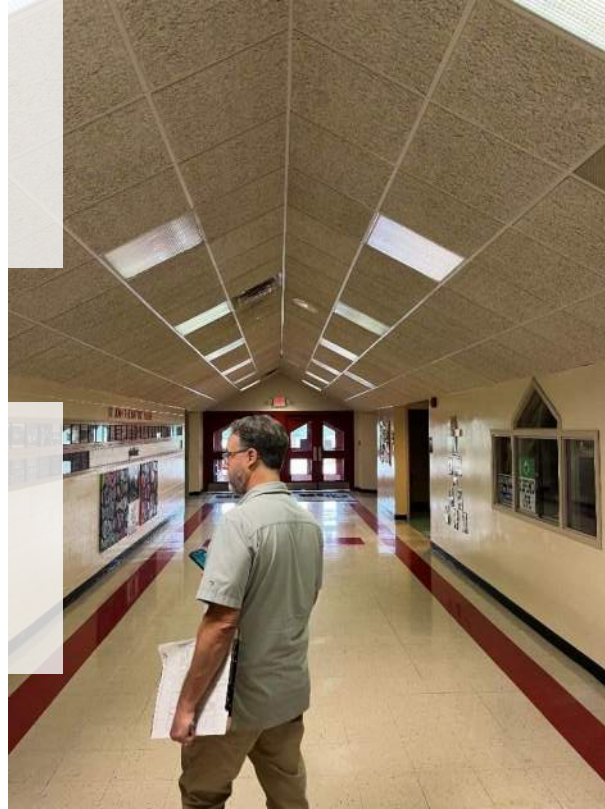
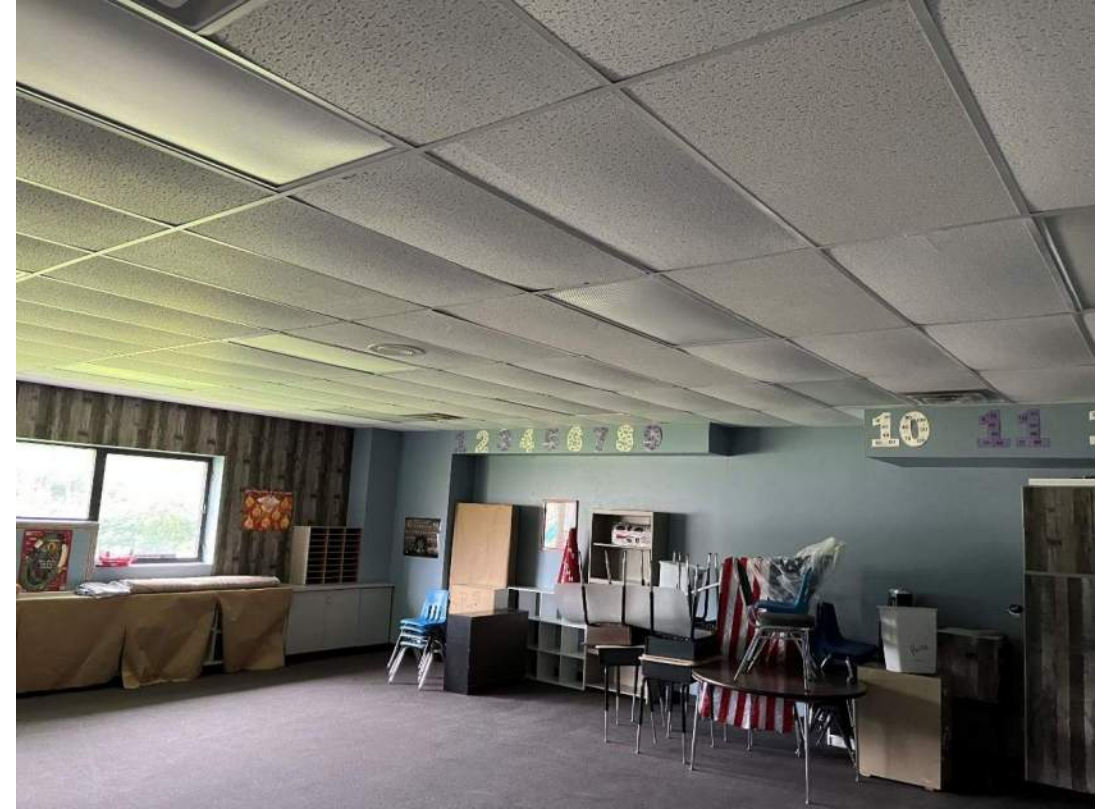
- Ceilings are primarily lay-in tile ceilings in acceptable condition
- 2x4 ceiling tiles in the school addition are sagging due to size and humidity

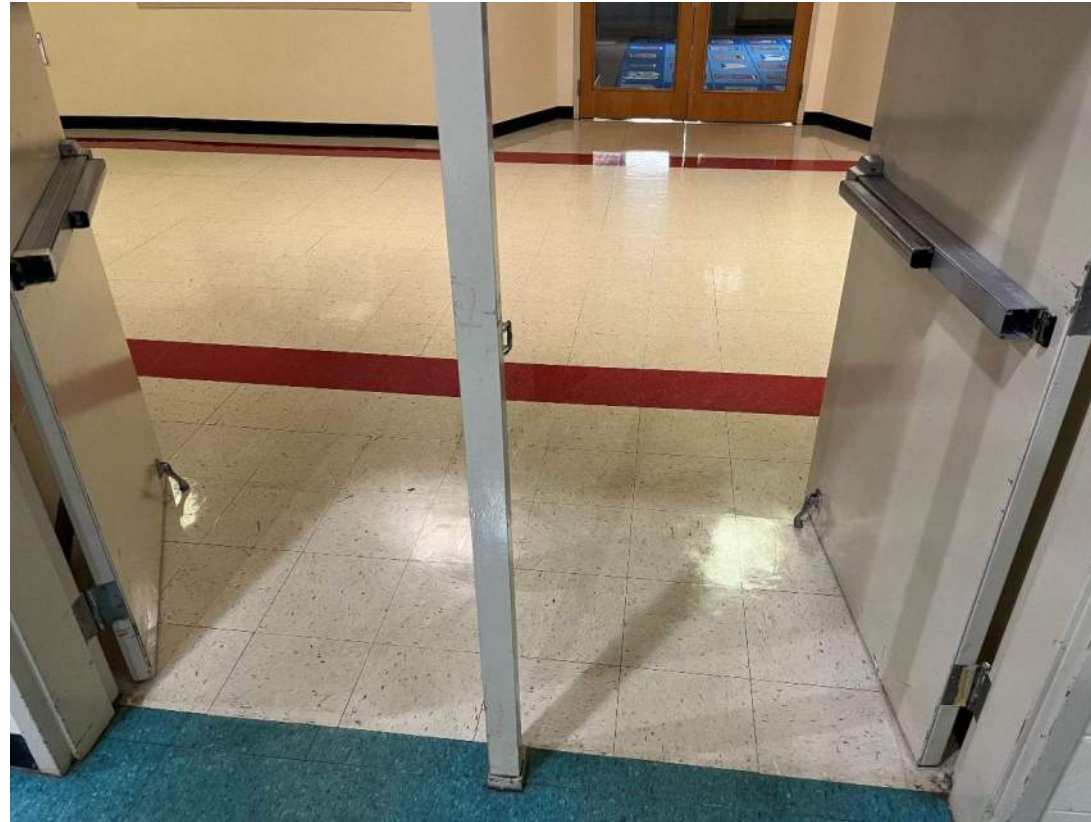
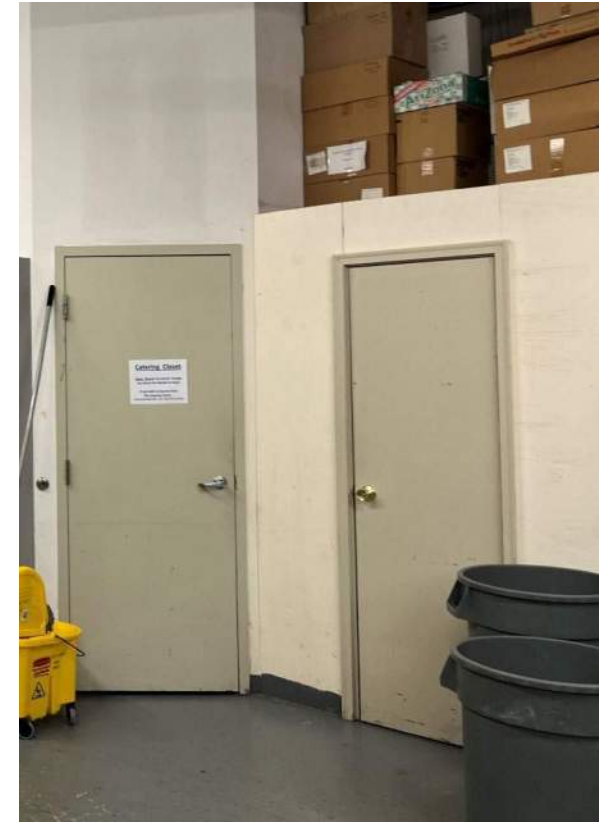
- Egress hardware is in acceptable condition
- Majority of hardware is code-compliant lever sets
- Owner should be mindful on non-compliant hardware including door stops (as seen in the gymnasium and corridors) and items prohibiting door swing clearance

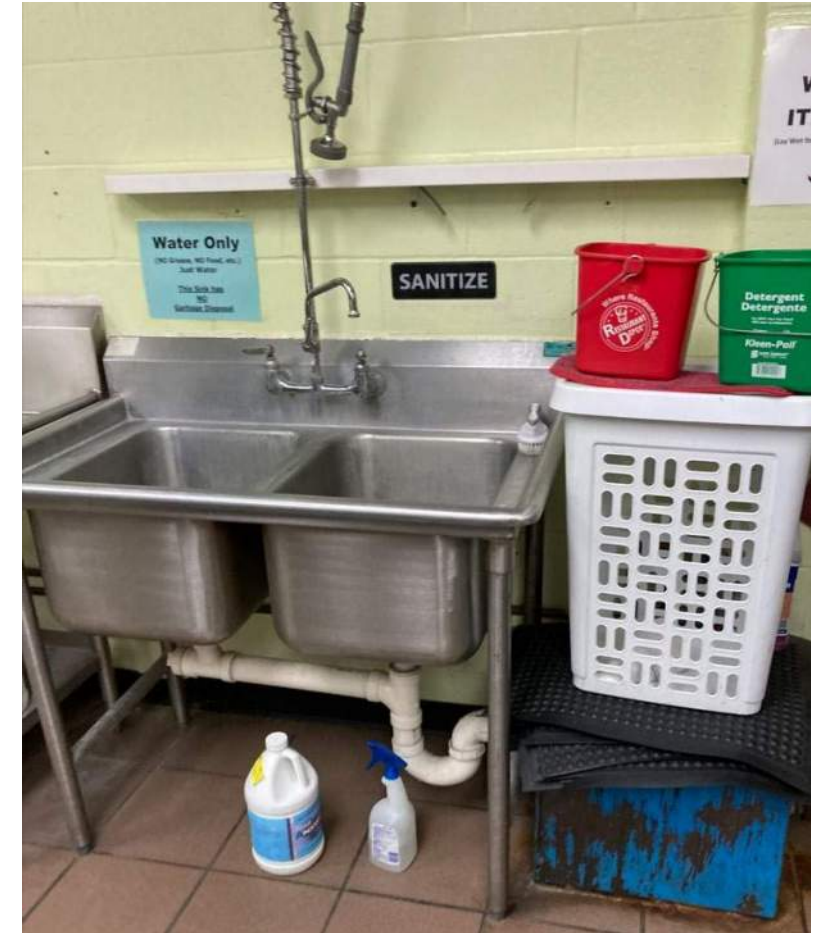
- Fixtures
 - Wall hydrants could be replaced with keyed hydrants to prevent unauthorized use.
 - Manual flush valves and various styles of manual faucets observed throughout. Various styles of toilets (floor mount tank type & flush valve, wall mounted flush valve)
- Kitchen Requires:
 - Three compartment sink for if there is food prep.
 - Handwashing sink
- Supply
 - Existing 3" water service – not able to shut off valves entirely. Replace valves. Add additional shutoff valve downstream of meter on 3" main.

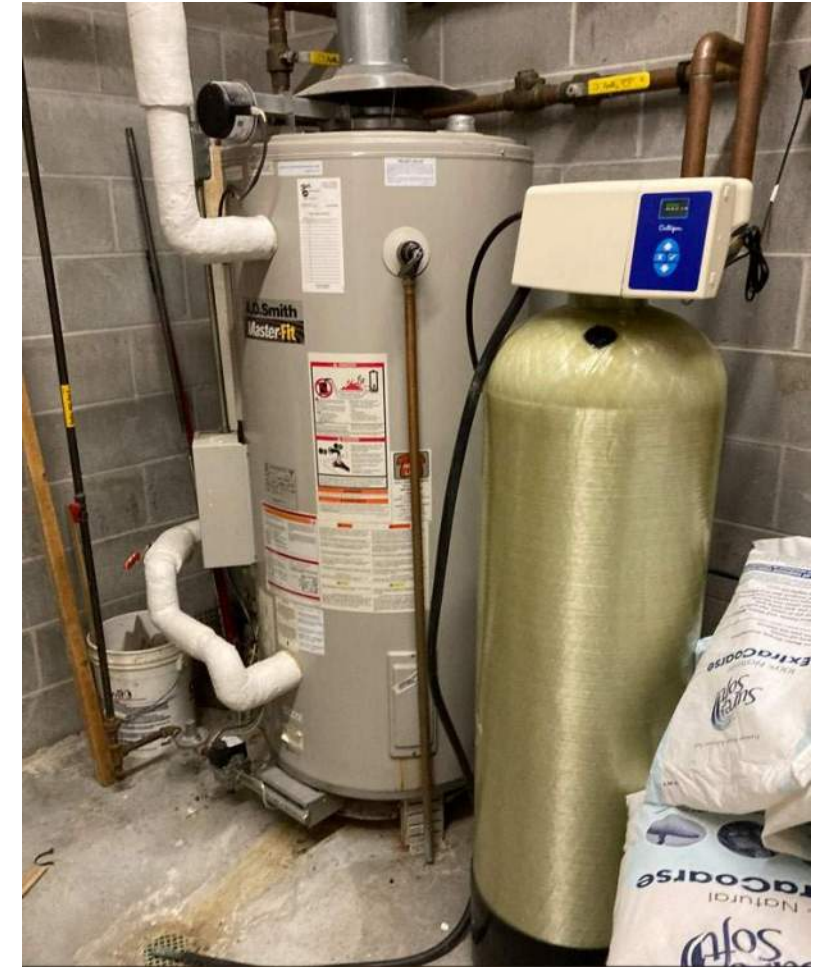
- Hot water circ pump reported to not be in operation/working order. Recommend replacement.
- Water Treatment
 - Water softener observed serving kitchen water heater. This should extend the life of equipment and prevent scaling of fixtures.
