CLARK &
ENERSEN

CHURCH OF THE HOLY SPIRIT
FACILITY CRITICAL NEEDS ASSESSMENT

JANUARY 2024

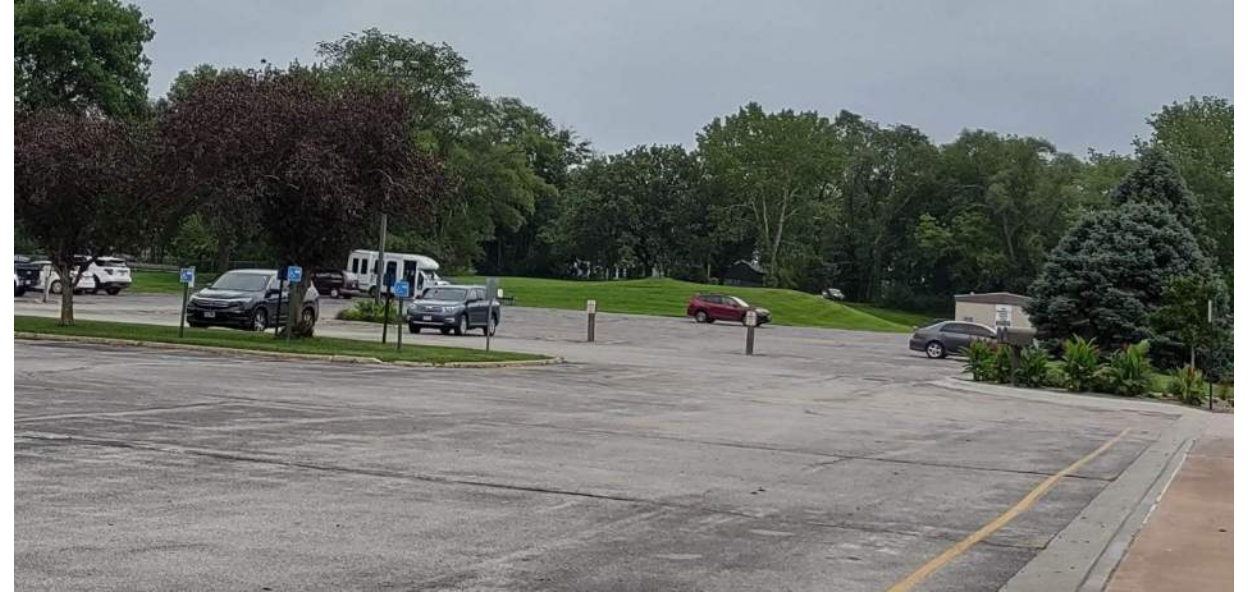
- ADA stalls adjacent to the church entrance do not meet current requirements.
 - Update pavement markings including aisles and curb ramps.
 - At the time when the parking lot is refinished, consider a new layout that would limit the need to cross a main drive to access the church and provide a clearly defined route with slopes that are less than 5% with no greater than 2% cross slope.

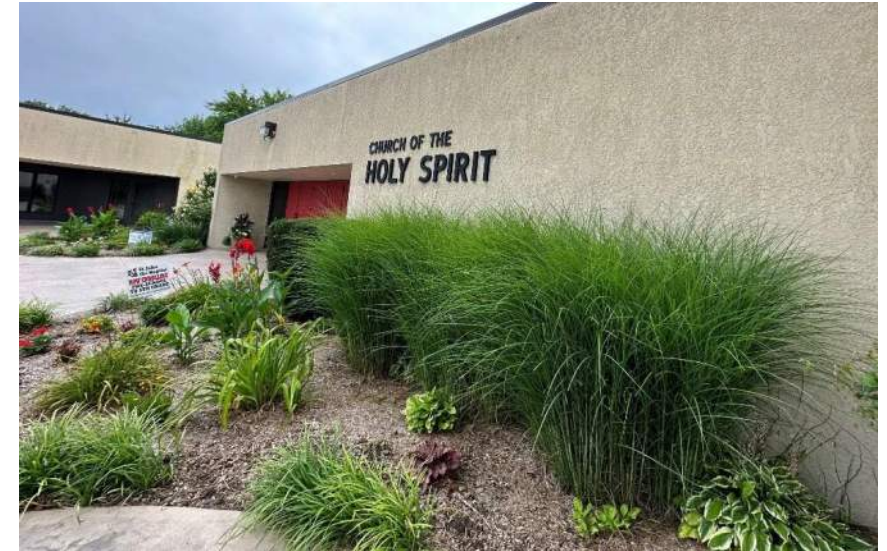
- Beautifully maintained facility
- Monitor health of trees on campus.
 - Emerald ash borer, needle blight and other diseases are impacting trees in the area.
 - Remove trees that are showing decline in the canopies.

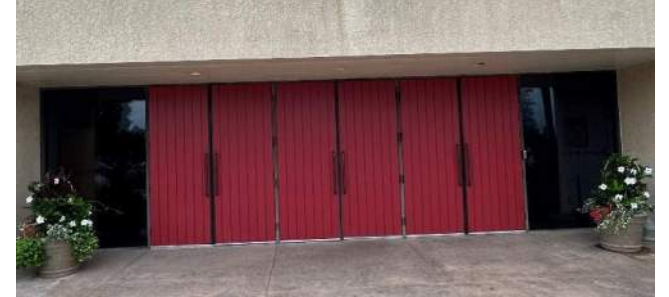
- The majority of doors on the church are original but have been modified
- Main entry doors are equipped with code compliant hardware.
- Both the main entry doors and rear doors have failed seals and should be replaced as part of a larger door and window replacement project.

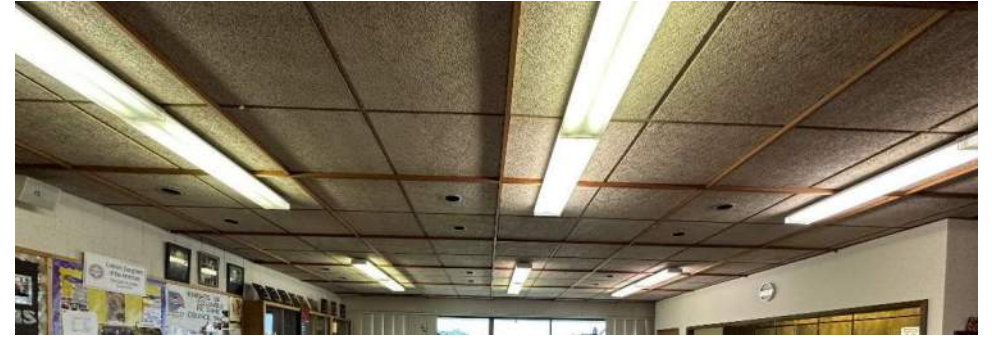
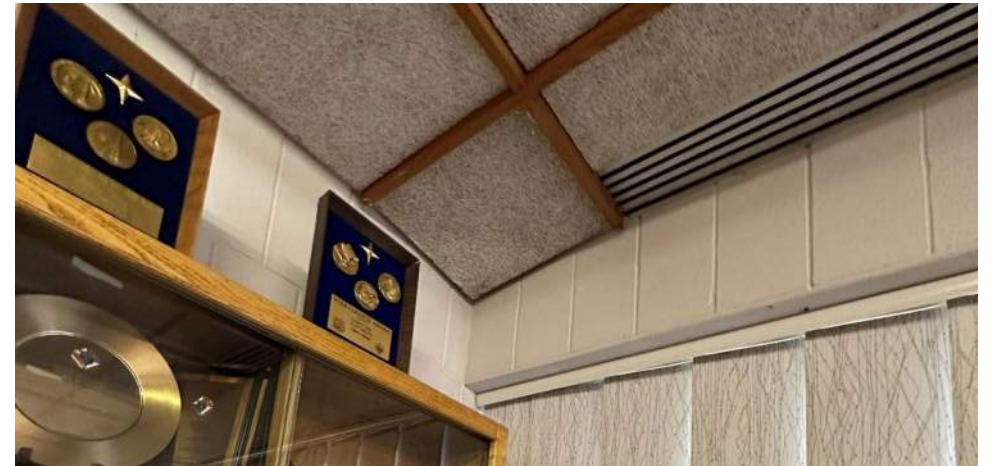
- The commons has the original direct-attached tectum acoustic ceiling in fair condition with portions on the perimeter no longer attached to structure above
- This ceiling system is atypical for worship facilities. While improving acoustics, the finish causes shadows and darkens the space. Consider replacement with suspended acoustic tile ceiling as part of a larger renovation project.

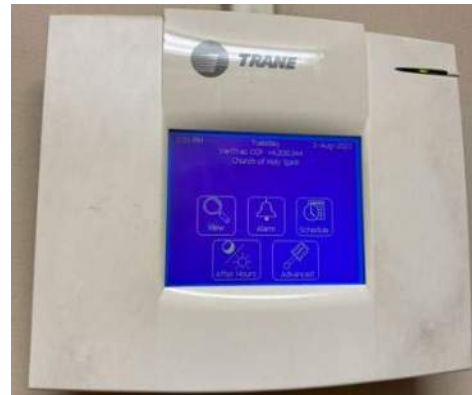
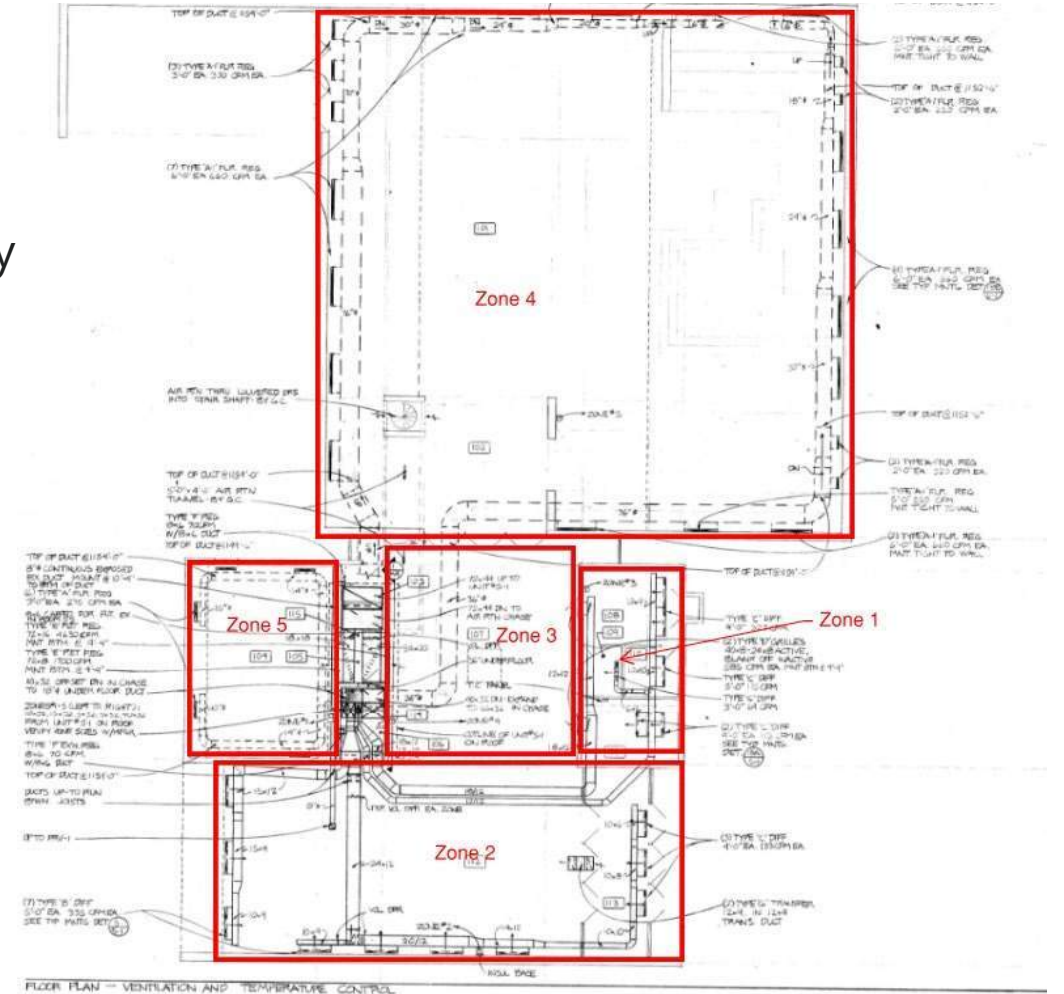
- Manufacturer controls – Trane Varitrac system to control different zones.
 1. Adoration chapel/Sacristy
 2. Commons
 3. Narthex
 4. Sanctuary
 5. West Room

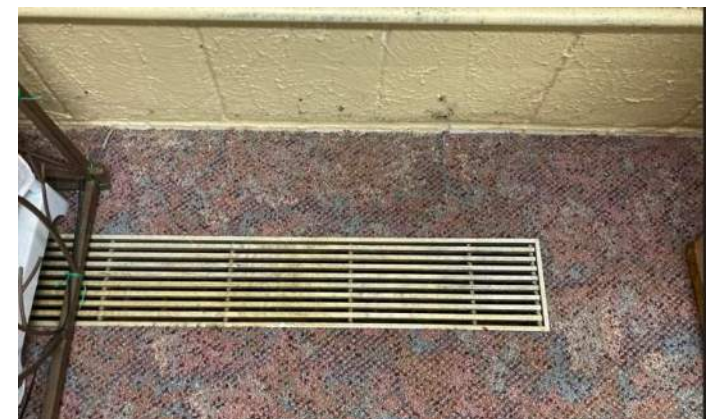
- 1 Multizone Rooftop Unit (DX/gas) –
 - 2004 Manufacture Date
 - Ashrae Median Life Expectancy: 18 Years
 - Maintenance costs will continue to increase due to R-22 refrigerant no longer manufactured.
 - Control issues reported after RTU was struck by lightning and control/circuit boards were replace. Verify with manufacturer operation of unit as designed.
 - According to project documents, underfloor ductwork contains asbestos inside and out.
 - Recommend cleaning underfloor return ductwork/plenum every 10 years for good air quality. Avoid for supply air asbestos ductwork.

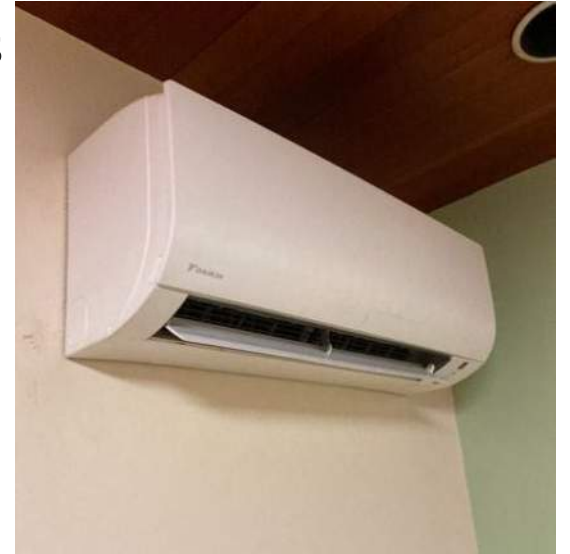
- Mini-split system manufactured in 2019 serves adoration chapel.
- Exhaust fan serving restroom did not appear to be operational. Recommend replacement.
- Unit heater in Conference room was reported to require manual operation, climbing a ladder. Recommend adding a thermostat to control operation of unit.
- Recommend adding exhaust fan to serve kitchenette in Commons area.

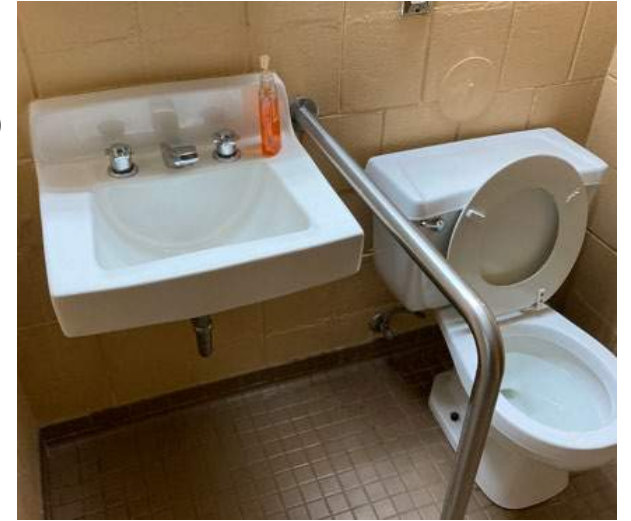
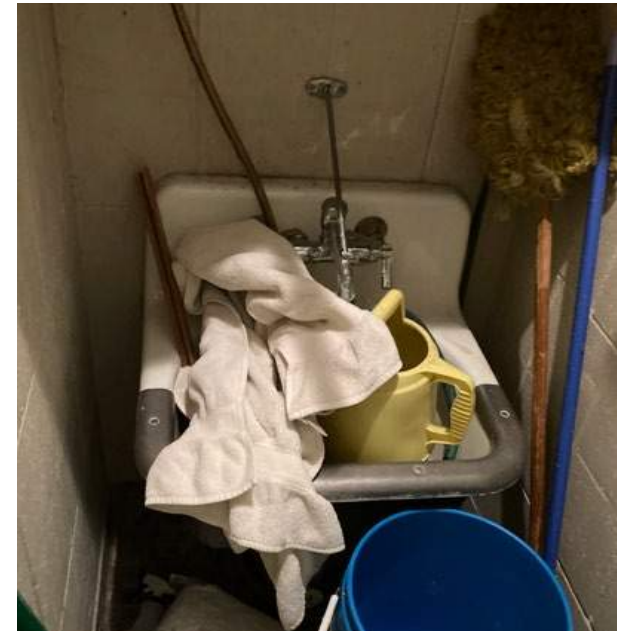
- Fixtures
 - Janitors sink could be replaced with floor mop sink basin for easier accessibility.
 - Manual faucets & tank type toilets
- Supply
 - 1" water service
 - If any future addition or wanting flush valves, water service size would need to be increased.
- Storm Sewer
 - Gutter & downspout
- Sanitary Sewer
 - No issues reported or observed.
- Valving
 - Recommend adding isolation valves at all water heaters when replacing in future.

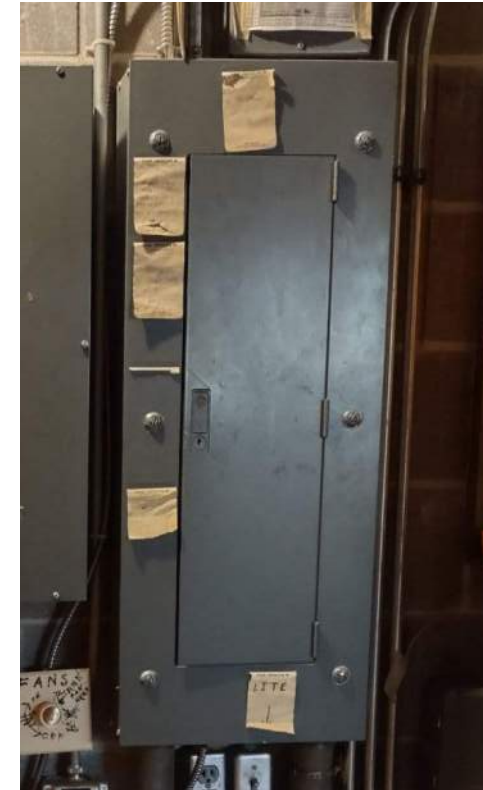
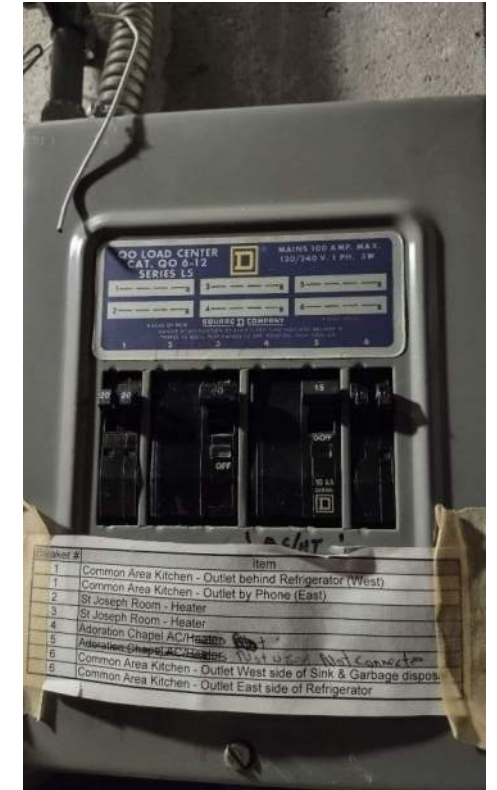
- There is a 150kva utility company transformer located on the southwest corner of the building, which feeds both the Church and the Rectory.
- The main distribution panel is General Electric brand, 600A, 208V, 3-phase, with fused breakers, and is original to the building. Recommend replacing this as a part of any remodel, or building addition project.

- The main electrical closet also contains a General Electric brand 225A, 208V, 3-phase panelboard (L1), and a Square D brand 100A, single-phase load center. Panelboard 'L1' is feeding mainly lighting and receptacle loads, appears to have 12 spare circuit breakers, and is original to the building. Recommend replacing panelboard 'L1' as a part of any remodel, or building addition project. There load center is feeding receptacles in the Commons Area kitchen, along with heaters for St Joseph room and Adoration Chapel, and does not have any spare circuits.

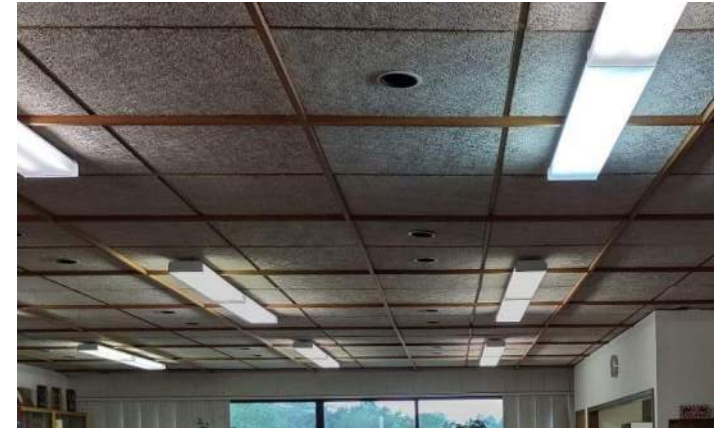
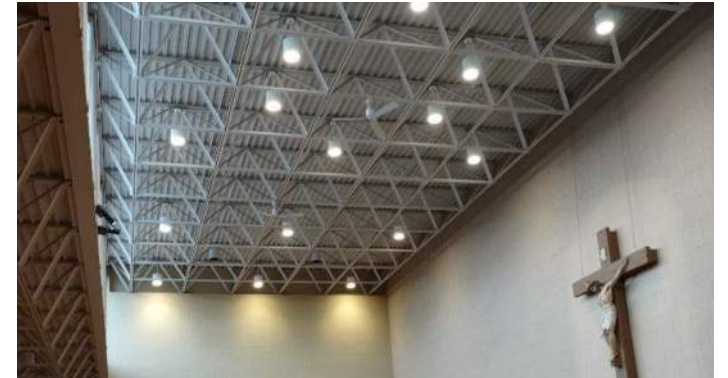
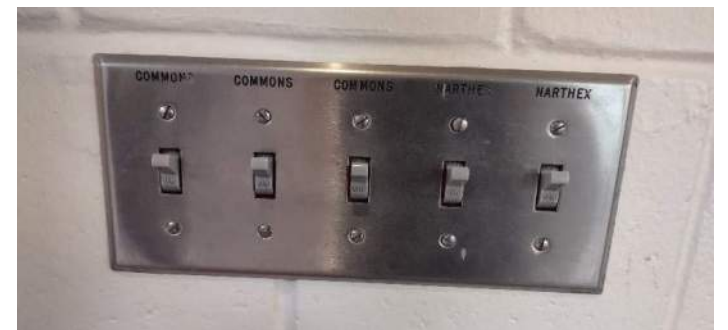
- Downlights in the church and the fellowship space have been relamped with LED type lamps. All 4' surface, and recessed, fixtures throughout the church have fluorescent lamping. Recommend replacing with LED type fixtures as a part of any remodel work.
- In the worship and fellowship spaces the light fixtures are switched by zones. No dimming control noticed. Recommend replacing with dimmable lighting controls.

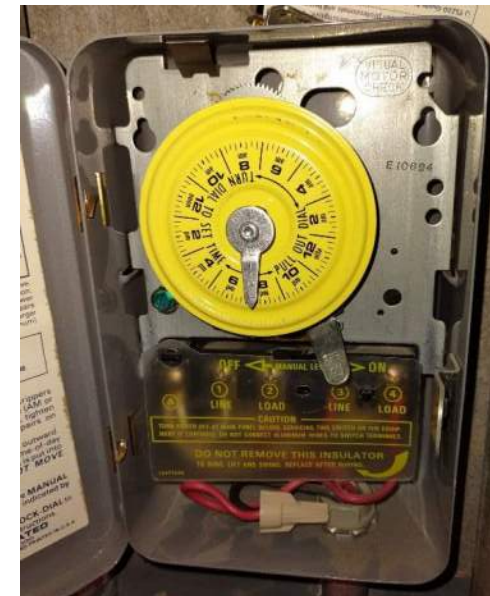
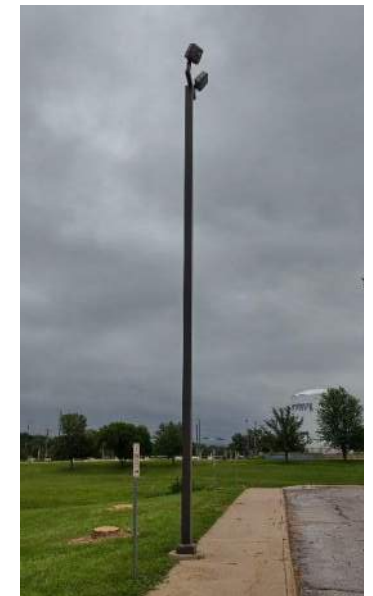
- Exterior building mounted fixtures are located at/near the exterior doors, and we were told that the majority of them have been changed out to LED type. Recommend adding exterior emergency lighting/function at every exit door.
- Only two poles for parking lot lighting, so it may not be properly lit. Recommend new pole type fixtures at new locations to adequately light the parking lot and drive.
- All exterior lighting is controlled by a time clock.

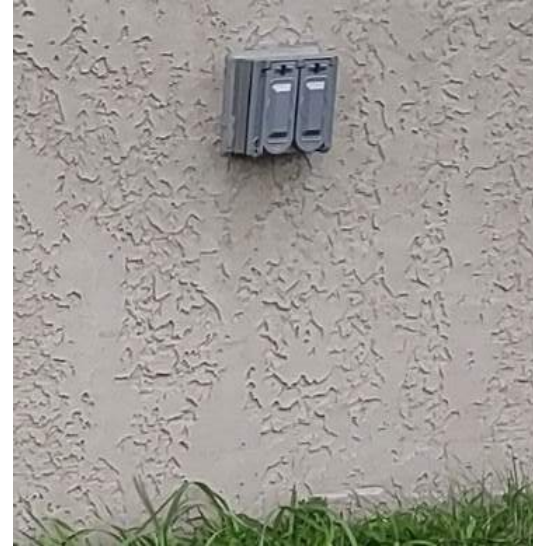
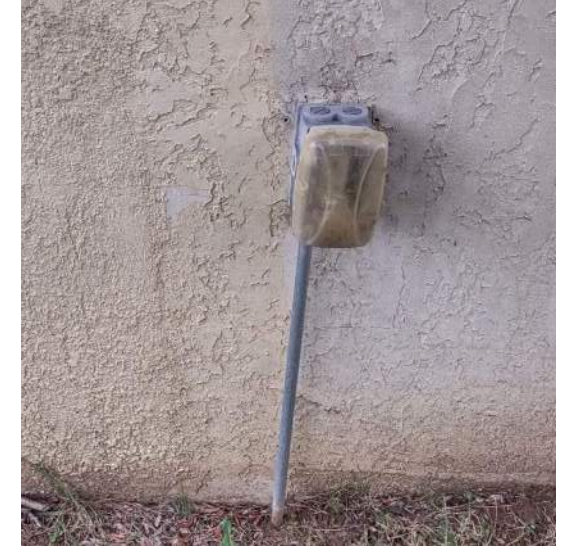
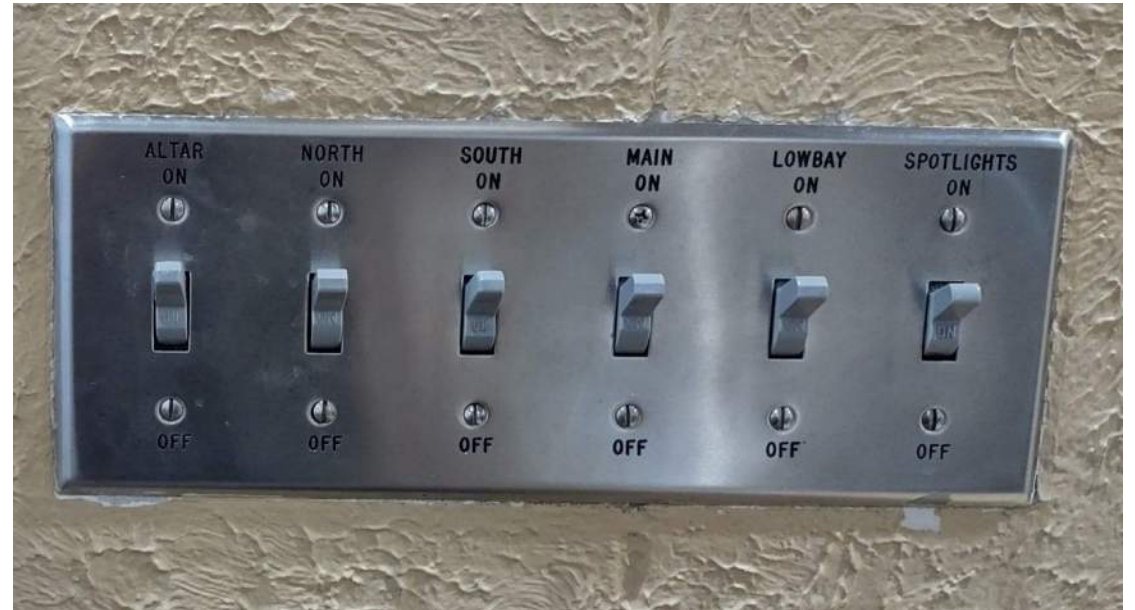
- Electrical devices are gray in color, with stainless steel coverplates, and are in good condition. Locations, and additional devices, should be considered with any future remodels.
- Exterior, weatherproof receptacles are minimal around the facility. Recommend adding exterior receptacles as a part of any future additions.

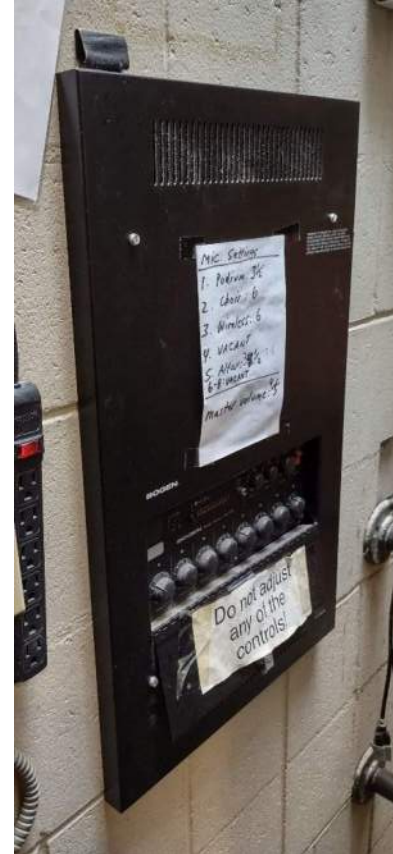
- Worship space has a sound system, and appears to have live streaming capabilities. Did not find information on the age of this system, or how well it works. Recommend having further conversations in order to determine whether or not this system should be upgraded to a newer system.

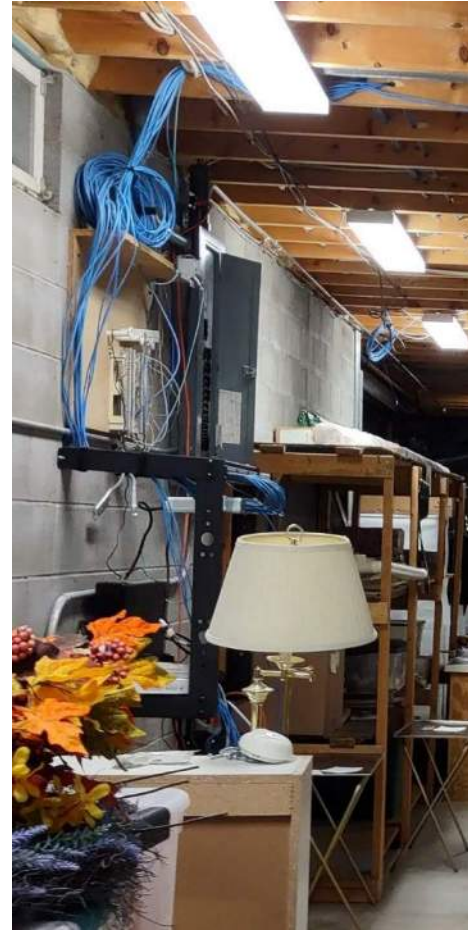
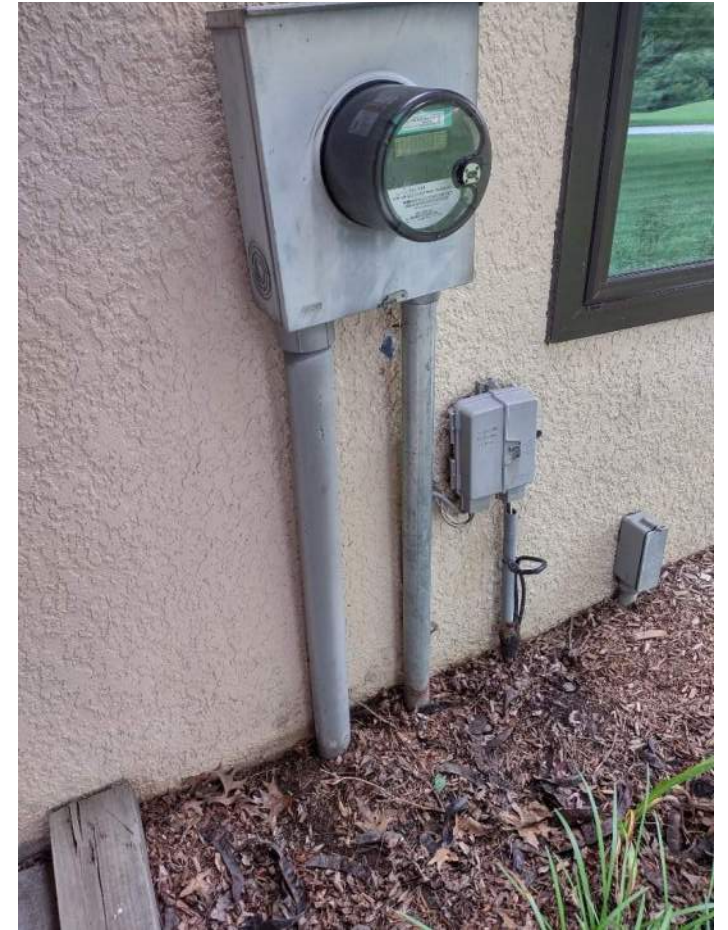
- Did not observe within the church any fiber service entrance location. All of the phone/data devices within the church portion of the facility appear to be fed from the fiber service entrance/rack located in the Rectory basement.

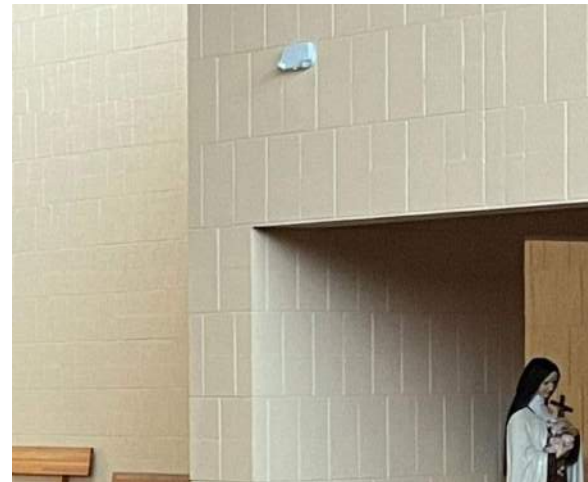
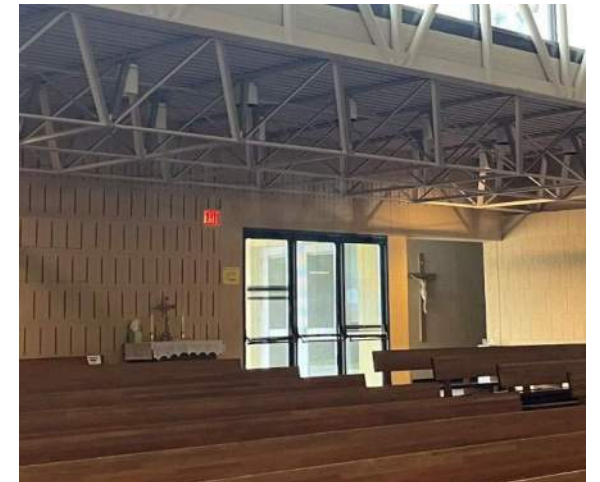
- There are a couple of exit signs, and emergency fixtures, in the church portion of the facility. Recommendation is to add/update exit signs and emergency lighting throughout the church.

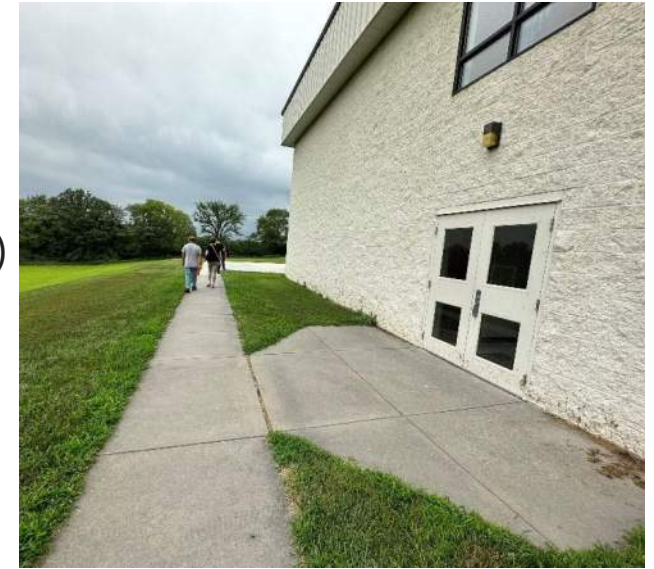
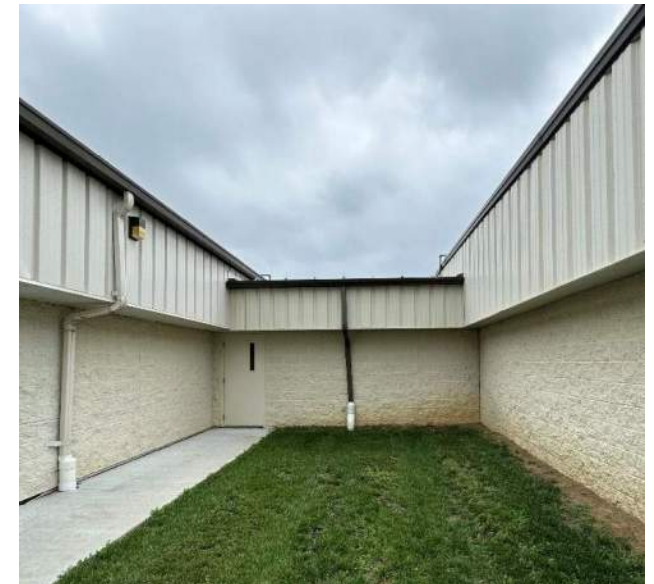
- The grade is fairly level around the building except the transition to the walkout.
 - Future projects (noted later in the document) should take into account the flatness around the building to increase slopes and promote drainage away from the building and paved spaces.
 - Swales can be added now to promote drainage in green spaces, particularly in some of the narrow courtyard areas. Try to provide a 5% - 10% slope away from the building in green areas.

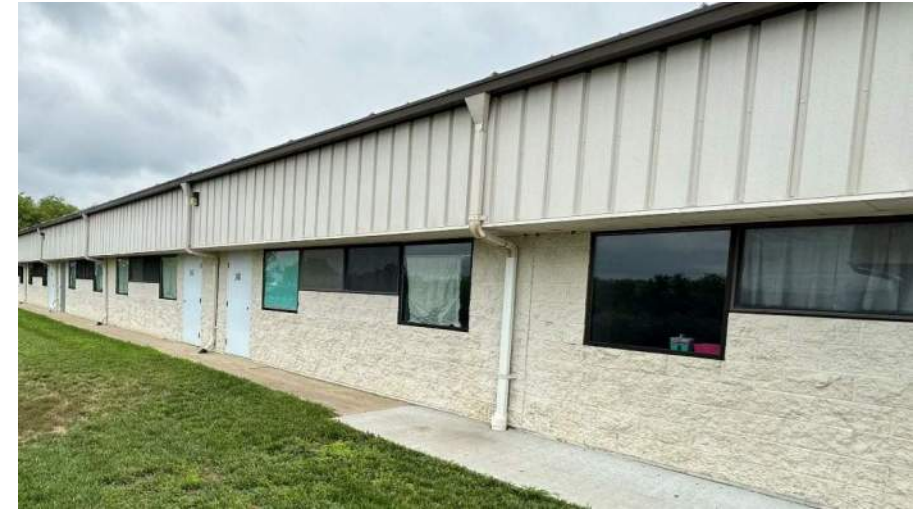
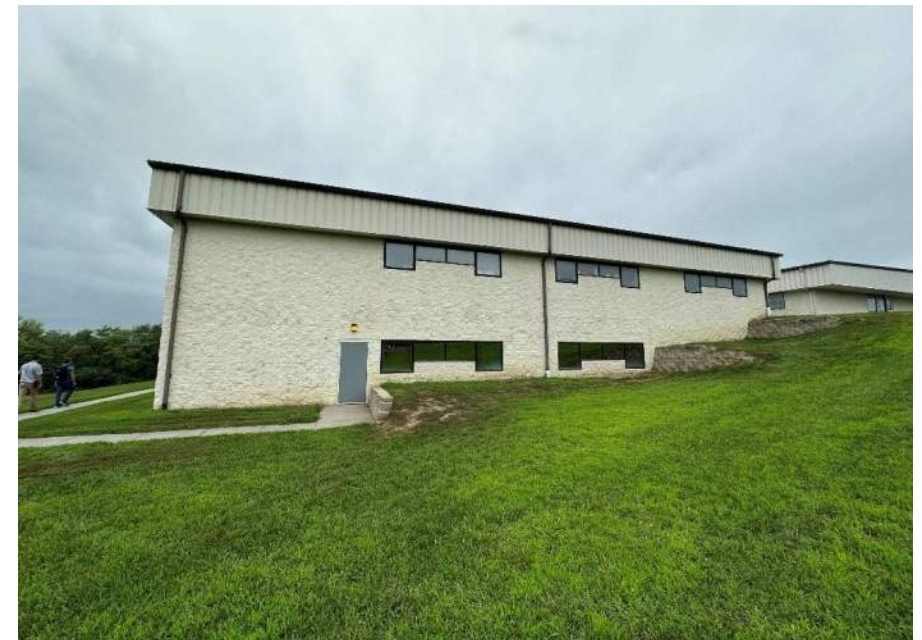
- The piped roof drains help alleviate excess drainage on site.
- Walls adjacent to playground area are greater than 30" in height creating a fall concern. Limit access or consider guard railing.

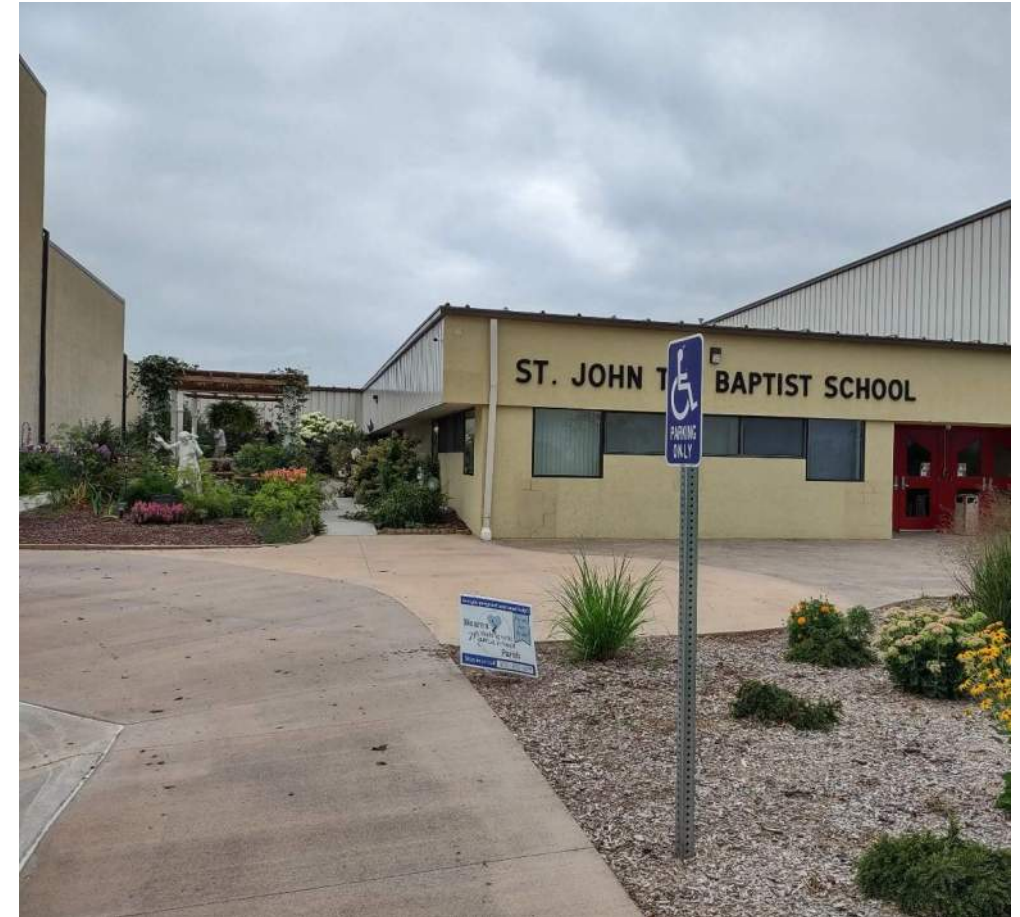
- ADA stalls adjacent to the school entrance do not meet current ADA requirements.
 - Update pavement markings including aisles and curb ramps.
 - Consider clearly defined accessible routes from any drop-off area and designated parking stalls with slopes that are less than 5% with no greater than 2% cross slope

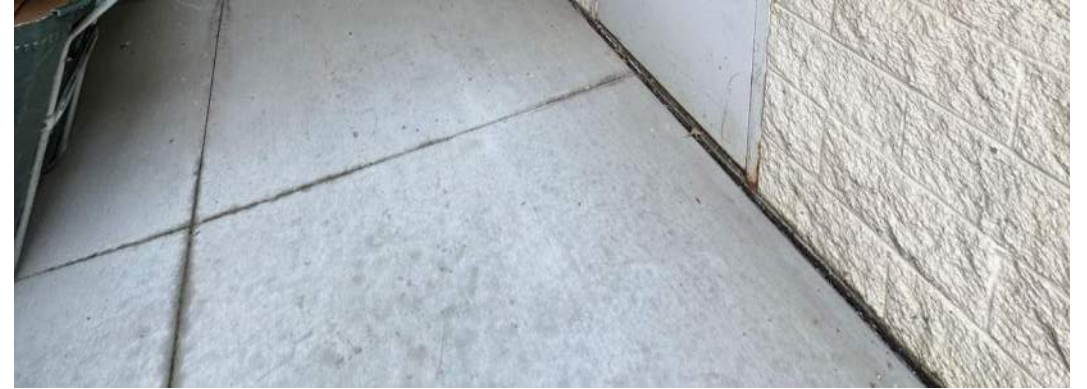
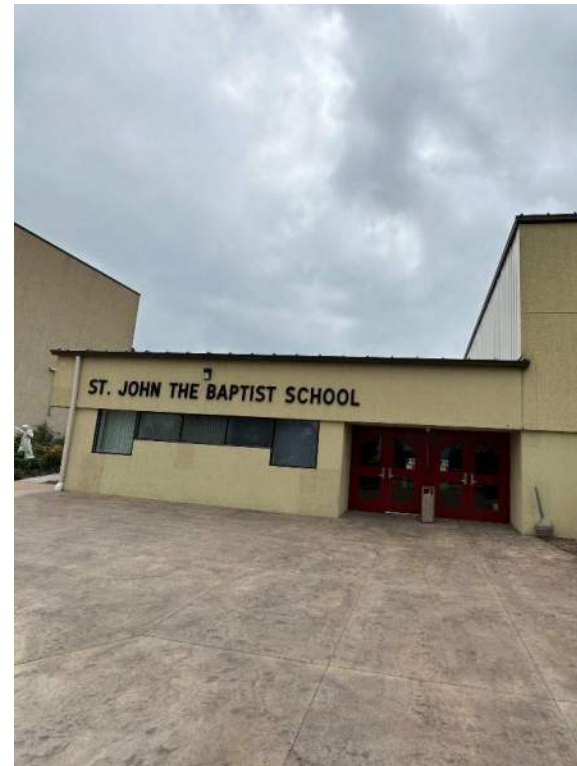
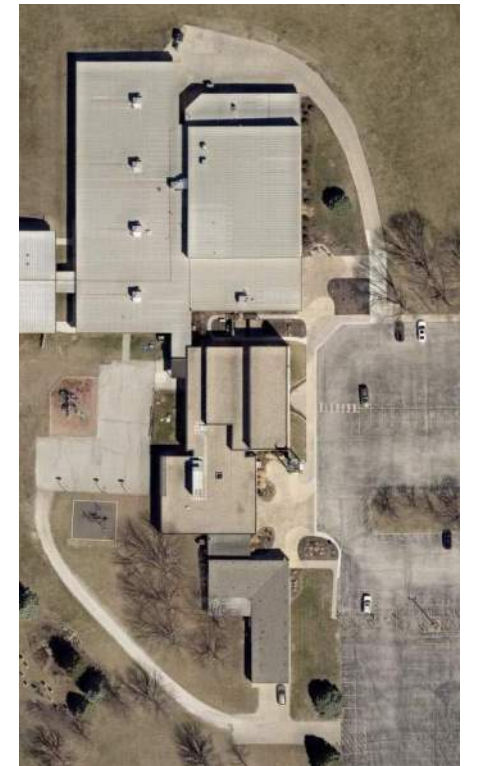
- Seal all expansion joints, especially adjacent to the building.
- The service drive bisects the front lawn.
- Consider realigning this to minimize its visibility and impact at the time of replacement.
- Consider screening the service area from the street and any future parking.

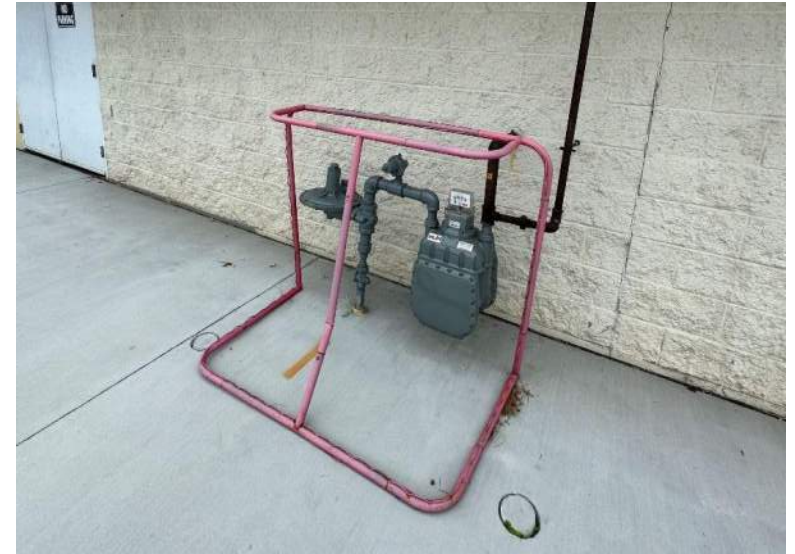
- The gas meter is exposed in the service area with minimal protection. Consider adding bollards similar to the transformers

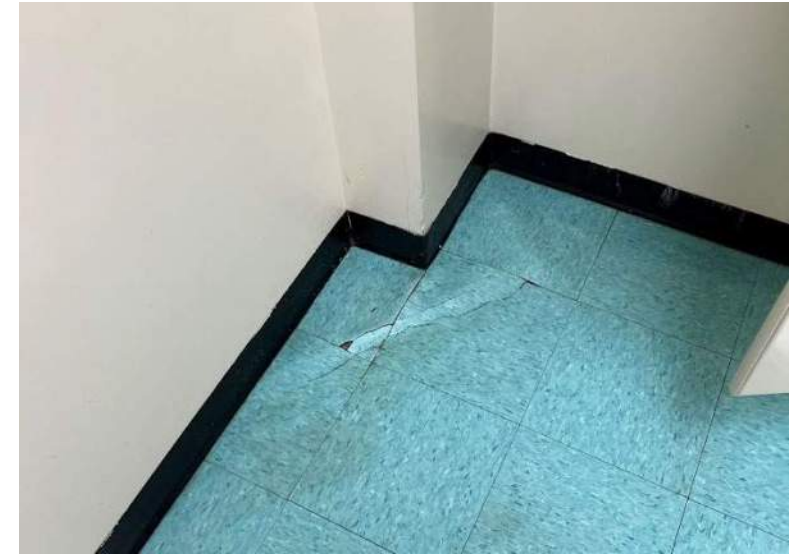
- Overall in good condition.
- Areas of settling slab in the restrooms while the columns and column bases are remaining stable.
- Consider poly jacking to correct settling and prevent further settling.

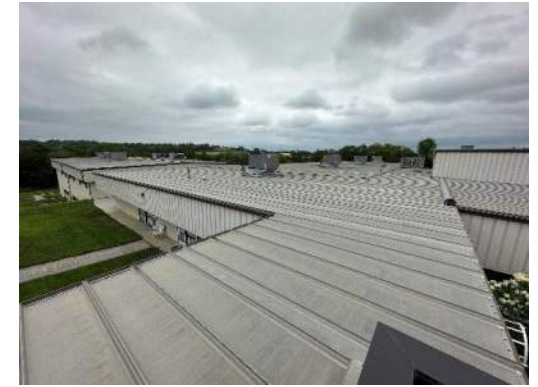
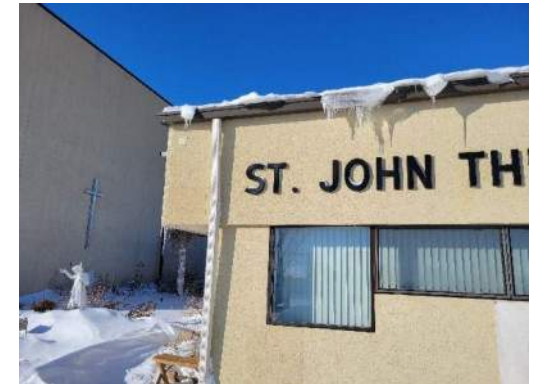
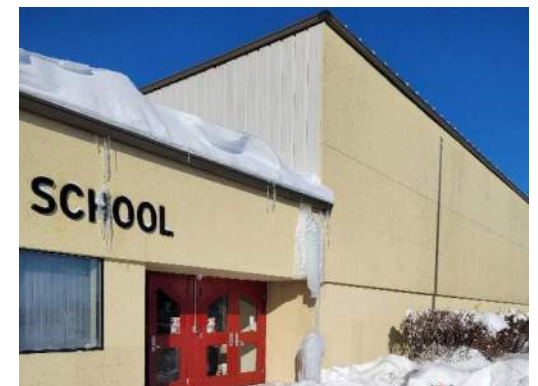
- Low-slope standing seam roofs in overall good condition
- Some areas have soft footing due to wider spans in structure and bag insulation
- Regular inspection of flashing between roofs and sidewalls should be conducted
- Ice dams were observed at the gutters and downspouts of the school following large snows and freeze/thaw cycles. While no water infiltration to the building was observed, monitoring should be conducted, ice jacks should be installed, and removal of large portions of snow and ice should be done prior to damage to gutters and downspouts.

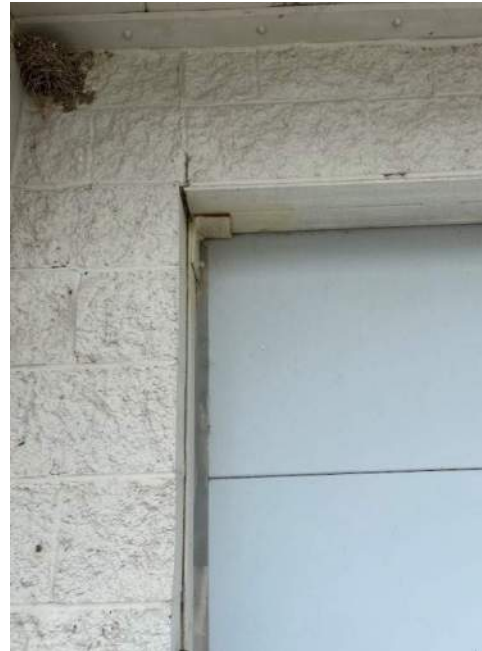
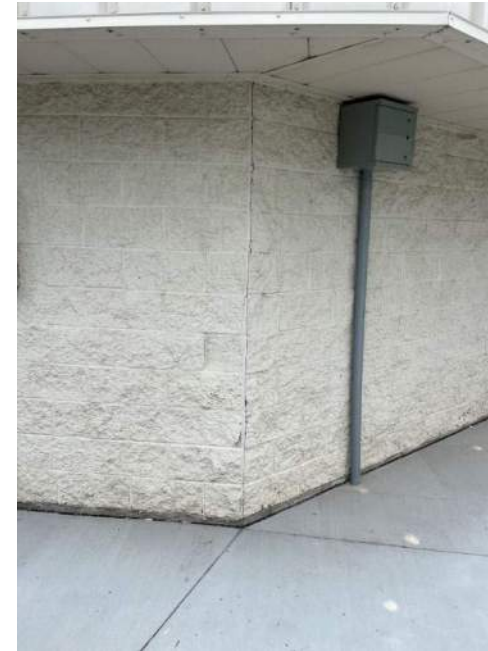
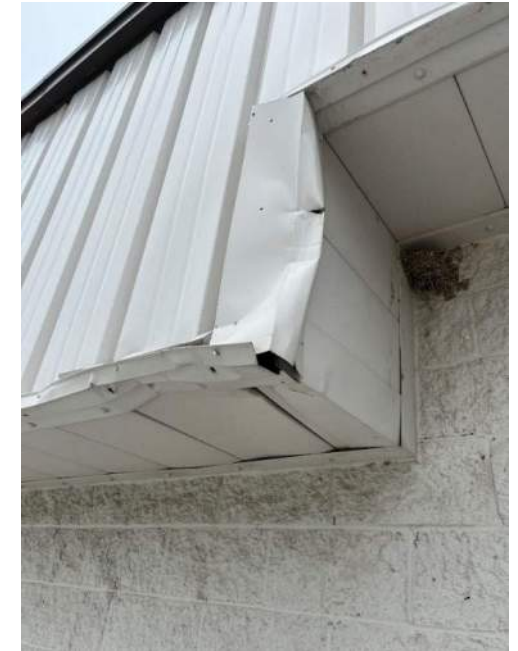
- CMU non-bearing block walls appear to be in good condition
- Grading along lower level should be monitored to keep water flowing away from the building.
- 45 degree CMU wall joint near kitchen is not toothed in. Monitor wall for cracking.
- Wall is damaged near delivery doors.
- Lintel over delivery door does not appear to bear a full 8" past the opening.
- Joint between sidewalk and wall is large along west wall. Joint should be caulked to prevent water infiltration.

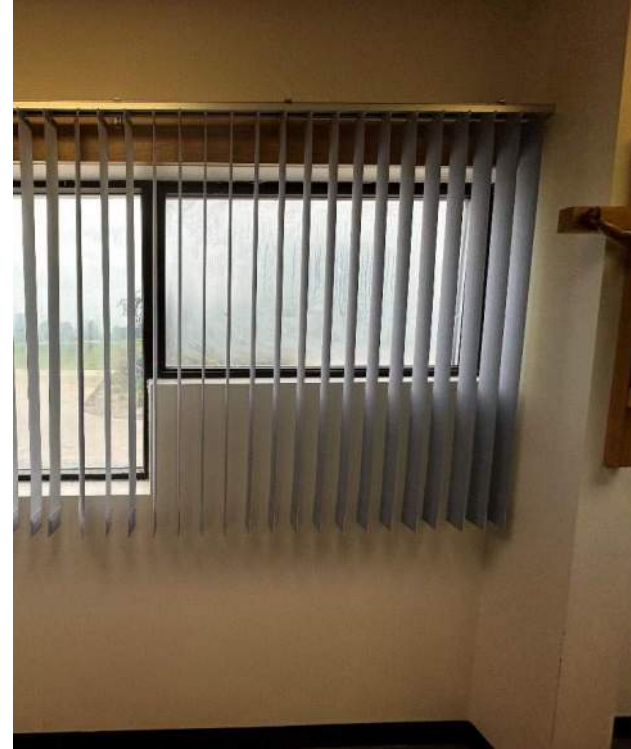
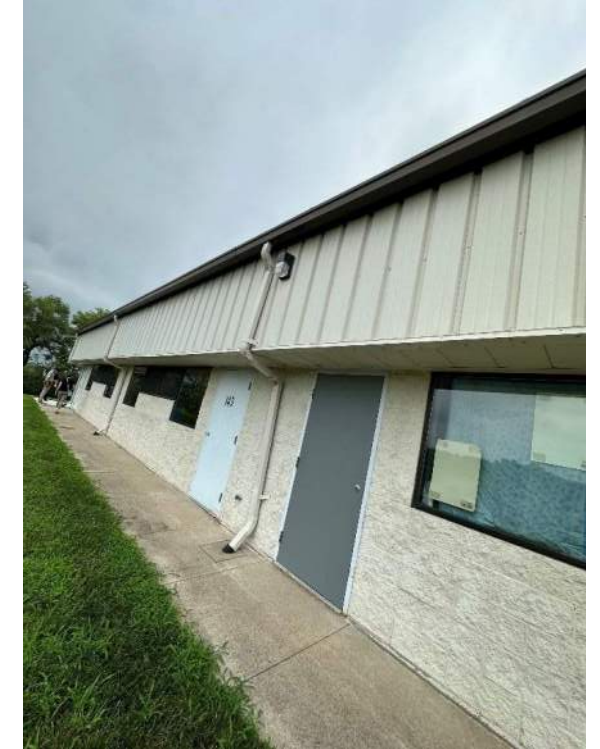
- Majority of windows are in fair condition
- Several windows have failed seals as seen when windows cloud
- Consider a full window replacement
- Most classrooms have doors that lead directly to the exterior. A large portion have been replaced. Continue to monitor doors and replace as required

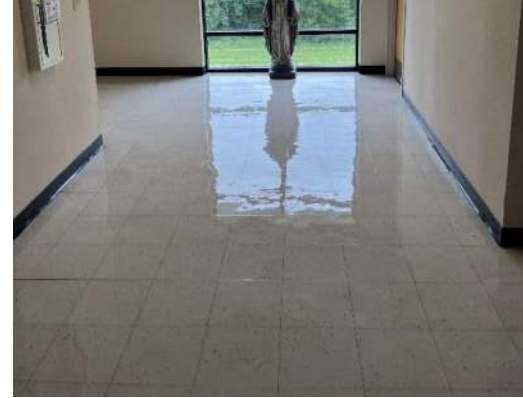
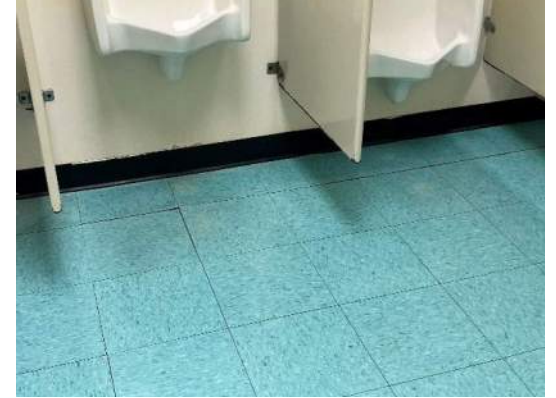
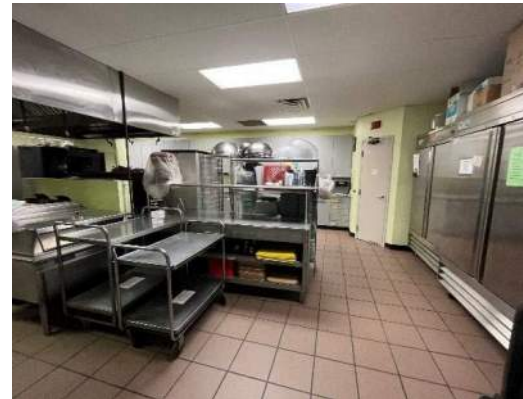
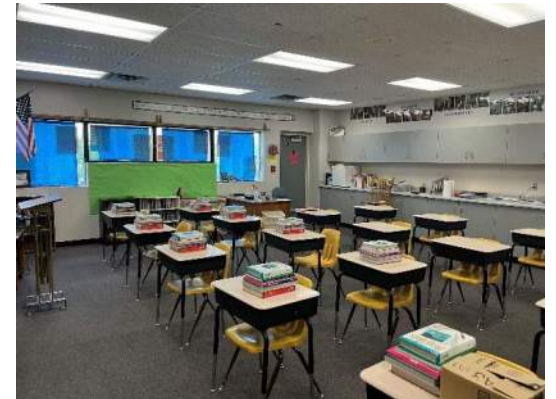
- Corridors are VCT flooring in well-maintained condition
- Restrooms are VCT flooring in fair condition due to water infiltration. Flooring should be replaced as part of a larger renovation project.
- Kitchen quarry tile is in good condition
- Classrooms typically have carpet in varying condition. A replacement plan should be implemented.

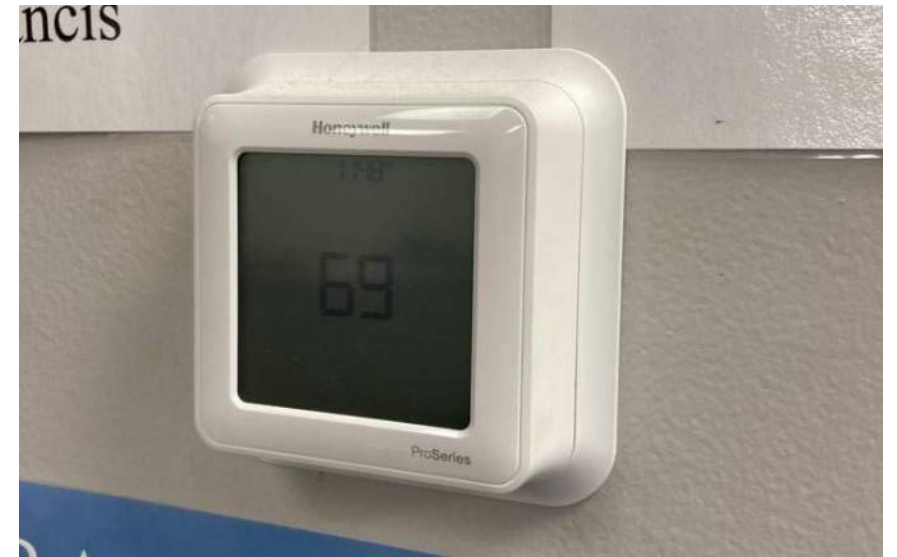
- Honeywell thermostats. Maintenance personnel mentioned that they are app enabled, but not able to access due to Diocese firewall.

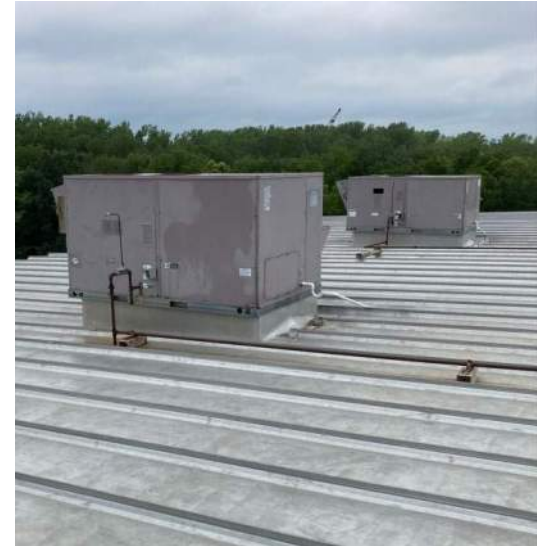
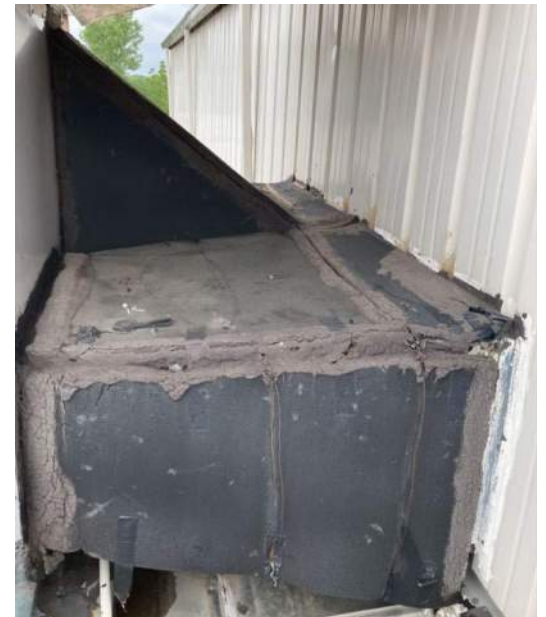
- 11 Rooftop Units –
 - 2000-2002: 4 units
 - Maintenance costs will continue to increase due to R-22 refrigerant no longer manufactured.
 - 2014-2015 – 2 units
 - 2017 – 2 units
 - 2018 – 3 units
 - Ashrae Median Life Expectancy: 18 Years
- Exterior ductwork insulation for gym RTU has significant wear and can lead to leaks and corrosion of ductwork.
