CLARK &
ENERSEN

CHURCH OF THE HOLY SPIRIT
FACILITY CRITICAL NEEDS ASSESSMENT

JANUARY 2024

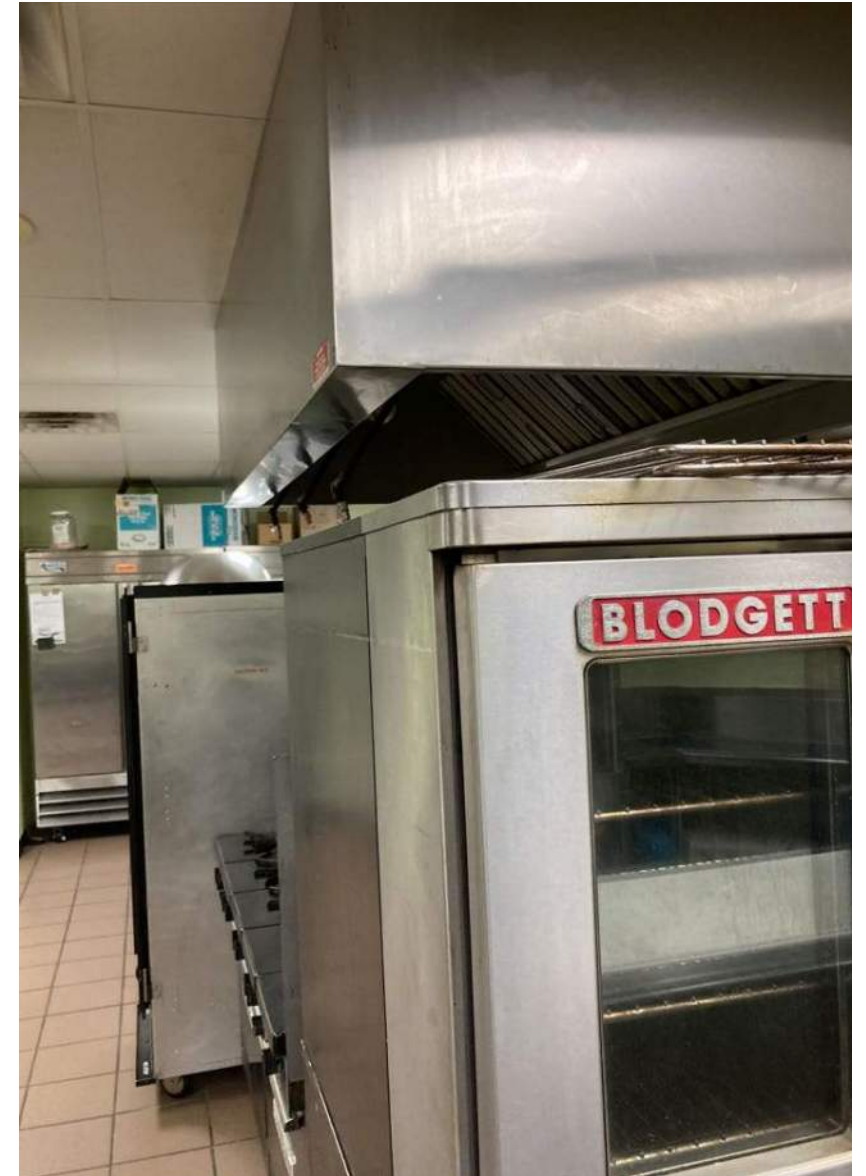
- Kitchen
 - Kitchen hood does not have a make-up air unit. If any revisions are made to kitchen, AHJ may require adding one.
 - Current hood does not provide 6" overhang on ends of kitchen equipment.
- Art Room
 - Current code requires exhaust for art rooms.
- Preschool Kitchenette
 - Current code requires exhaust for kitchenettes.

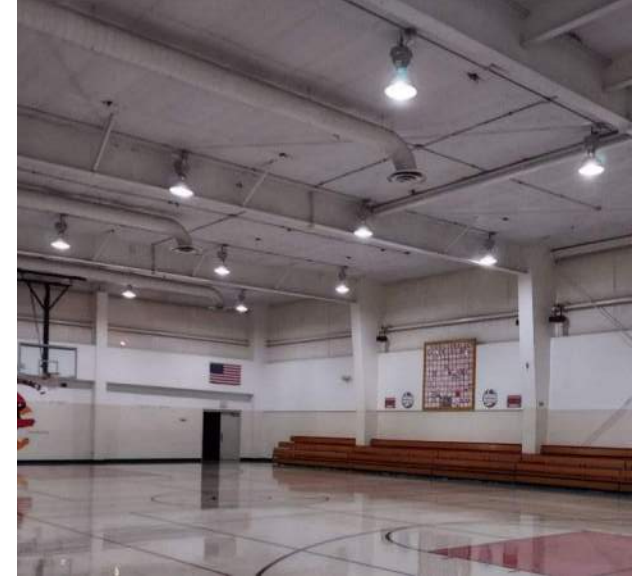
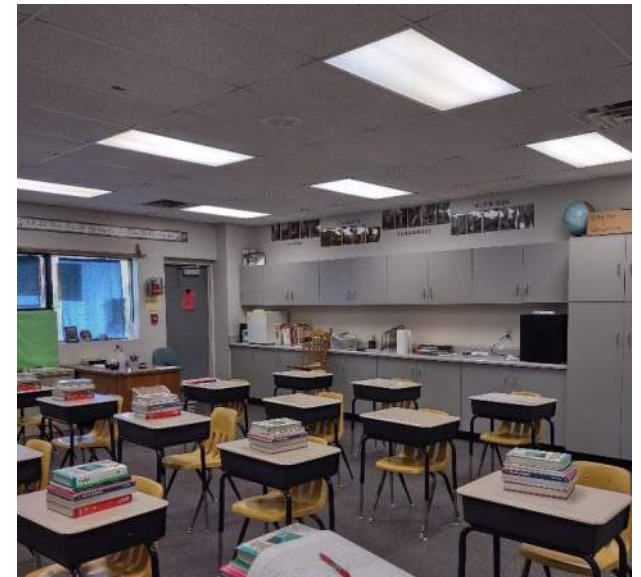
- Fluorescent type lighting throughout the school. Recommend 1-for-1 replacement with LED type.
- Gym lighting has been re-lamped with LED type lamps.
- Dual-level switching in the classrooms.
- Occupancy sensors for lighting control in the restrooms.
- Exterior wall mounted light fixtures are located near most of the exterior doors, and appear to be controlled by photocells. Most of these fixtures have been replaced with LED fixtures. Recommend adding exterior emergency lighting/function at every exit door.

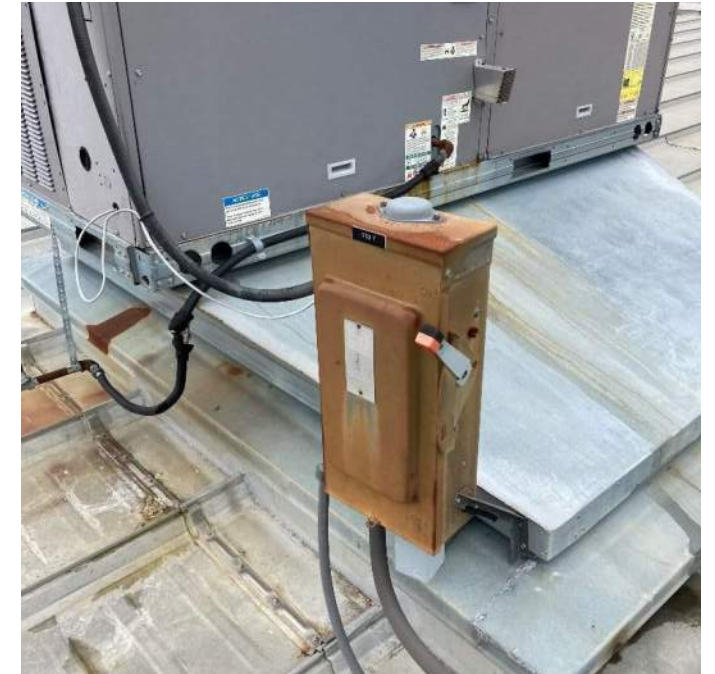
- Several disconnect switches for the HVAC equipment are not working correctly. Fuses need to be replaced, and at least one disconnect needs to be held shut with a screwdriver.
- Recommend replacing each faulty disconnect switch, with appropriate fuse size to match the circuit breaker size. Feeders may also need to be replaced if they are not sized correctly.

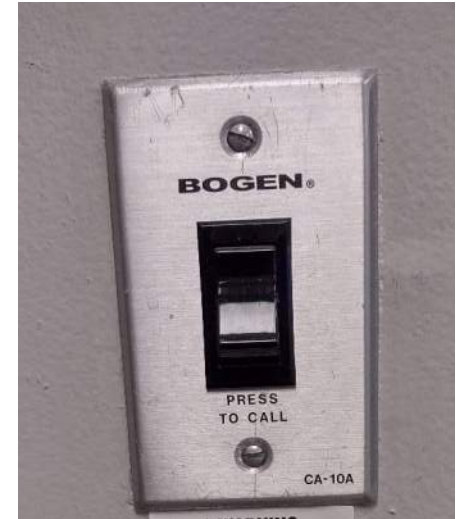
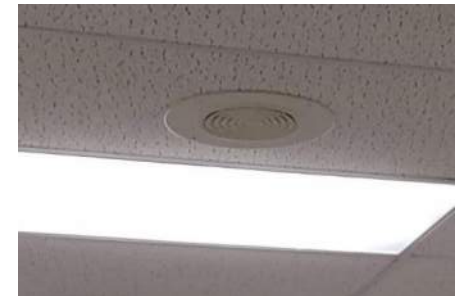
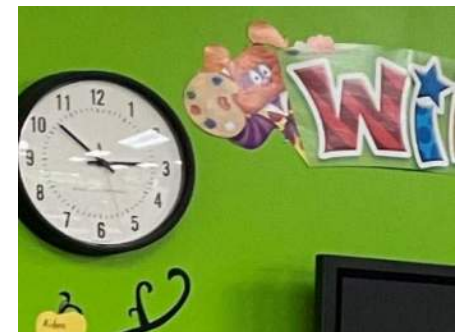
- Classrooms have call buttons on the wall, but the microphone is located in the ceiling with the speakers. Not always clear communication for intercom purposes.
- Other speakers are located throughout the facility for announcements.
- There is a hardwired master clock system throughout the building, with clocks located in the classrooms and common spaces.

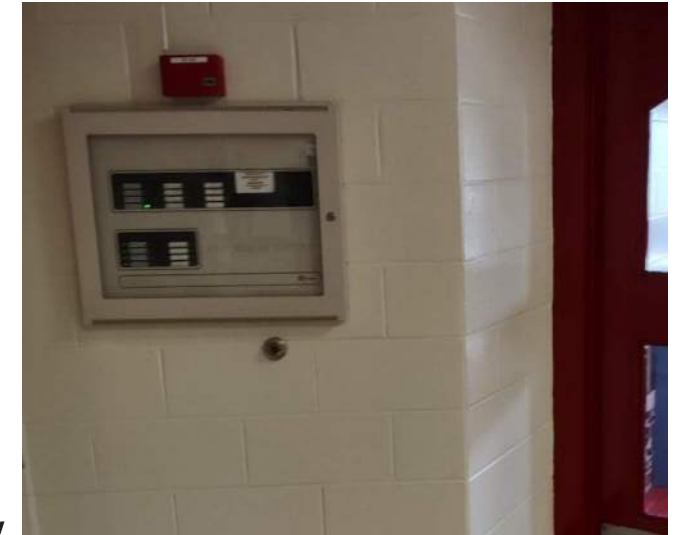
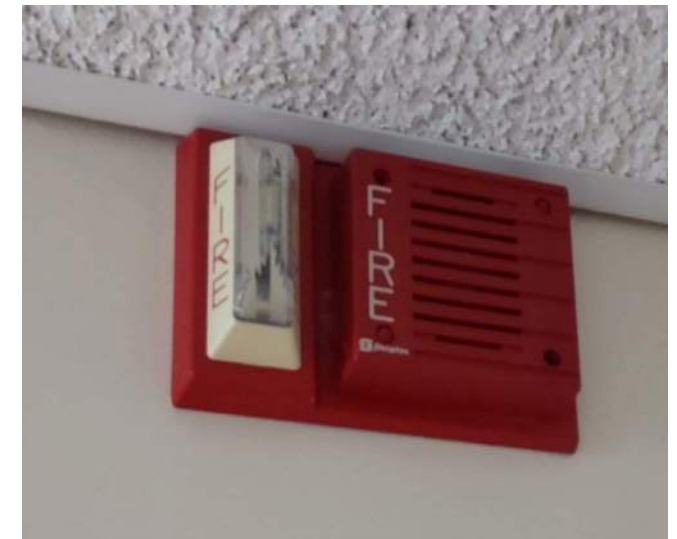
- There is a Simplex brand fire alarm system for the school which includes pull stations at the main exits, horn/strobe devices in the general areas, smoke/heat detectors, and kitchen hood connection. Appears like the system is original to the school.
- Observed CO detectors in the classrooms, but there are no horn/strobe devices in the classrooms (may be required by the local Authority Having Jurisdiction).
- Many exterior exit doors within the classrooms do not have the code required pull stations.
- Due to its age, may need to replace the fire alarm panel if any devices are added to the system.

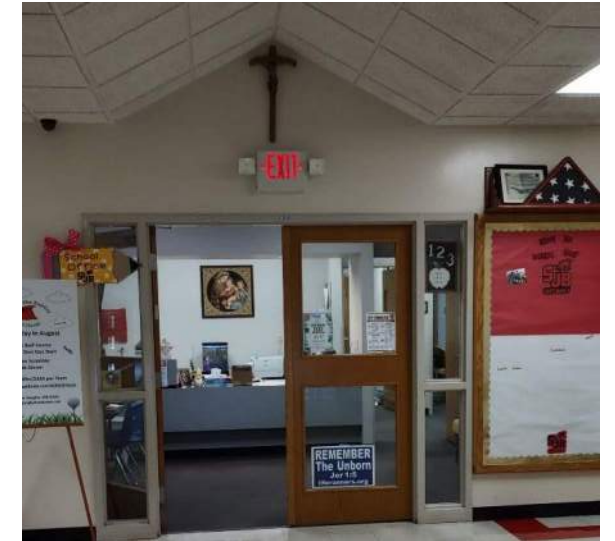
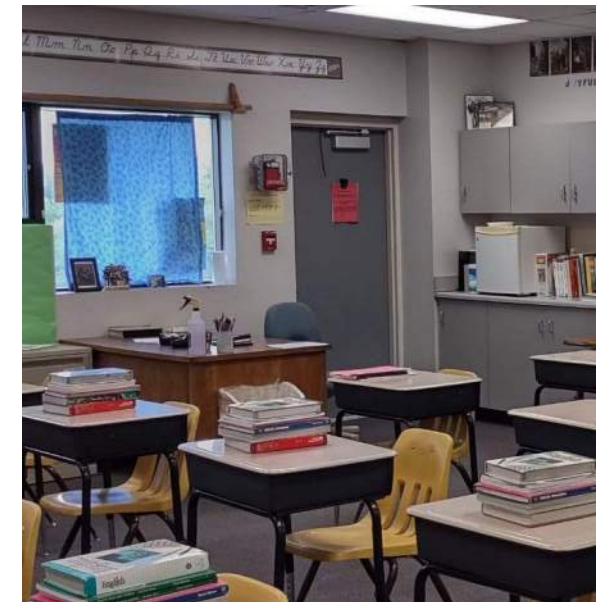
- There are exit signs and emergency fixtures located throughout the school portion of the facility, although not all locations appear to be fully covered (especially exit doors from classrooms). Recommendation is to add/update exit signs and emergency lighting throughout the school, in order to provide complete coverage.

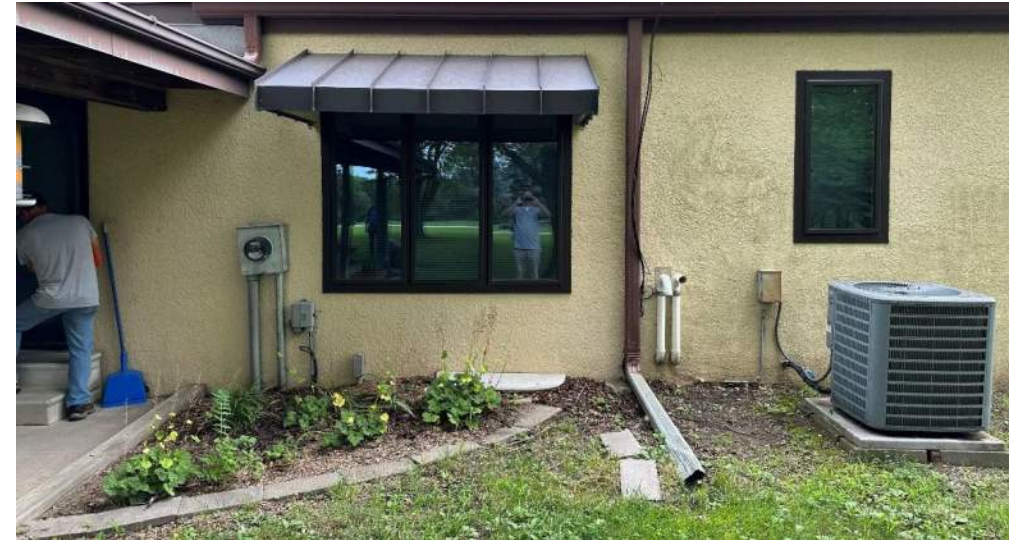
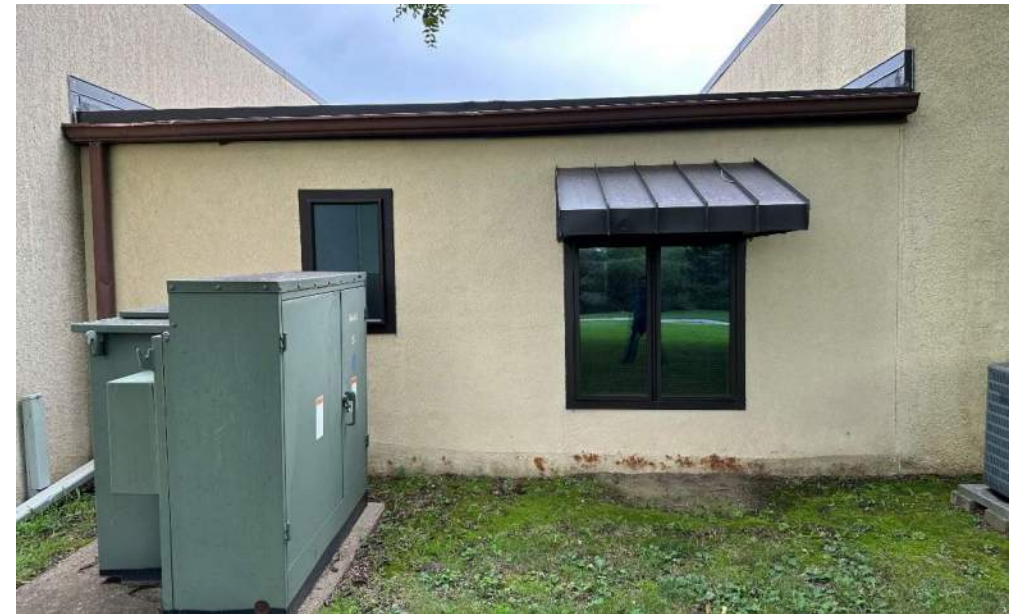
- Moisture adjacent to the building appears to be an issue.
 - Pipe downspouts below grade to limit water adjacent to the building.
 - Add swale to provide positive drainage away from the building.

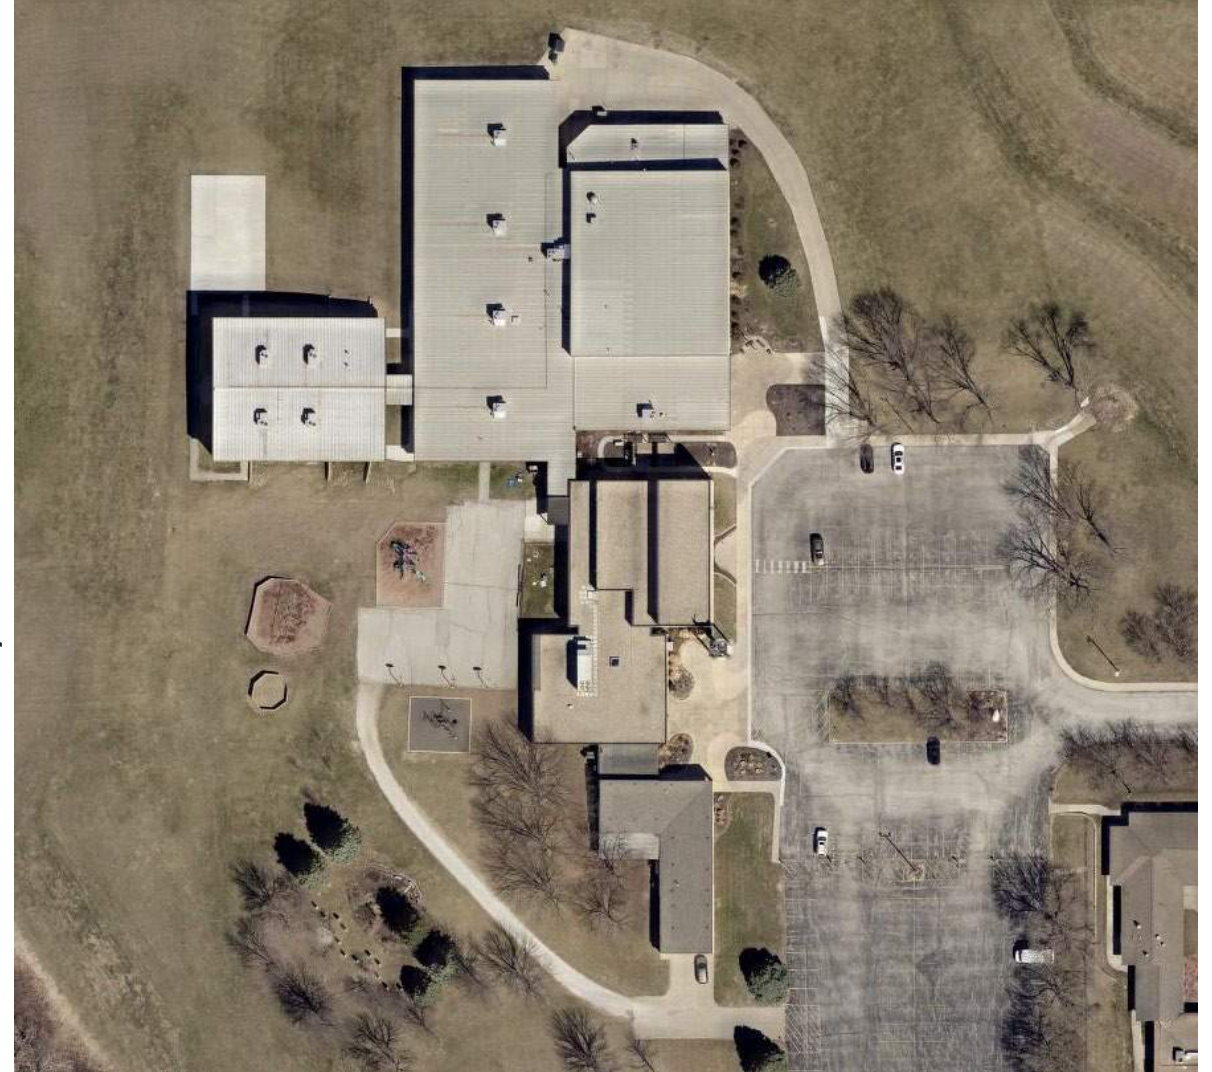
- Consider limiting access from the rectory driveway to the playground area with bollards.
- Look at resurfacing the drive.
- Connect all exterior doors with a paved surface for accessibility.

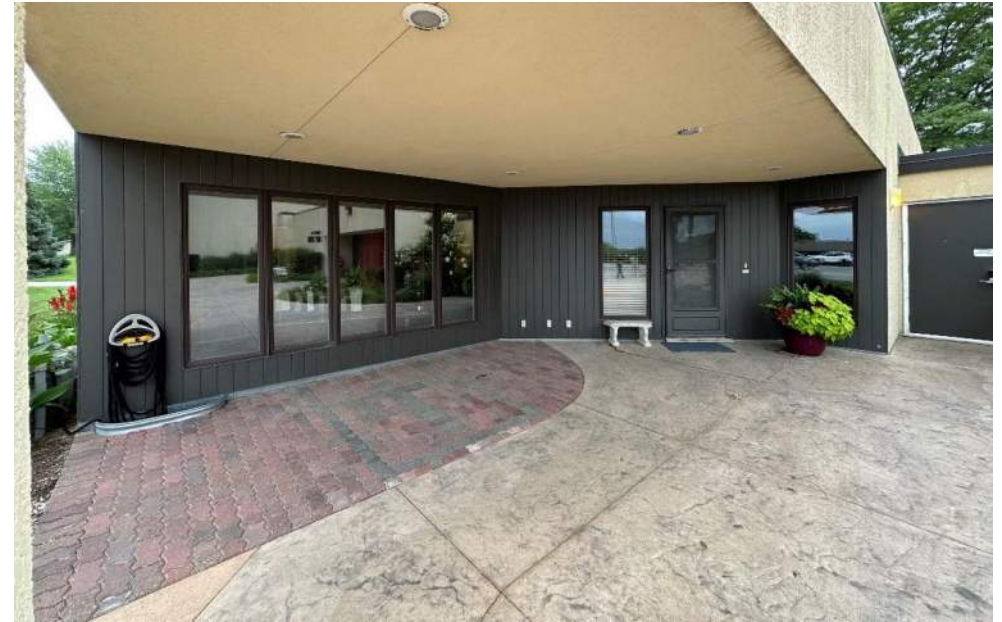
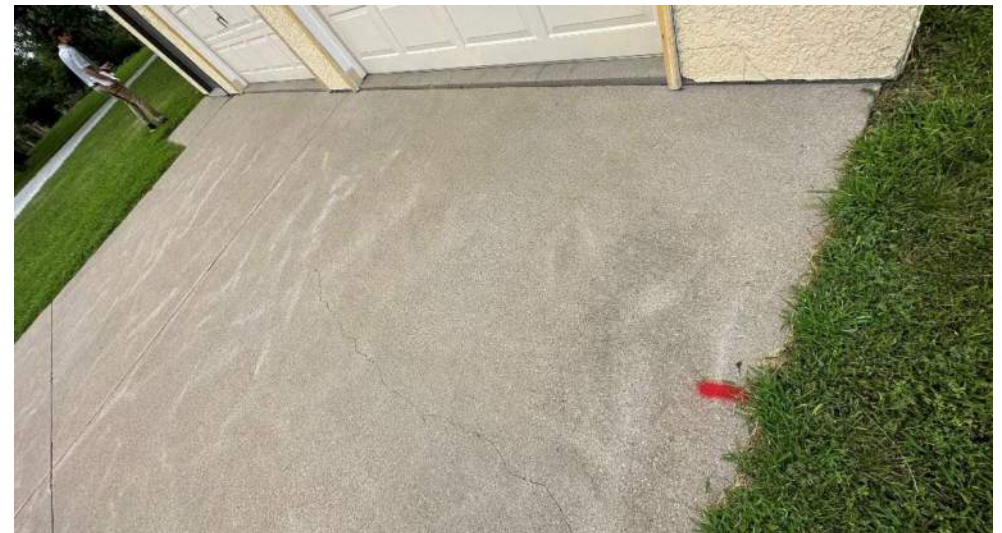
- Overall the pavement has been well maintained, including the colored concrete and pavers.
- There are a few areas of cracking in the driveway. Routing and sealing the cracks will increase the longevity of the pavement.

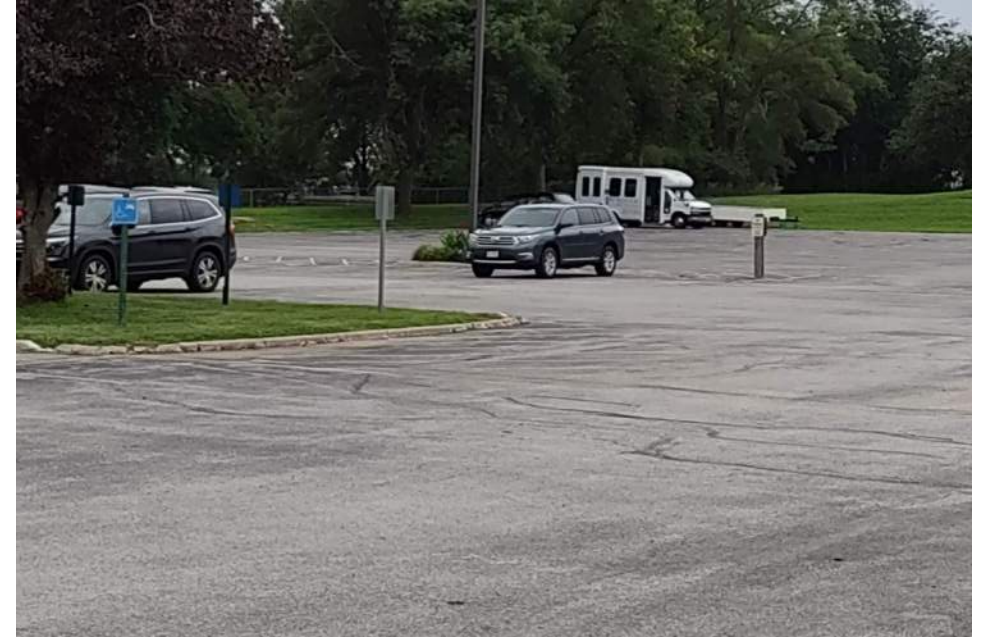
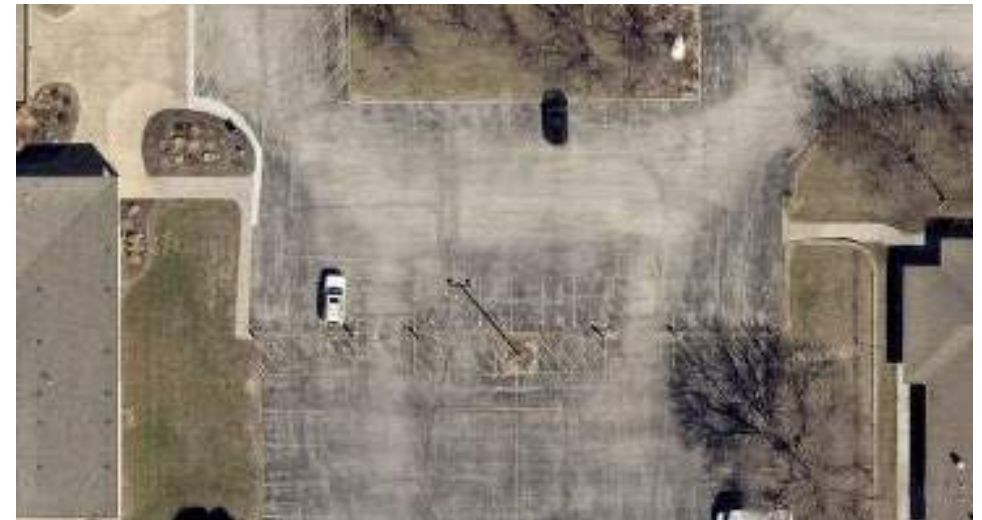
- The asphalt parking is reaching the end of it's life and considerations should be made for its replacement.
- Reorientation of the parking stall layout should be considered at this time.

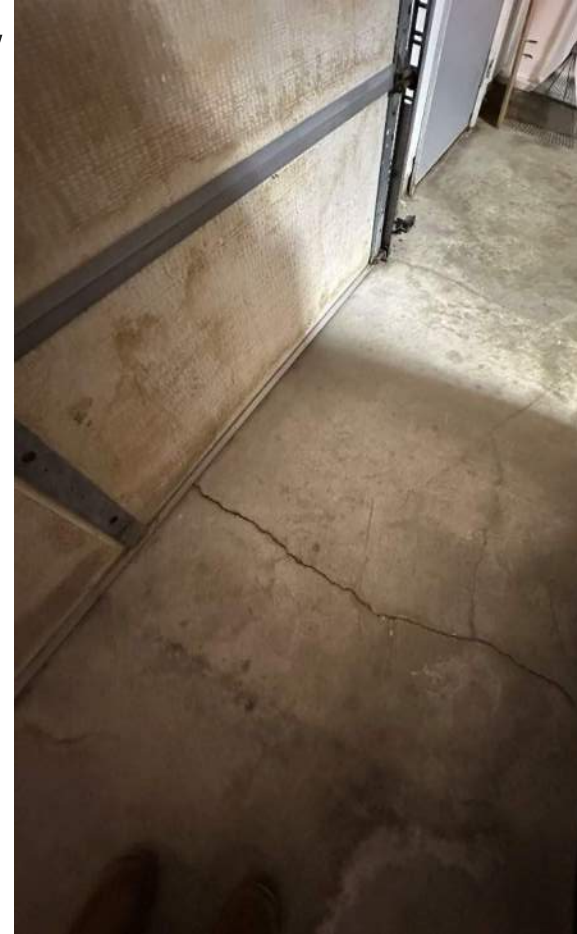
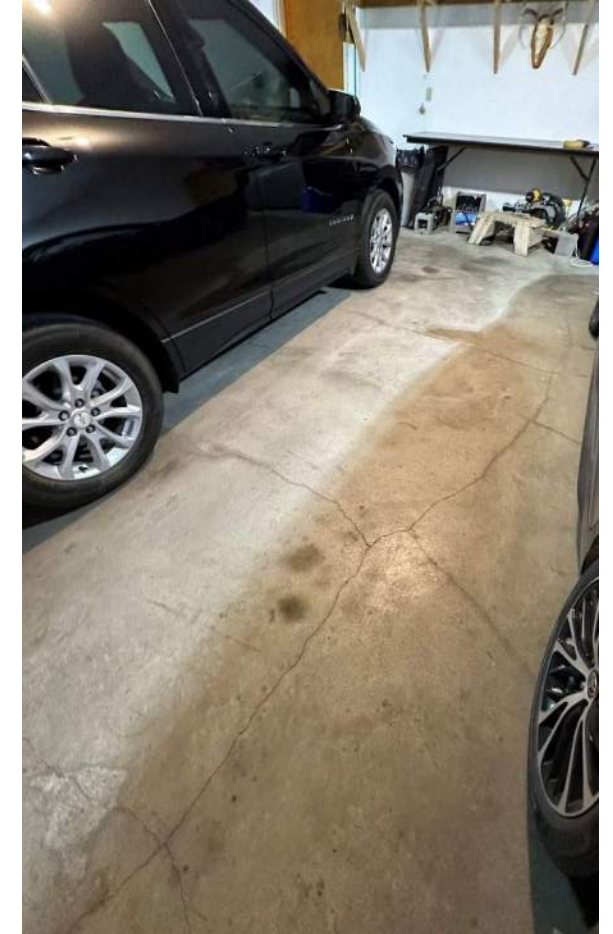
- Foundation is drawn up as continuous footings under the CMU bearing walls and spread footings under the columns. No foundation concerns were observed.
- Garage slab has some cracking.

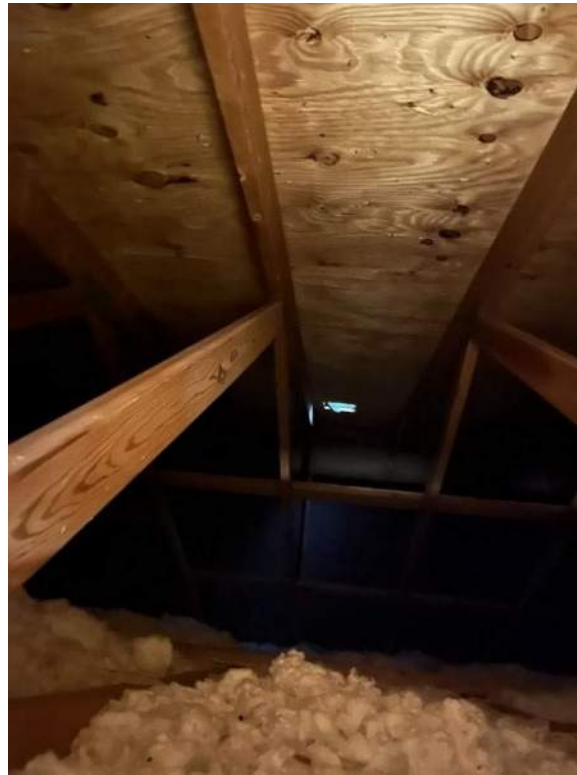
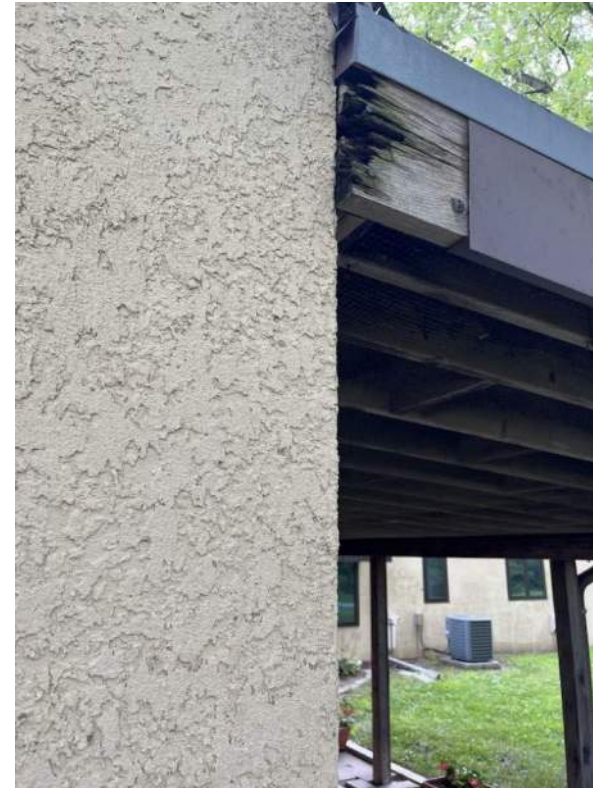
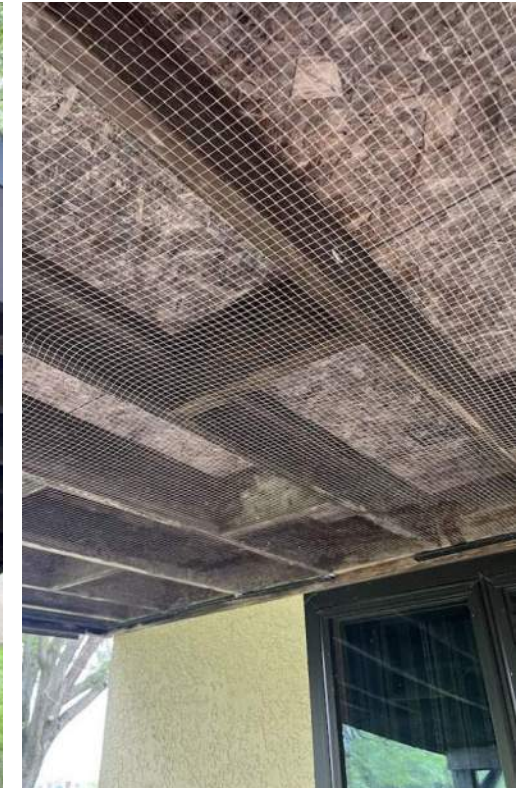
- Roof structural system is wood trusses.
- Roof of the patio has significant rotting on the exterior rafter.
- Exposed OSB at patio roof has potential for future corrosion.
- Garage ceiling shows signs of potential roof leaks.

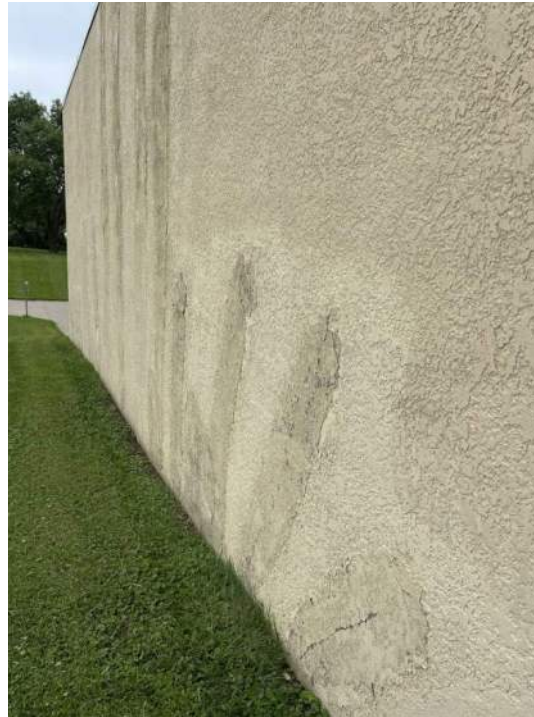
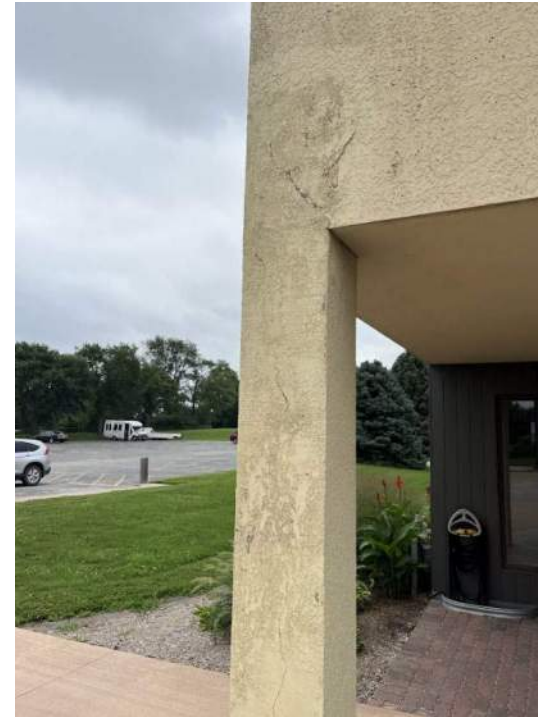
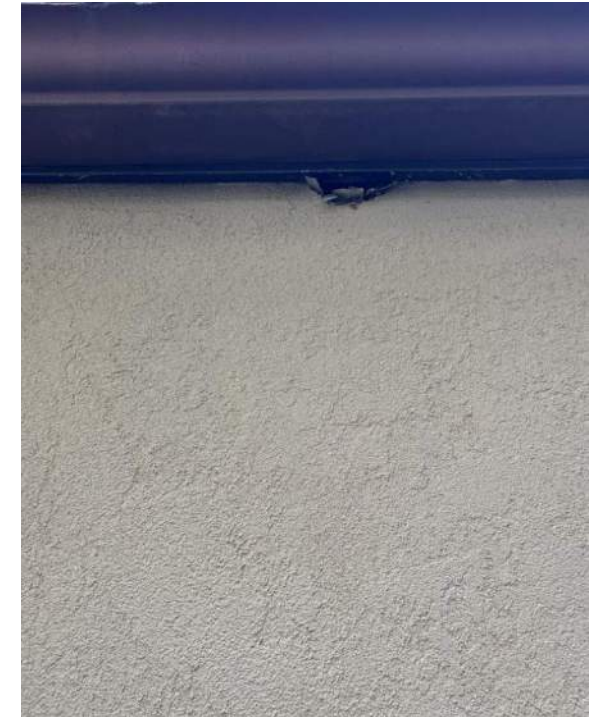
- Basement walls are bearing CMU. Appear to be in good condition.
- Above grade walls are stud bearing walls, and appear in good condition.
- Exterior finish is cracked and in poor condition.
- Recommend full replacement of exterior finish.

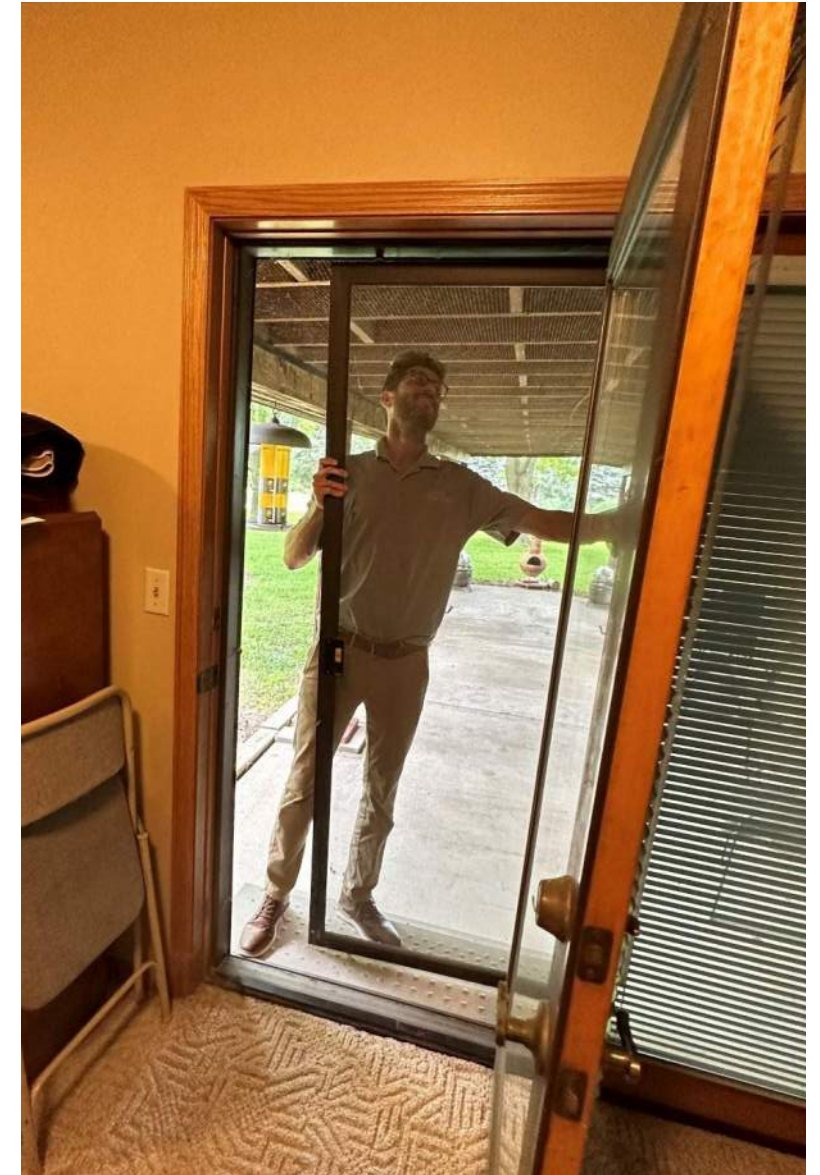
- Majority of existing windows, doors, and patio doors are in original condition
- Recommend a full window replacement due to age
- Screen doors come off of tracks easily. Recommend cleaning, greasing, and resetting tracks as part of a temporary fix before full replacement.

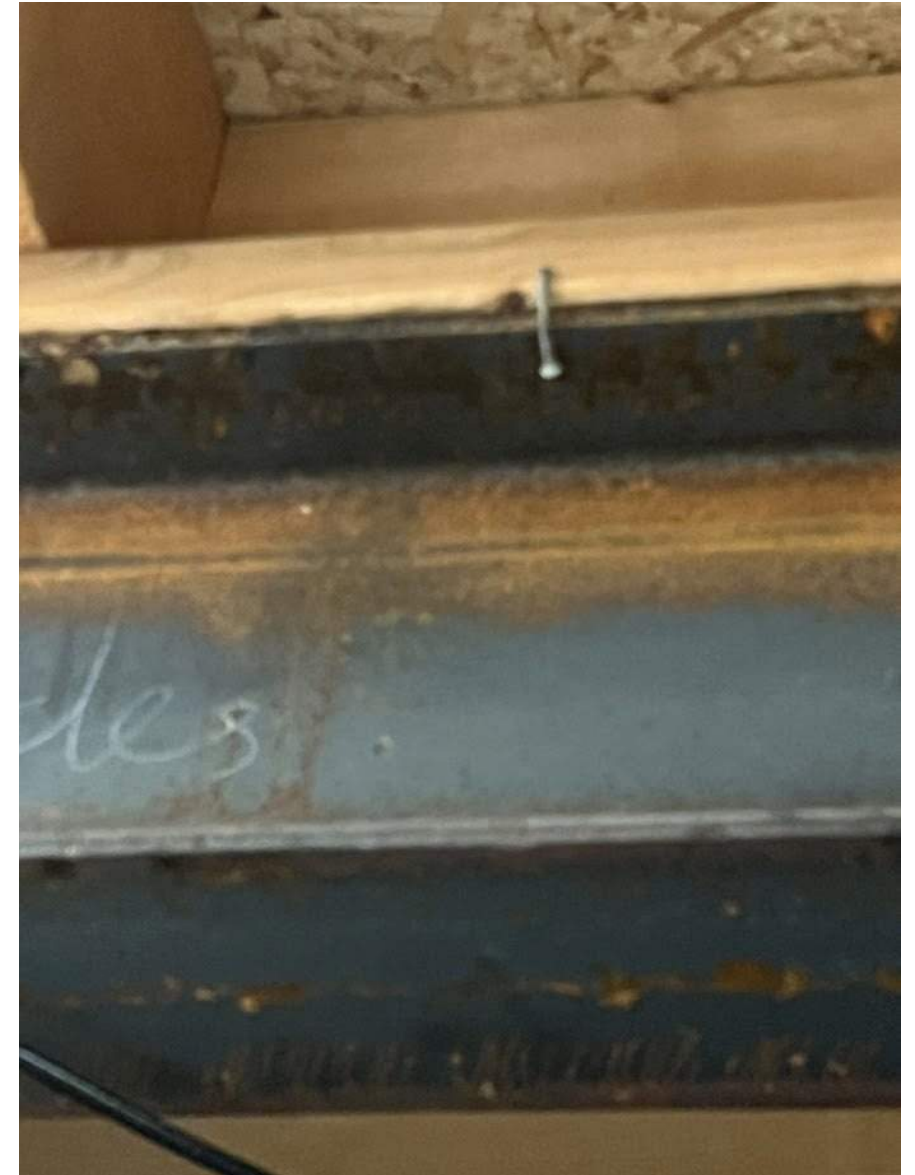
- Structural system consists of CMU bearing basement walls with intermediate steel framing. Above grade structure is wood bearing walls and wood roof trusses. Overall the structural systems appear in good condition.
- Top plate connection to the steel does not appear to be rigidly attached.
- Steel is unpainted. Painting the steel beams and columns would prolong the lifespan of the structure.

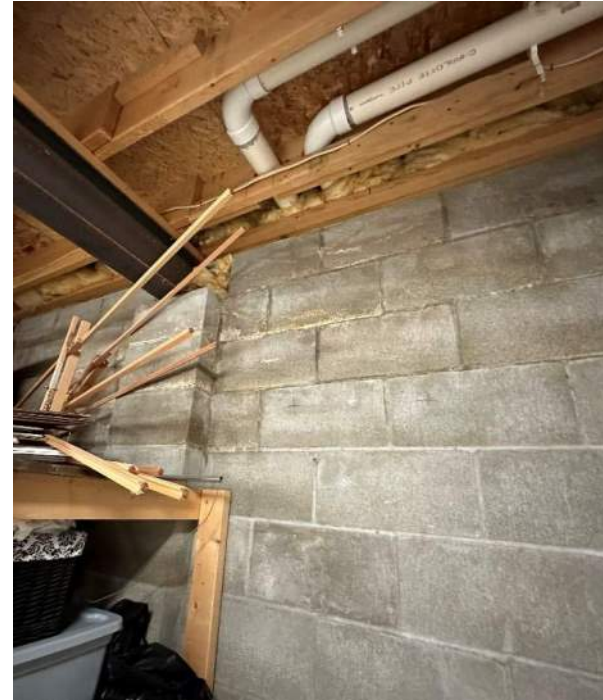
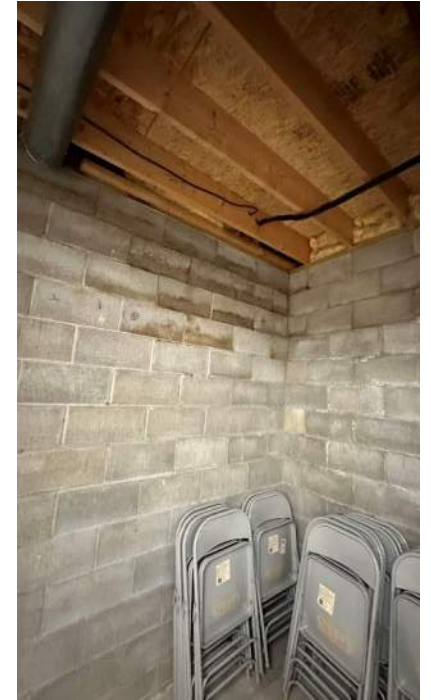
- Basement walls are unfinished CMU with extensive water infiltration observed. Recommend regrading exterior site to prevent water infiltration
- If the basement is finished, walls should be sealed and furring should be added to allow for proper ventilation
- Walls on the main level are in good condition and typical for a well-maintained residence

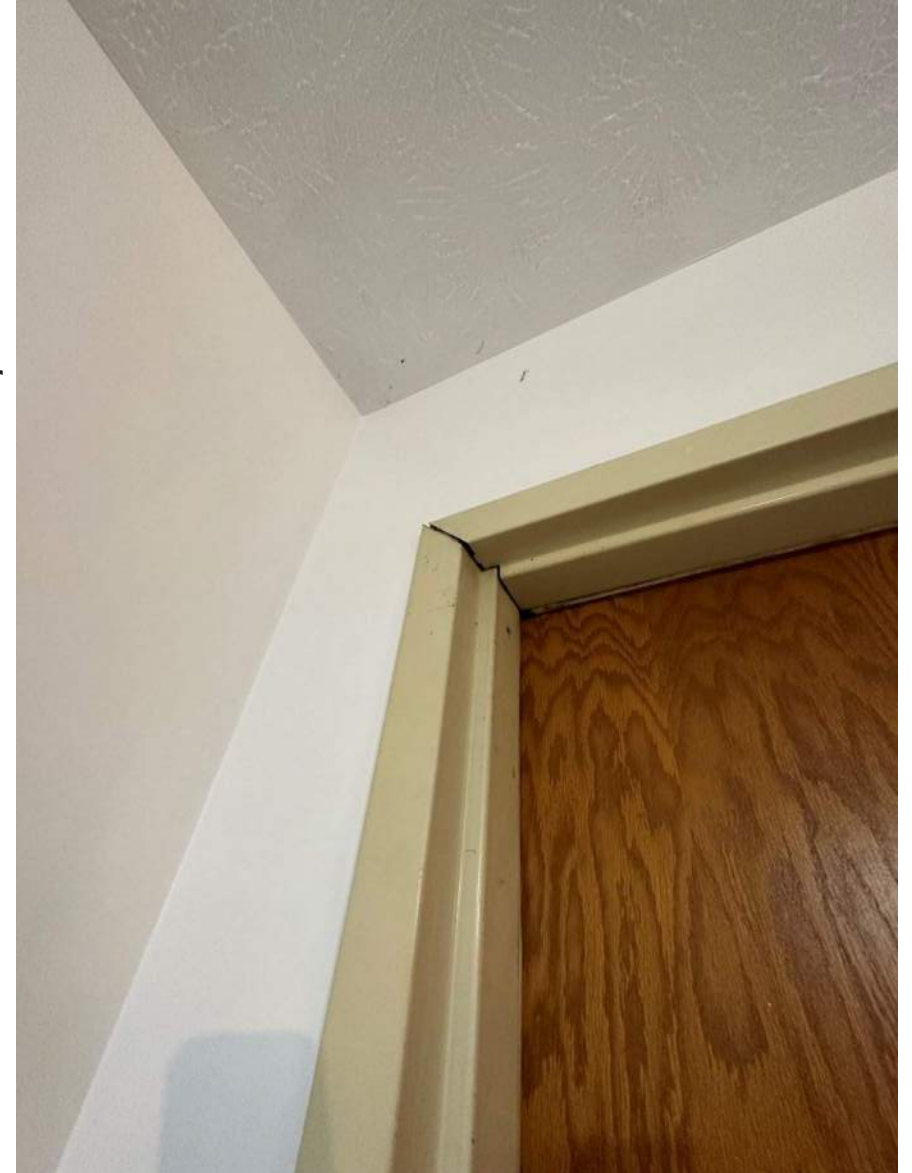
- Majority of doors are good condition wood doors in wood frames typical of a residence
- Hollow metal frames are provided when required for fire separation and are in poor condition and no longer meet fire code requirements. Replace as part of a larger renovation project

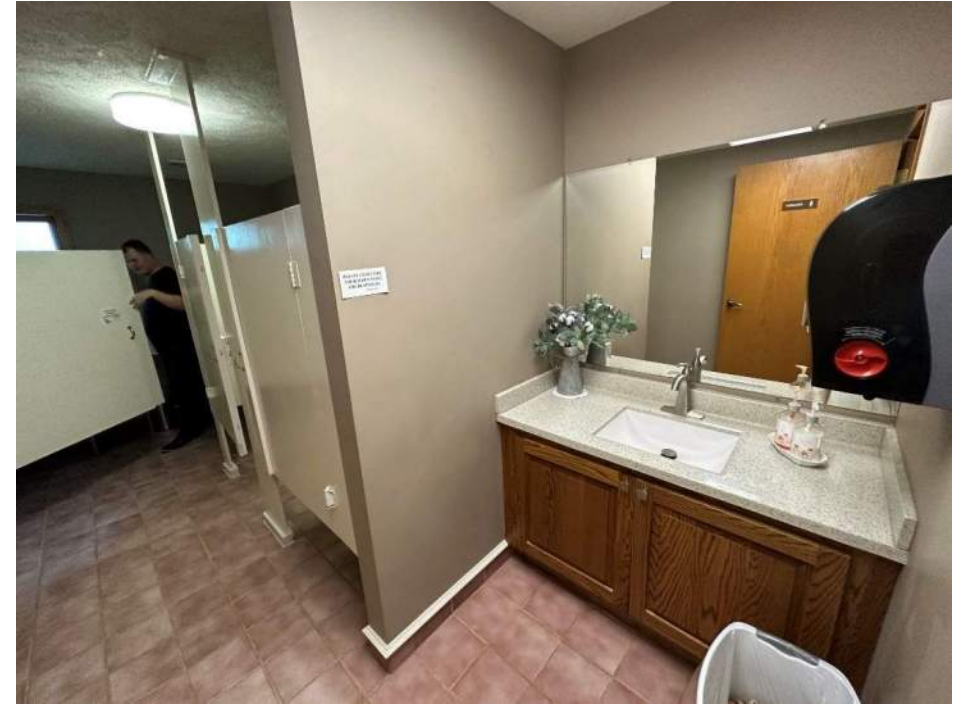
- Women's Restroom is an addition between the commons and rectory
- Stall partitions and doors are made from plywood and do not meet current codes
- The partition doors are loud and disruptive
- Wood partitions do not hold up well to water commonly found in restrooms
- A full renovation or replacement should be planned after consulting the master plan

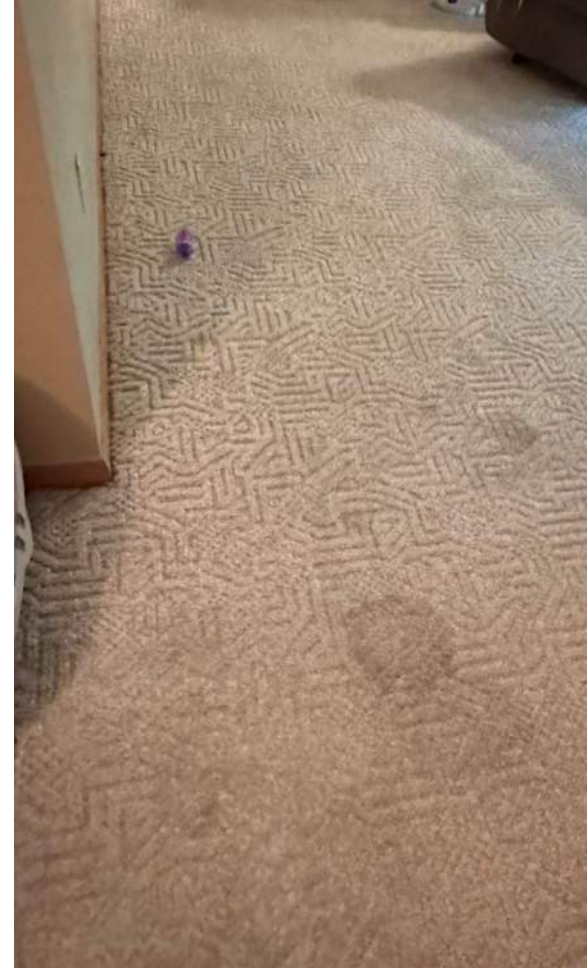
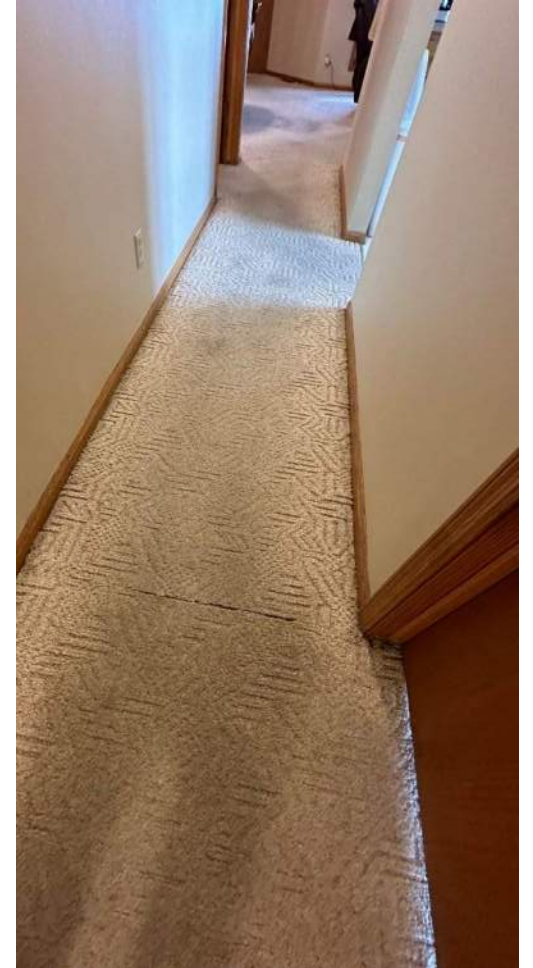
- Floor in rectory is primarily broadloom carpet in poor condition
- Staining, wear spot, and separation observed consistent with assumed age
- Recommend full replacement of carpet with similar residential carpet or hard surface flooring

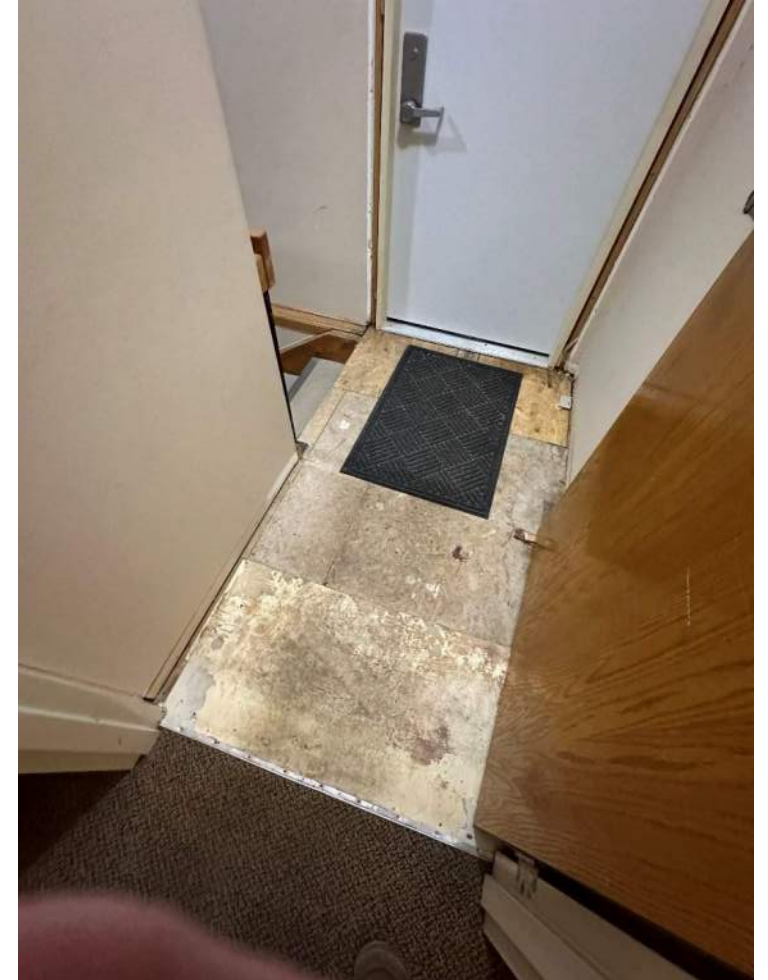
- Hard surface flooring found in rectory is in varying condition
- Poor condition hard flooring found at top of stairs especially near exterior door and potential deterioration from water
- Loose rug can be a tripping hazard and not acceptable for most building insurance policies
- Recommend installing either walk-off carpet or hard flooring with proper grip

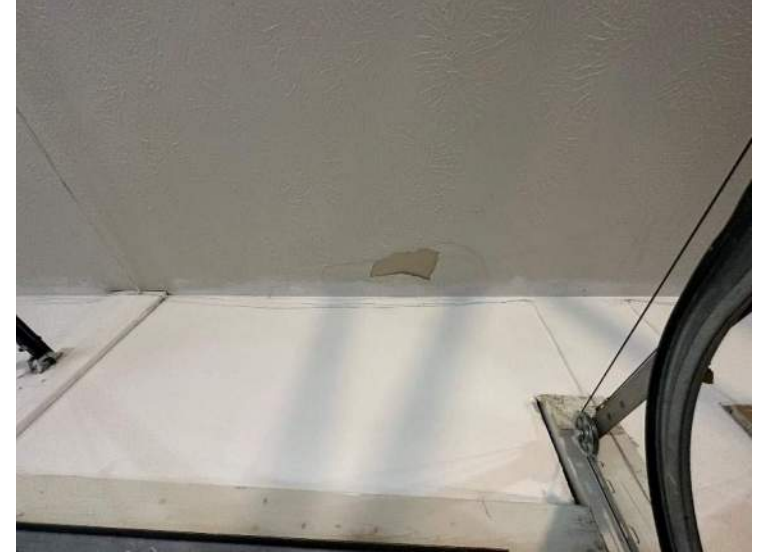
- Ceilings are drywall attached to structure in overall acceptable condition
- Some areas appear to be repaired previously
- Some water infiltration observed in garage above doors
- Further exploration required to determine source of water
- Recommend correcting soon to prevent any further damage and potential mold in walls

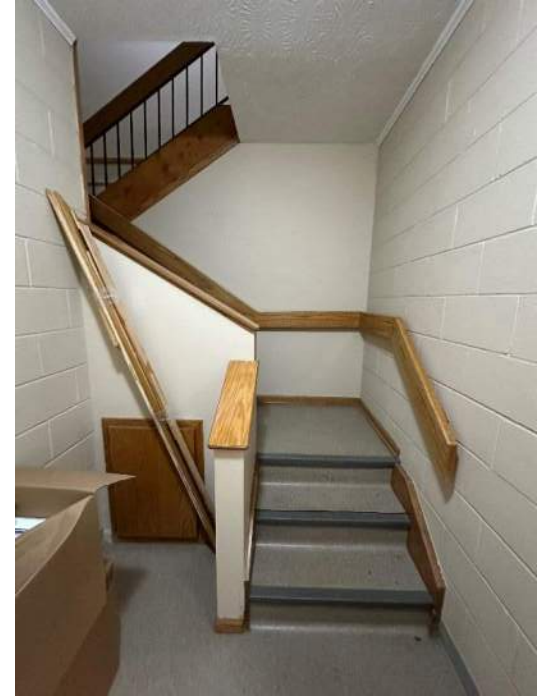
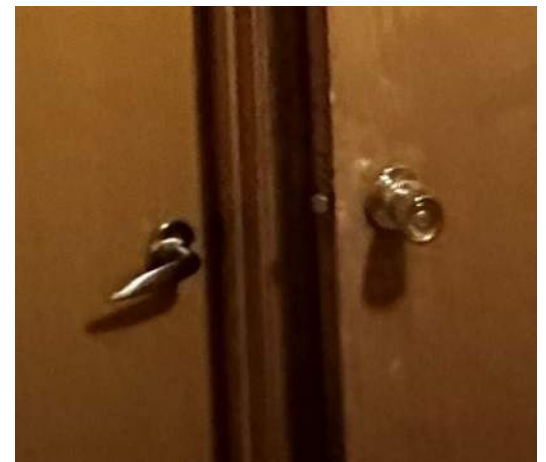
- Inconsistent hardware found throughout residence
- While not a code requirement, replacing with consistent levers would be recommended
- Stairs to the basement are complicated and not code compliant for commercial spaces
- If basement is renovated for a different use, a full update to the stairs will be required

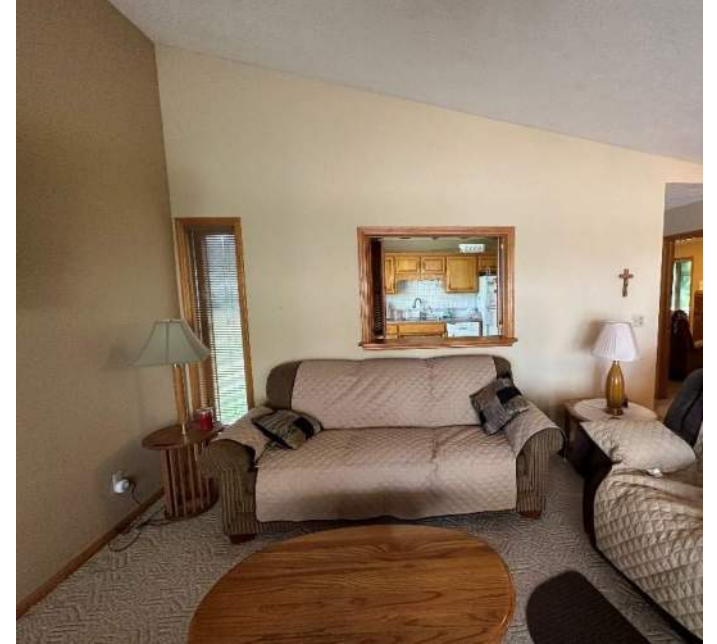
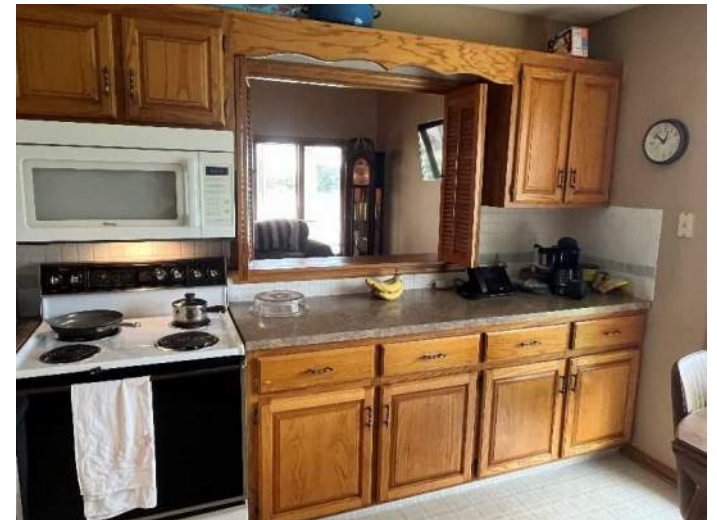
- The rectory is consistent with a typical residential building of its age.
- Some finish upgrades should be completed as outlined throughout this section.
- The restroom and office addition appears to be of similar construction type to the rectory but connection details to the adjacent buildings is unknown and could be spots for water infiltration and cracking due to lack of expansion joints.
