CLARK &
ENERSEN

CHURCH OF THE HOLY SPIRIT
FACILITY CRITICAL NEEDS ASSESSMENT

JANUARY 2024

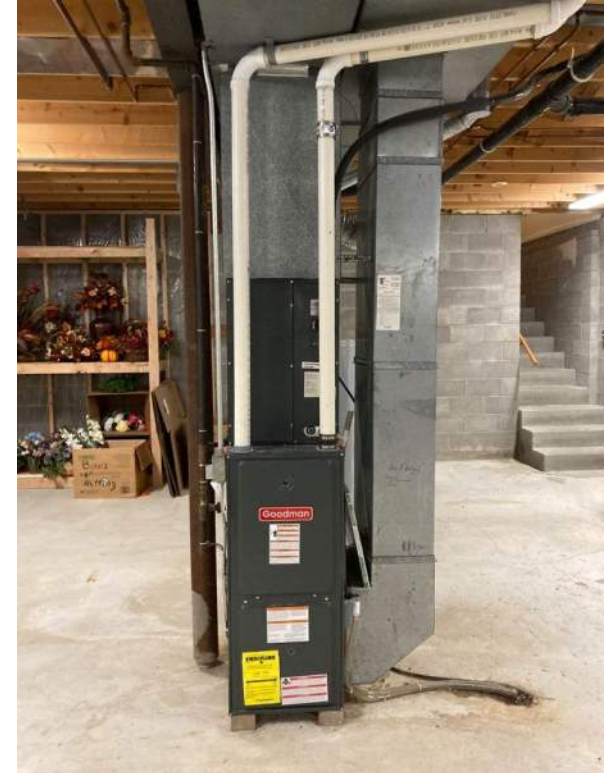
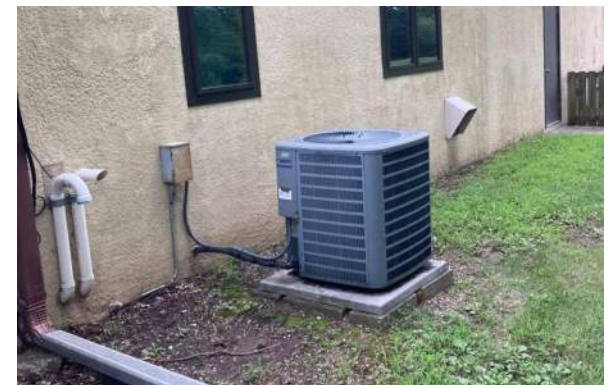
- Equipment
 - Two furnaces & condensing units w/ humidifiers
 - South Furnace serves south half of building (Dining Room, 2 Bedrooms, Kitchen, Living Room, Laundry)
 - North Furnace serves north half of building (Bedroom, Pastors Suite, 3 Offices, Waiting, Entry)
 - Recommend cleaning ductwork w/ floor registers every 10 years for good air quality.
 - Manufactured in 2008
 - Ashrae Median Life Expectancy
 - Furnaces: 18 years
 - Condensing Units: 15 years

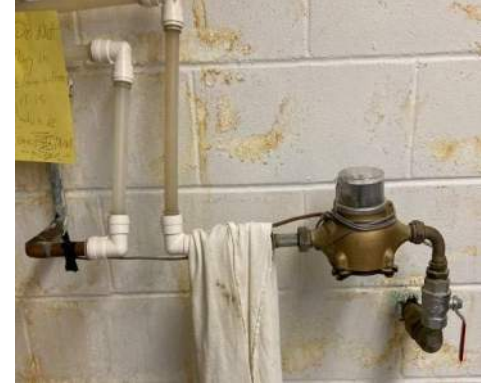
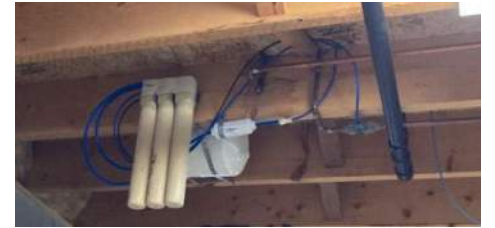
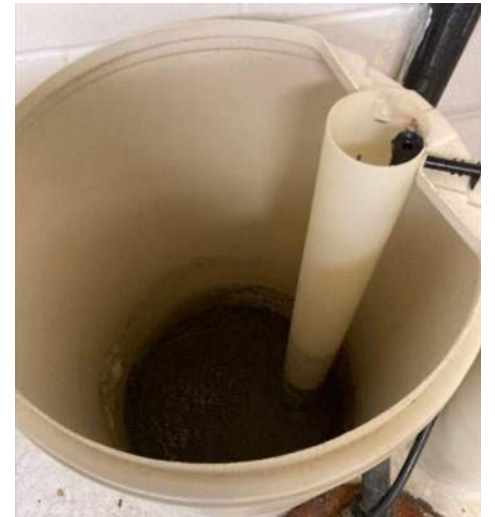
- Fixtures
 - Manual faucets
- Supply
 - ¾" water service
 - No insulation on domestic water piping. Recommend insulating hot water piping per energy code.
 - RO system for kitchen sink observed.
 - Provide regular maintenance for water softener, adding salt as necessary.
 - Recommended to route new unsoftened cold water to wall hydrants since all cold and hot water is currently being softened.

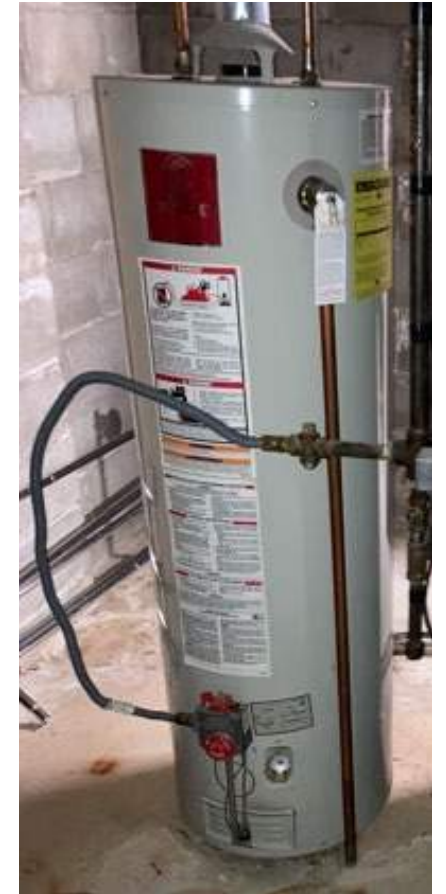
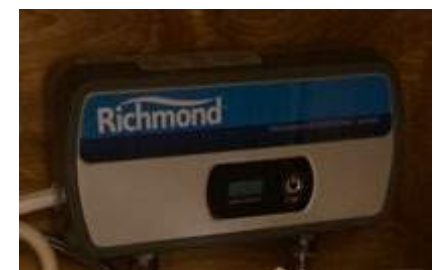
- Storm Sewer
 - Gutter & downspouts
- Sanitary Sewer
 - No issues reported or observed.
- Irrigation
 - None observed.
- Equipment
 - Two gas water heaters
 - Manufactured in 1999 & 2016
 - Replace upon failure
 - An instantaneous electric water heater serves the women's restroom (2016).

Rectory Hot Water Heater - Gas - 40 gal	1999
Rectory Hot Water Heater - Gas - 40 gal	2016
Women's Restroom Instantaneous Elec Water Heater- 3.5 kW	2016

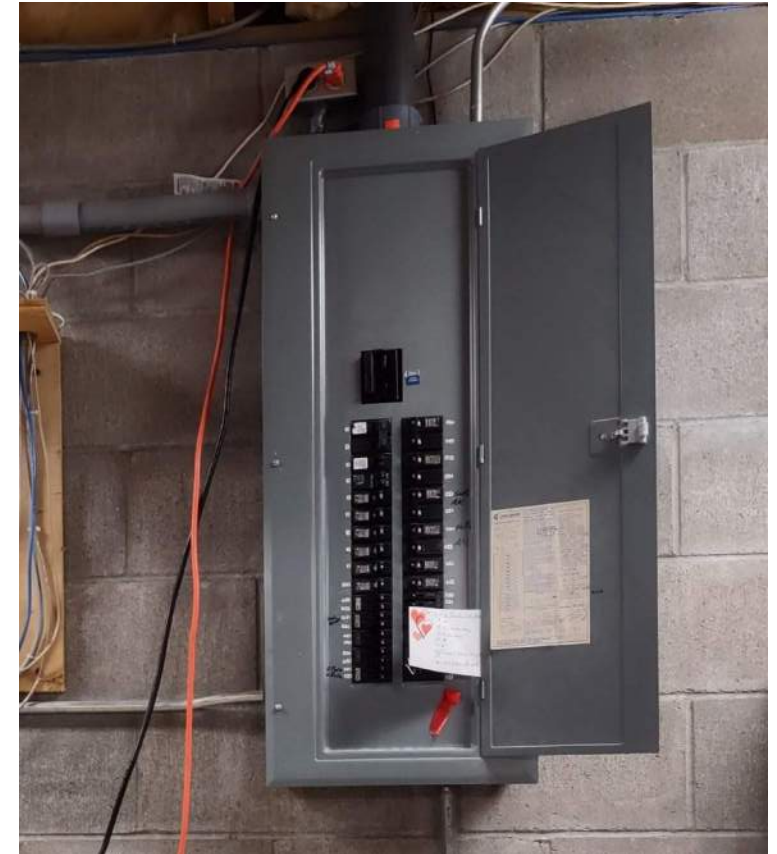
- The rectory electrical service is single phase, and is fed from the same transformer as the church, but is metered separately.
- There is a single 200 amp panelboard in the basement which serves the living spaces and the offices. There are no spare, or spaces, on this panelboard.

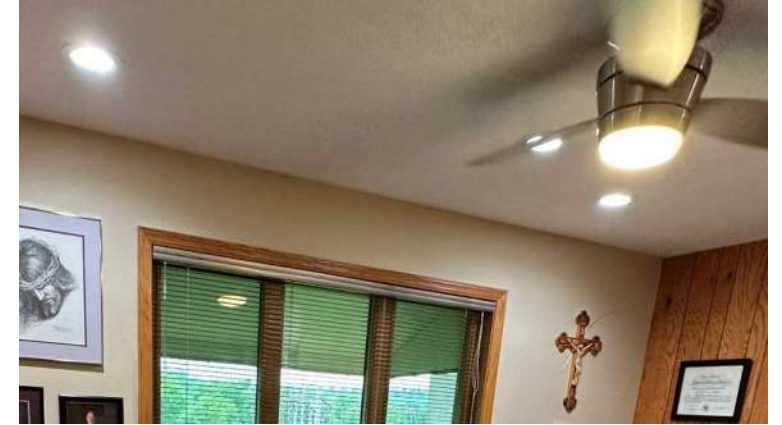
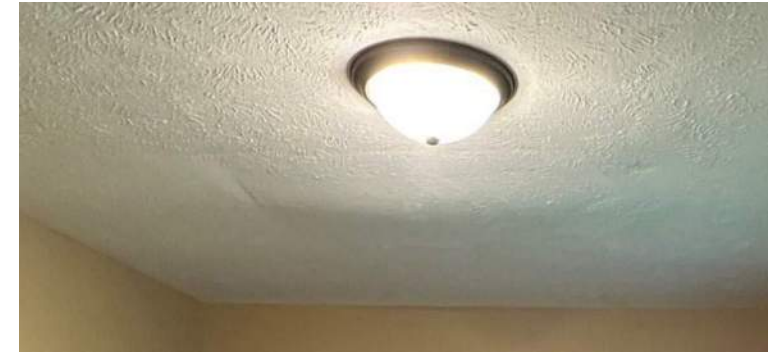
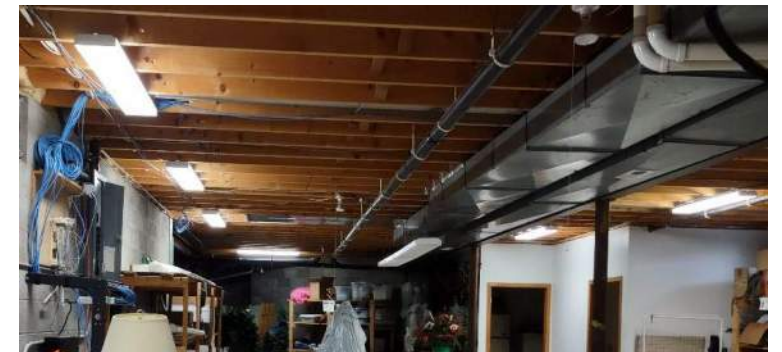
- Incandescent lighting in the residential and office areas, with surface mounted, lensed, 4' fluorescent lighting in the basement.
- Recommend replacing fixtures with LED lighting at least in the office areas.

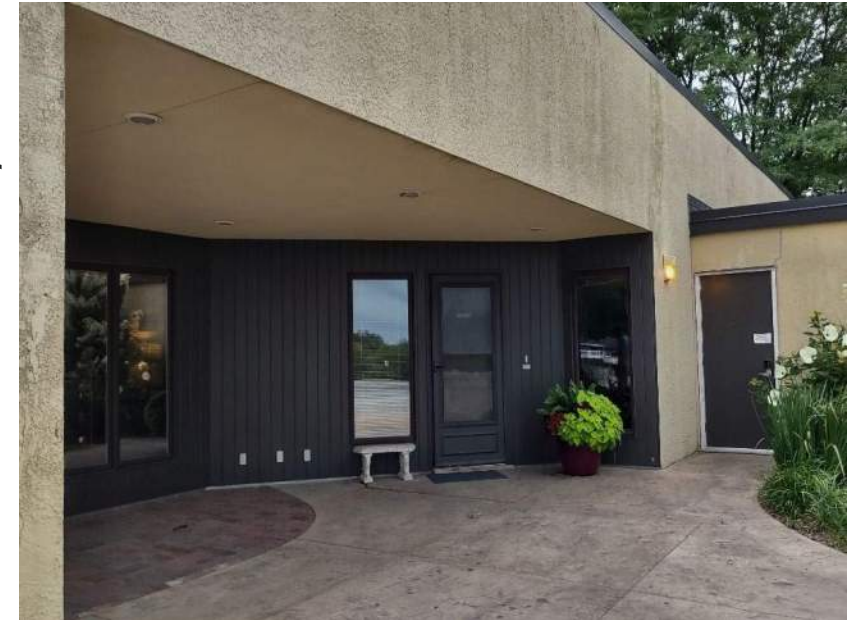
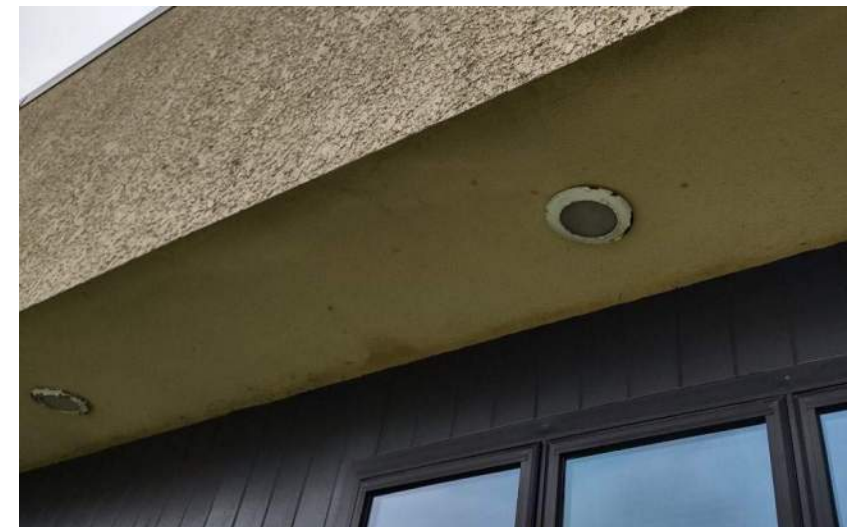
- Exterior wall mounted light fixtures, or recessed downlights, are located at most of the exterior doors, and most have been replaced with LED fixtures. Downlights have peeling paint on the trims and look rather worn. Recommend replacing these downlight fixtures with LED type.
- Recommend adding exterior emergency lighting/function at the door near the offices.

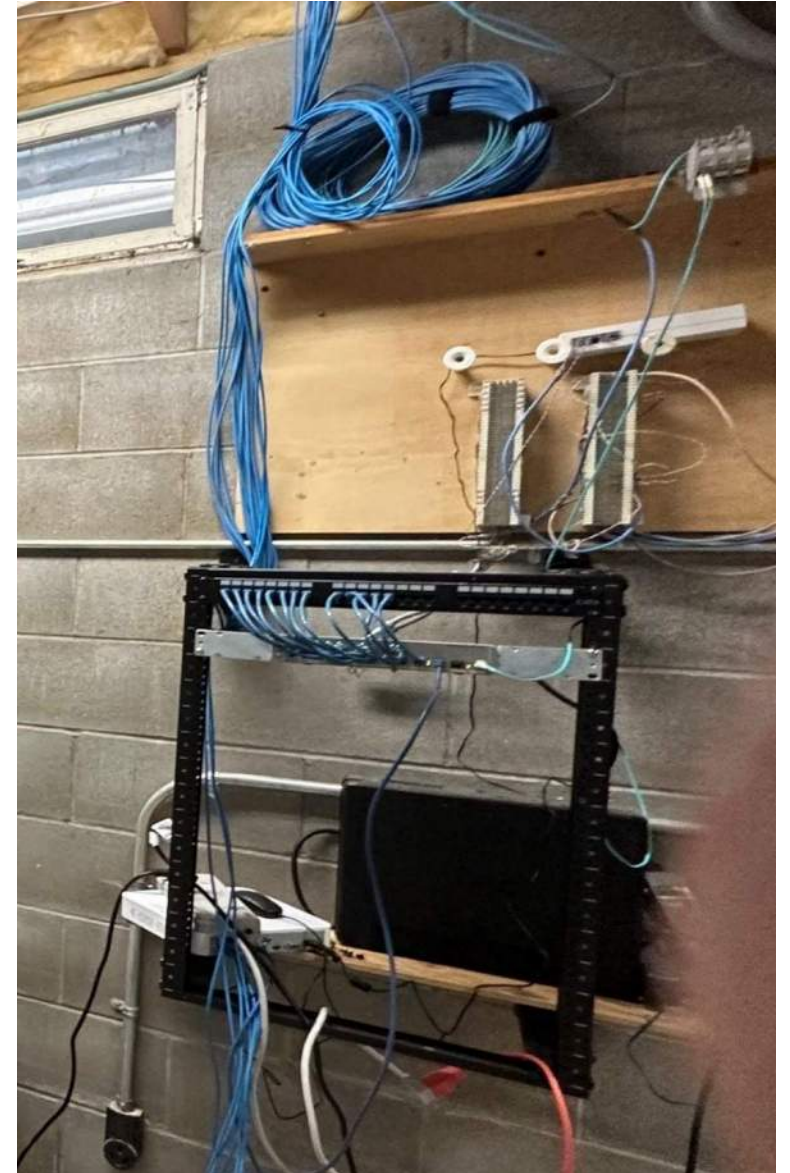
- Fiber service entrance is located in the basement, and appears to also feed the telephone/data devices in the church.
- Small server rack is also located in the basement.

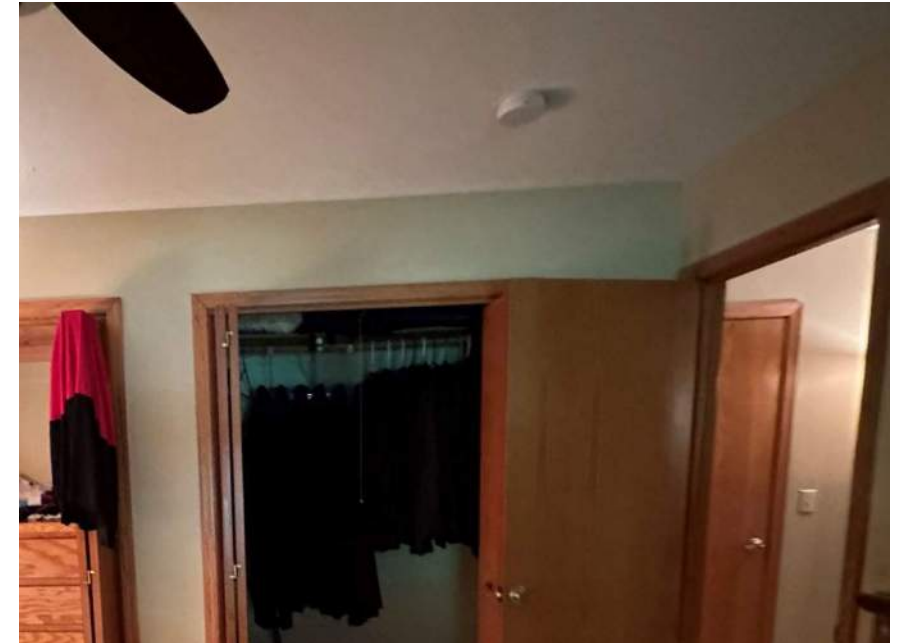
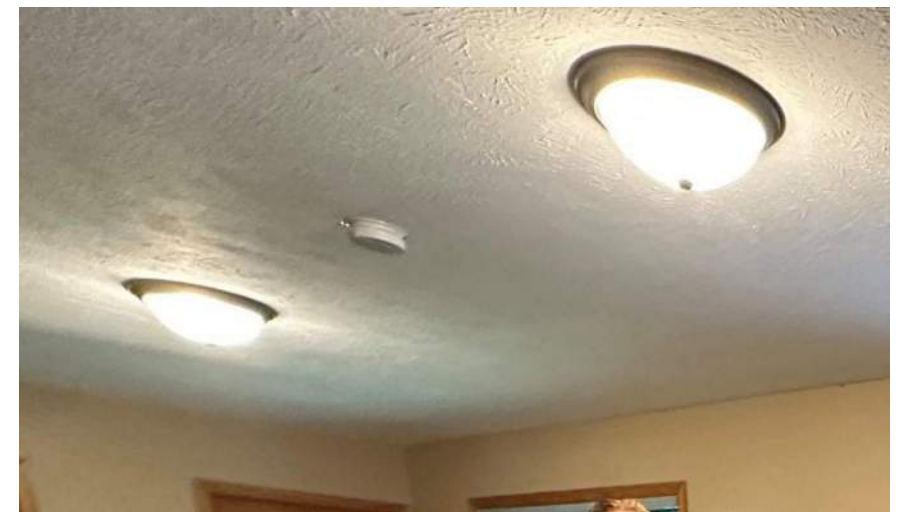
- Observed stand alone, residential type smoke detectors in the resident portion of the rectory, but there is no fire alarm system.
- If/when a fire alarm system is added to the church, recommend extending devices from this system into the rectory portion of the building.
